National TAB  
1329 E. KEMPER ROAD  
SUITE 4210  
CINCINNATI, OH 45246

**Report: TAB REPORT**  
**Function: Test, Adjust, & Balance**  
**Date: 01/30/2024**

**12-25-23 MEZEH HAMILTON TOWNSHIP, NJ**

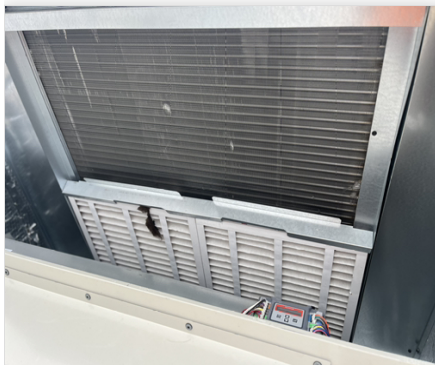
Missing\_filters  
01/30/2024

**Issue Name :** Missing filters for RTU-1  
**Description :** RTU-1 is missing 2 filters. Recommend installing filters prior to sites opening.  
**Created By :** National TAB                      **Assigned To :** National TAB - David Annan  
**Status :** Open  
**Priority :** Medium                                      **Asset Tag :** RTU1  
**Originated Date :** 01/30/2024 - David Annan - National TAB
