Pre-Grid Punch List CFA 5702

Prepared by Will Turnbough

Jul 10, 2025

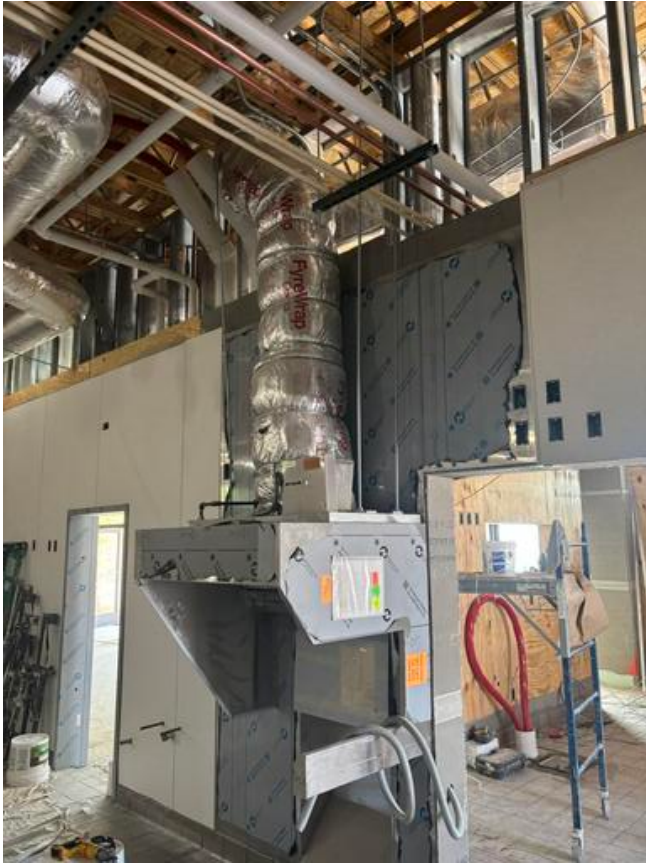
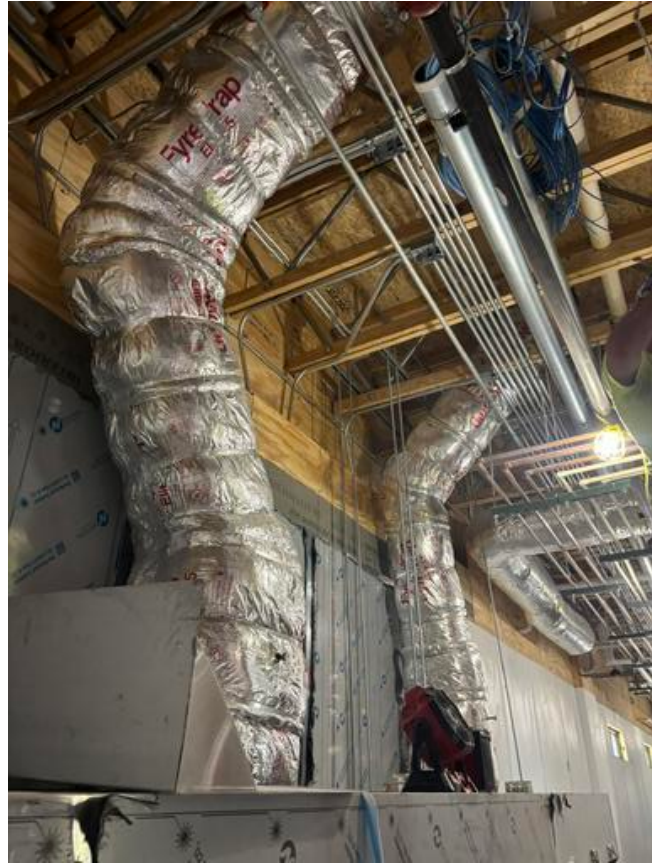
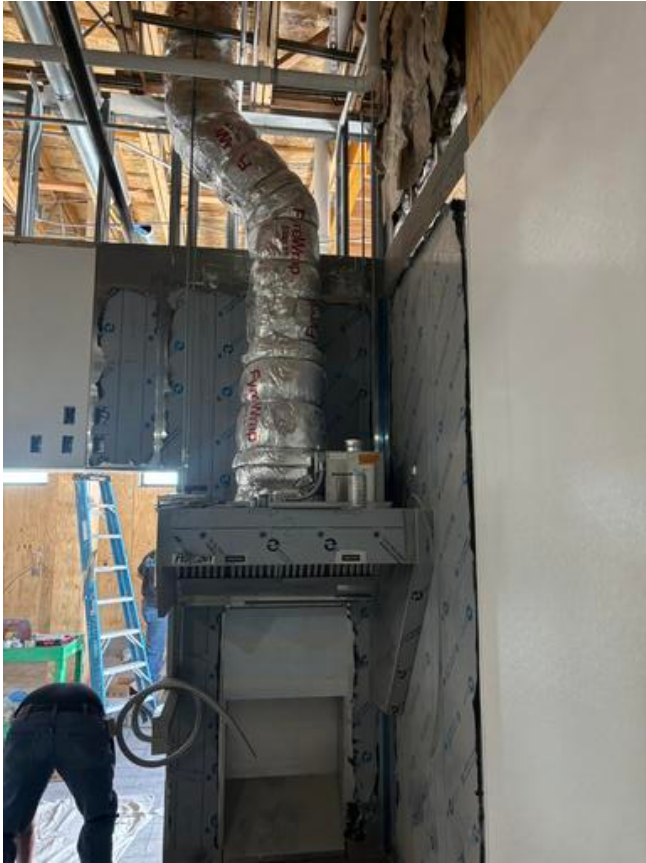
#42 [EXHA 003] [NEW] CRITICAL – Incorrect grease exhaust duct ells.

Grease ductwork not constructed with long radius centerline $R=3W/2$ fittings per specification. Short radius, mitered ells, and offsets greater than 45 degrees are not allowed.

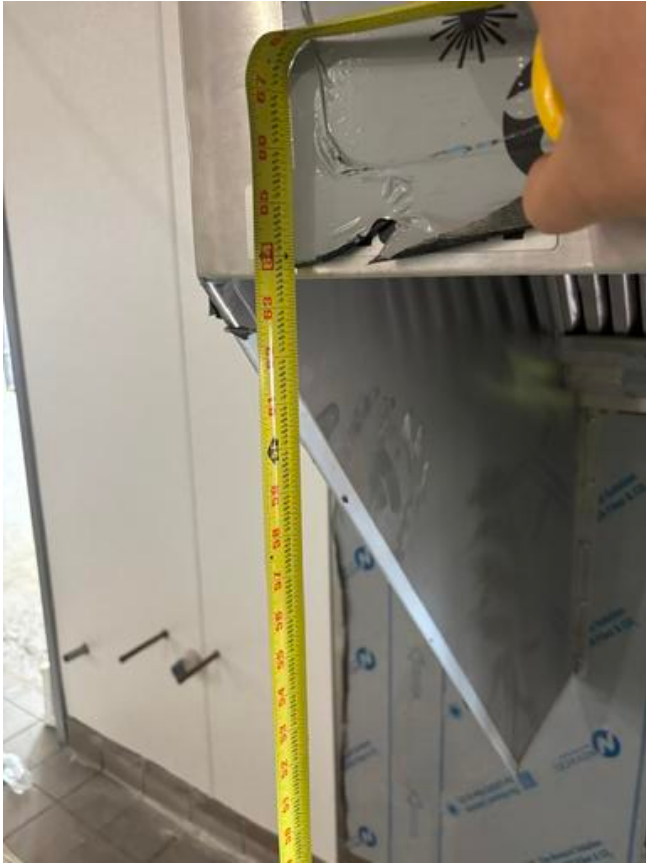
IMG_3130

#41 [HOOD 006] [NEW] CRITICAL – Improper hood height.

Hoods not hung to design measurements from Halton shop drawing. Review hood height and make duct adjustments in riser to accommodate. Biggest deviation is hood 2 which is at 63.5". The other hoods are all within 1/4"

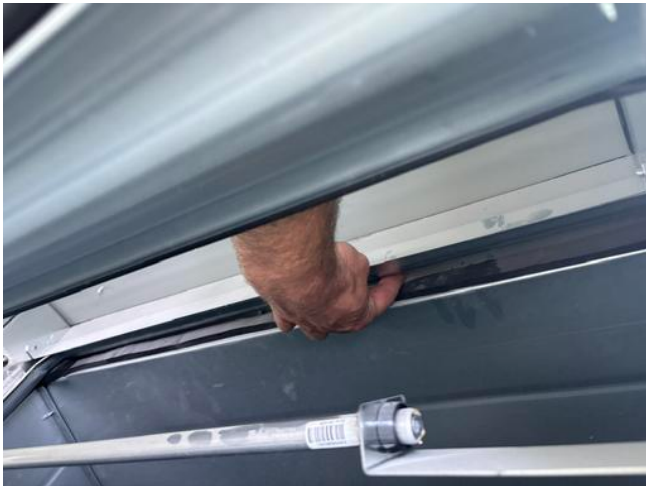
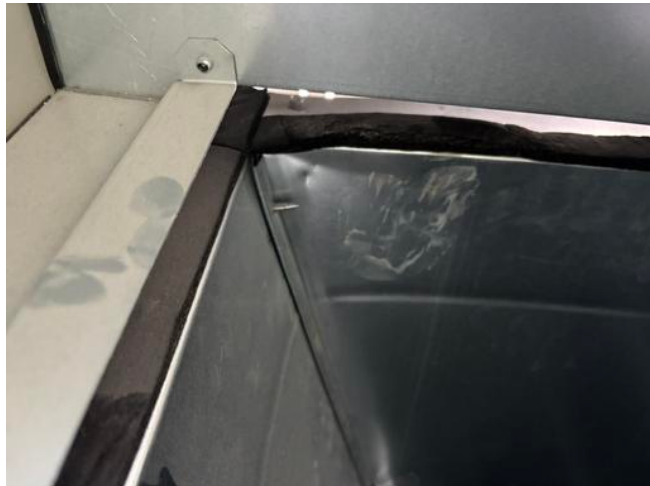
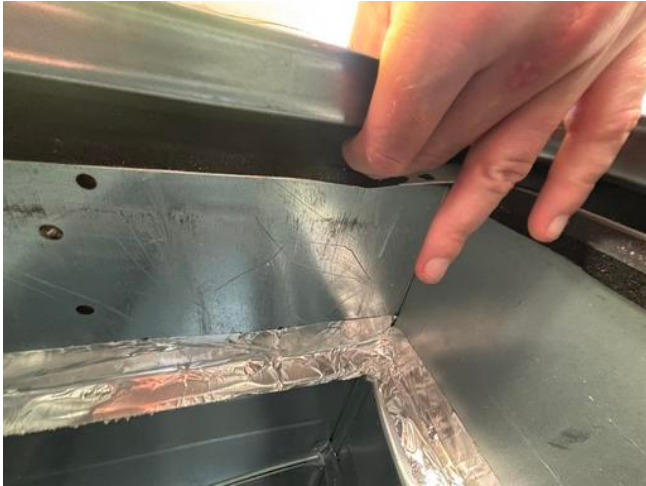
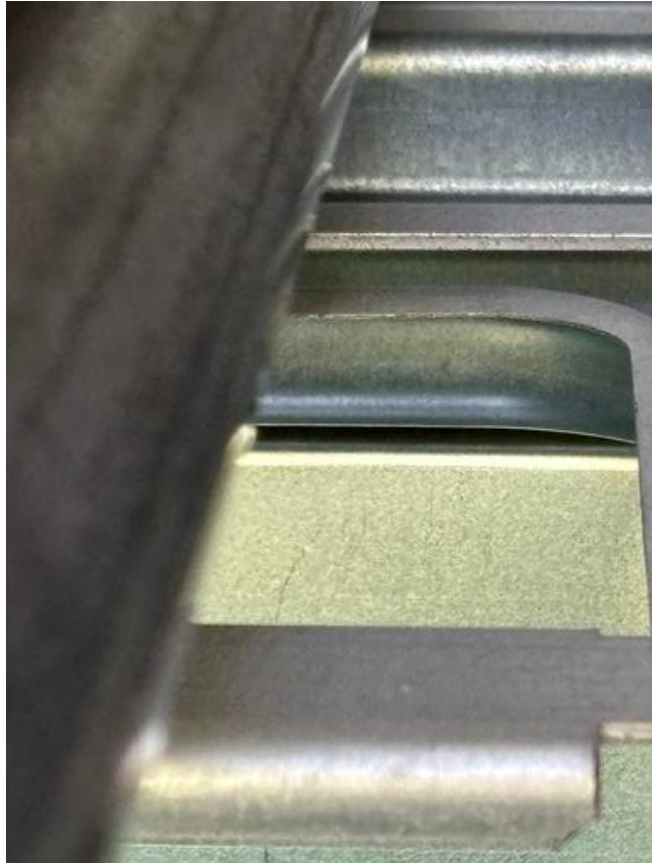
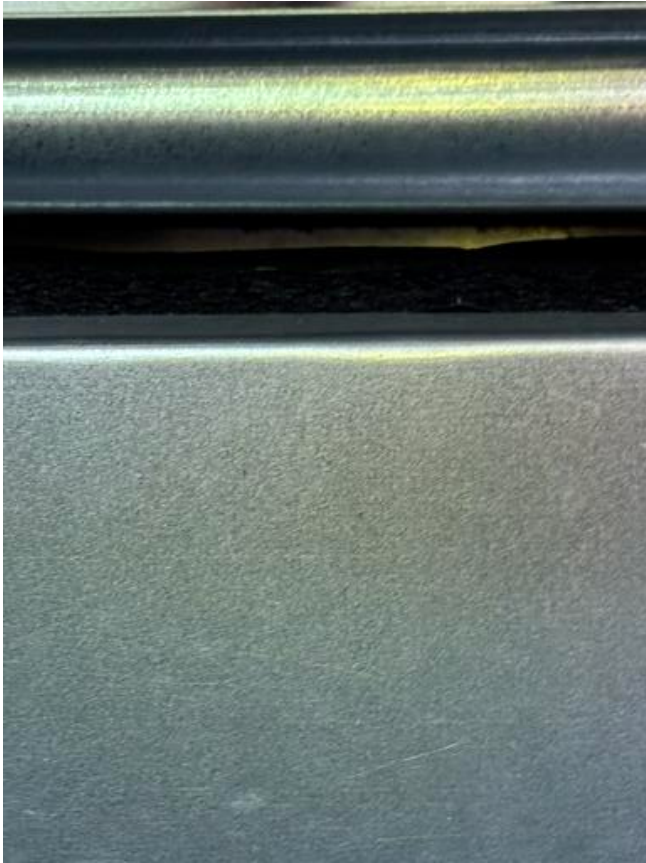
#40 [UNIT 001] [NEW] CRITICAL – Equipment is leaking air.

There is gapping at connections of ducts to AC's and/or the ducts are not aligned properly. Units need to be reset on the curbs.

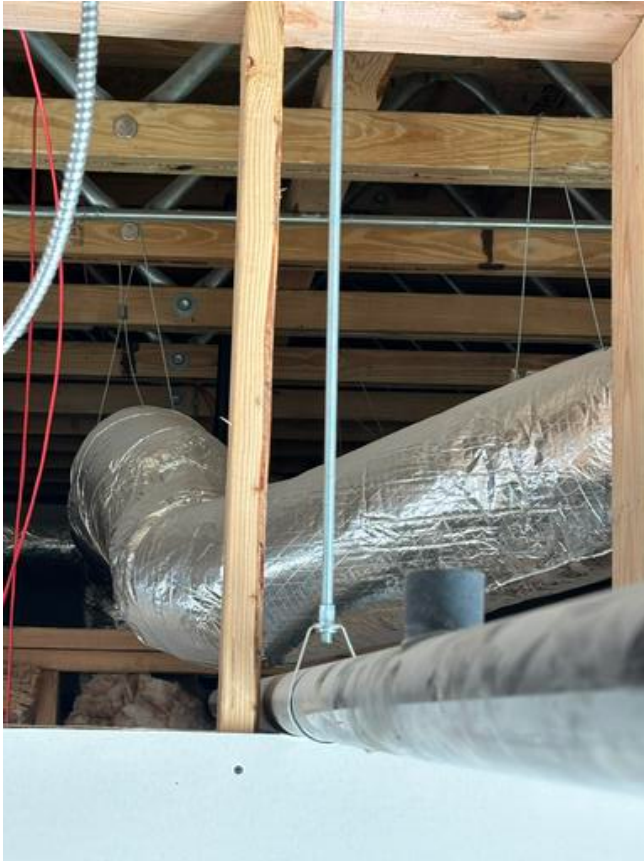
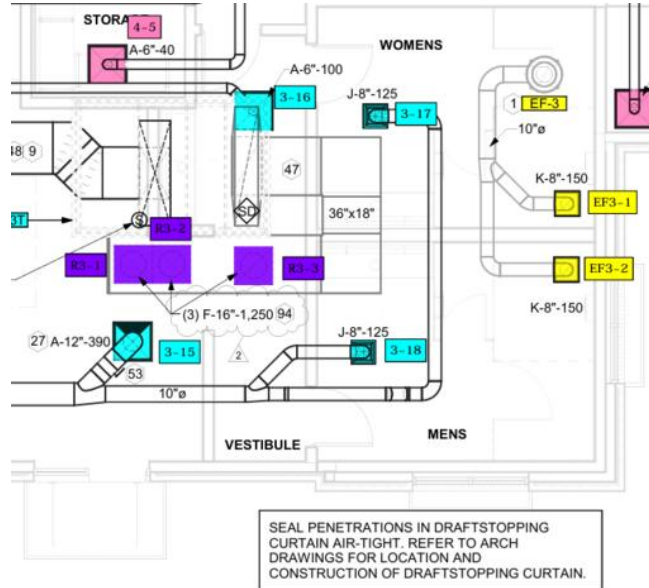
#38 [DUCT 017] [NEW] CRITICAL – Duct not installed per plans.

Diffuser 3-18 has additional bend in duct that needs to be removed.

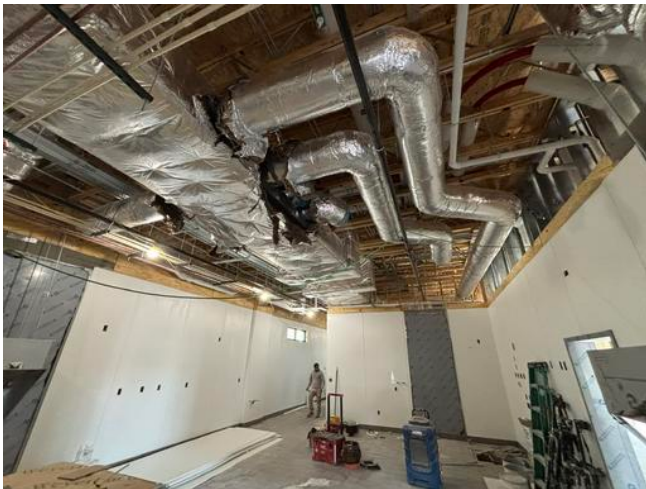
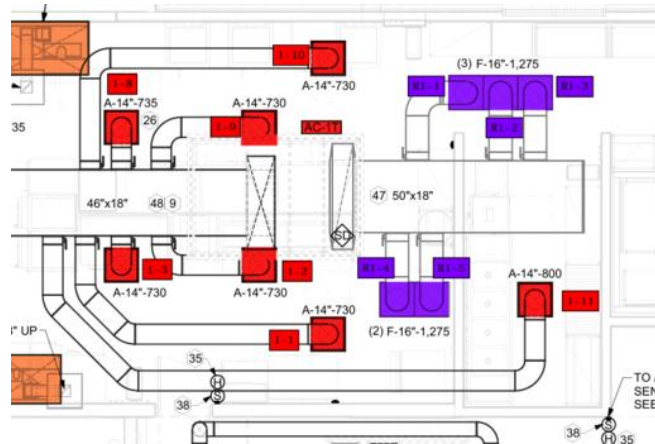
#37 [DUCT 017] [NEW] CRITICAL – Duct not installed per plans.

Ductwork for diffusers 1-1 and 1-11 are not installed per design. They have a 90 degree instead of 45 degree transitions which could impede airflow.

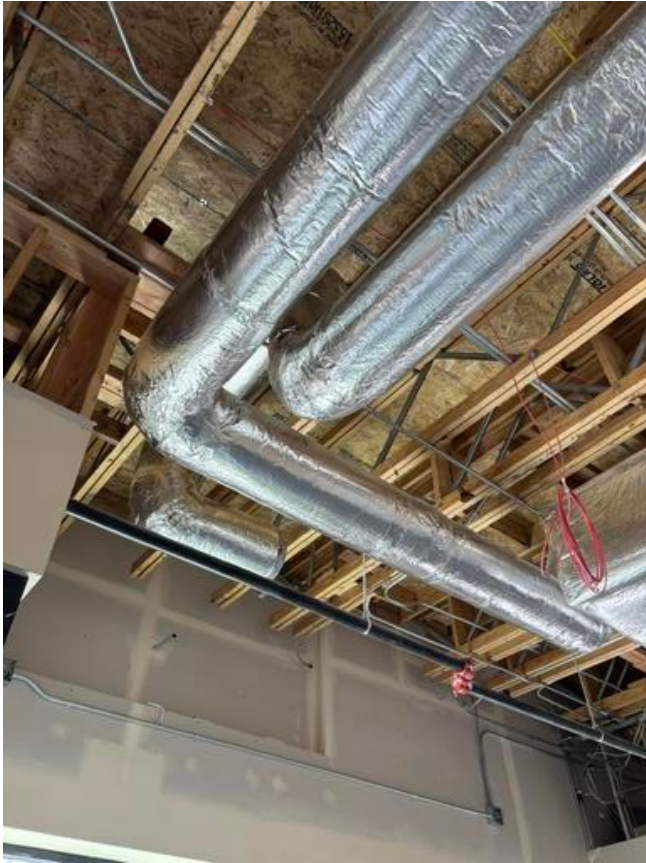
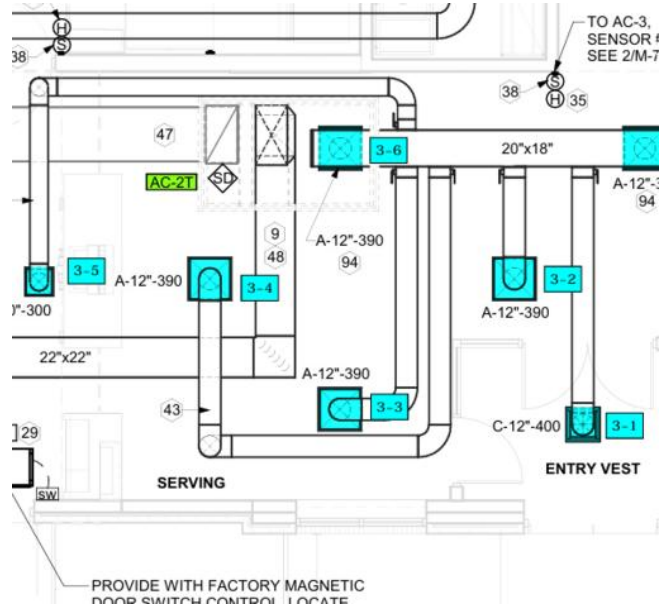
#35 [DUCT 017] [NEW] CRITICAL – Duct not installed per plans.

Diffuser 3-3 has additional transitions added in the duct run that will likely cause issues getting airflow to design. Appears that 3-4 duct run was installed in wrong spot which caused the deviation. This should be corrected.

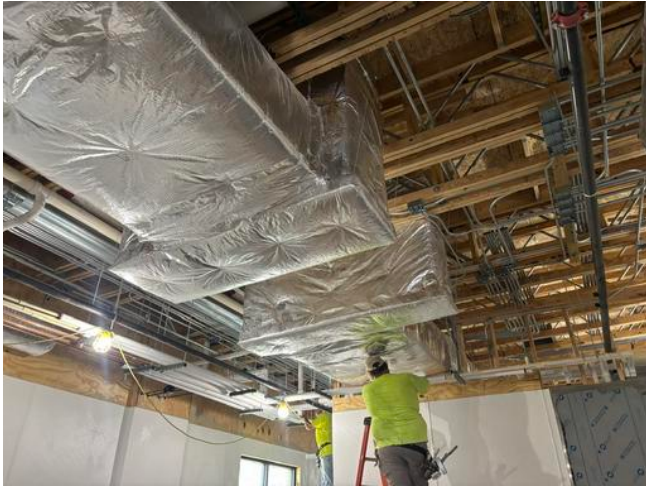
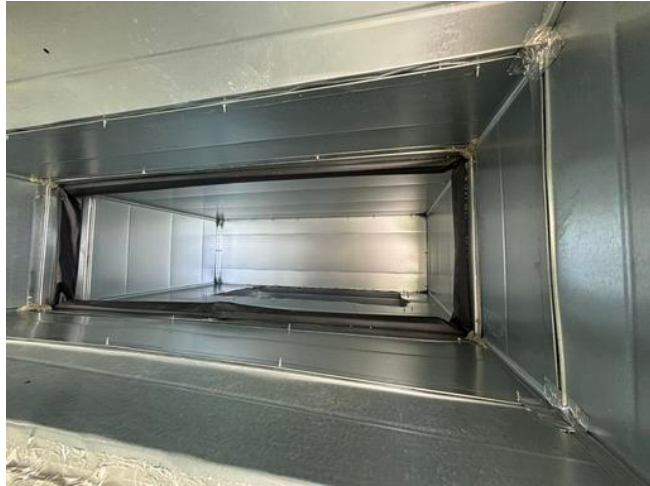
#34 [DUCT 499] [NEW] CRITICAL Turning vanes/duct drop elbow construction

Turning vanes are not installed in the supply drops. They must be installed as single thickness vanes NOT double thickness. See notes 47 and 48 on sheet M101T. The duct drops do not transition from full size of curb opening to the size shown on drawing. This will have to be corrected to allow for turning vanes.

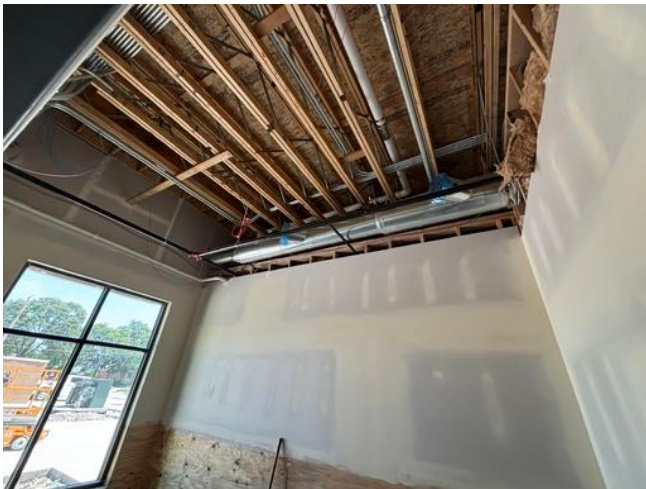
IMG_3174

#33 [DUCT 499] [NEW] CRITICAL AC-4 mastic/insulation

AC-4 mastic and insulation is in progress. Unable to complete yet due to tile work.

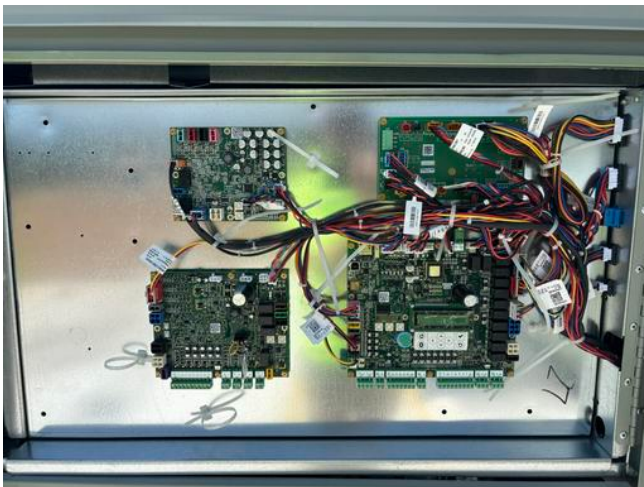
IMG_3021

#32 [CNTL 003] [NEW] CRITICAL – Wiring specifications.

Temperature and humidity sensor wiring is not installed yet. Temperature sensor wiring should be CAT 5/5E and the humidity sensor wiring should be 18/2 shielded, twisted, pair typical of Belden 8760

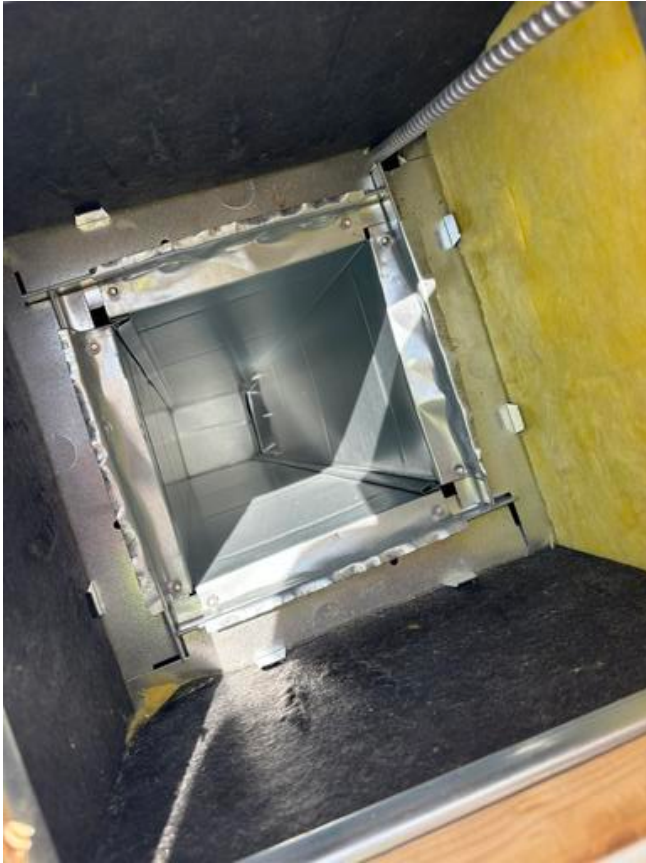
IMG_3118

#31 [EXHA 500] [NEW] Restroom rectangular duct riser.

Restroom exhaust rectangular duct riser not correctly lined per specification and is missing backdraft damper.

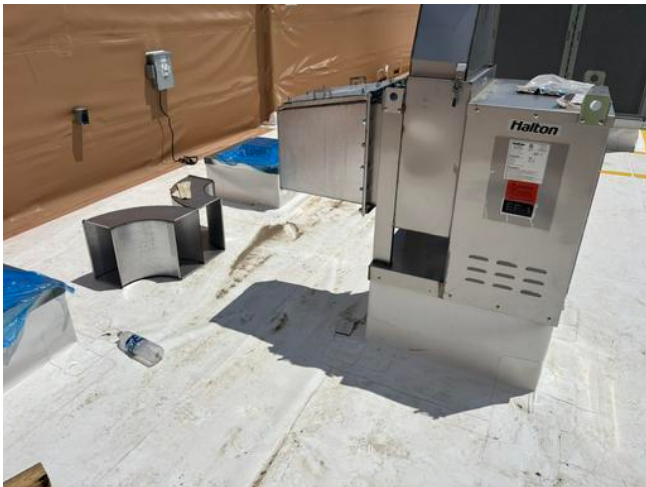
IMG_3098

#30 [EXHA 508] [NEW] Exhaust fan G2 Drip Guard.

Exhaust fan G2 Drip Guard
is missing.

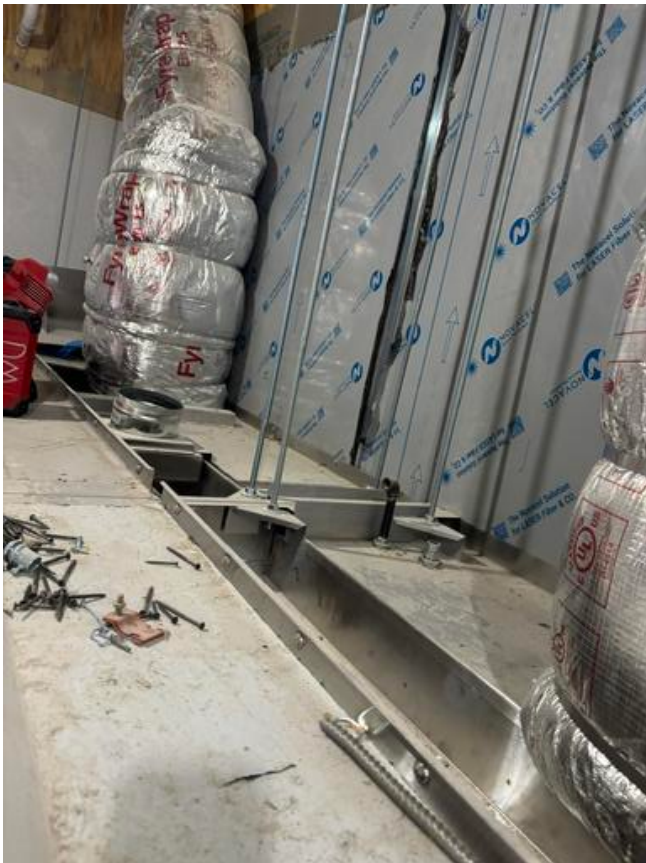
IMG_3146

#29 [HOOD 502] [NEW] Hood support brackets.

Hood 1 not hung from all support brackets.

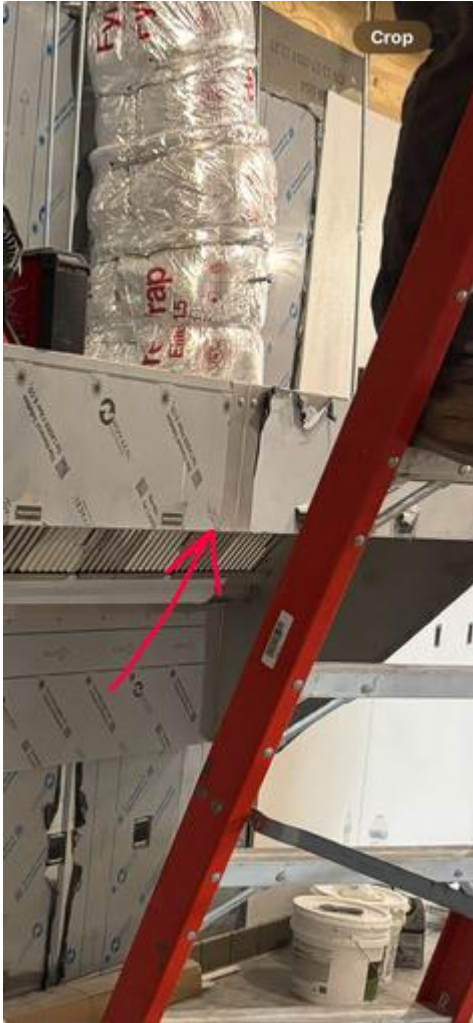
IMG_3181

#28 [HOOD 511] [NEW] Hood 1L/1R hardware.

Hoods 1L/1R are missing splice brackets that are to be installed at their midpoint connection seams.

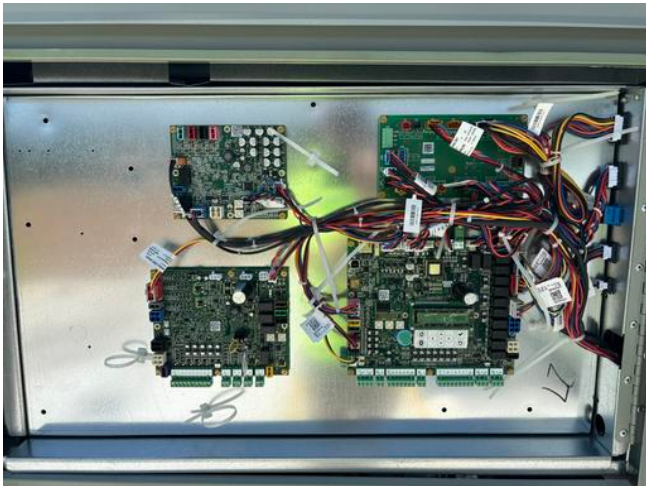
IMG_3021

#27 [UNIT 504] [NEW] Equipment Fresh Air Tempering.

FAT Tempering kits have not arrived from Trane yet per the MC. Install probe in the supply duct after the first 90 degree transition.

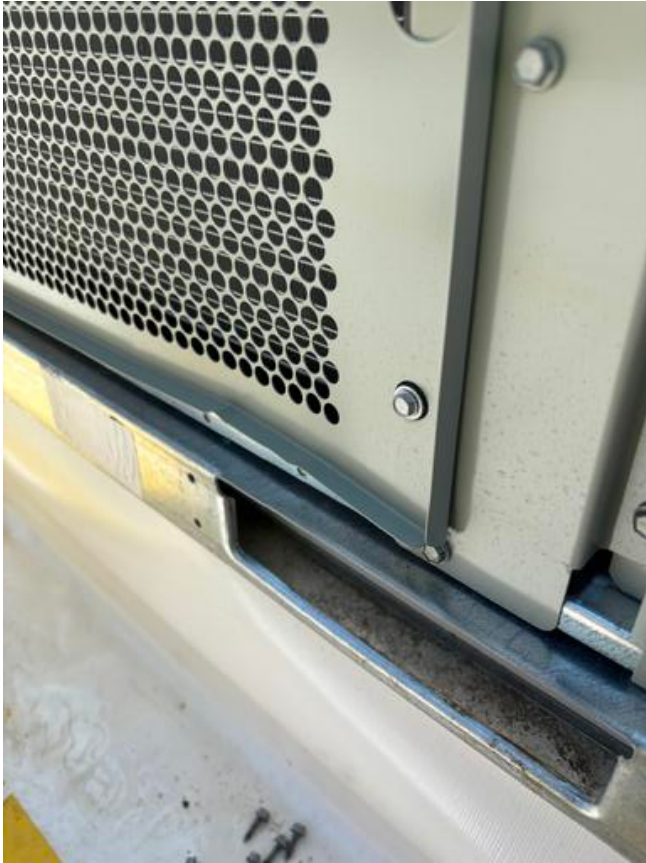
IMG_3077

#26 [UNIT 512] [NEW] Equipment hail guards.

AC4 condenser panel is bent
and needs to be
straightened.

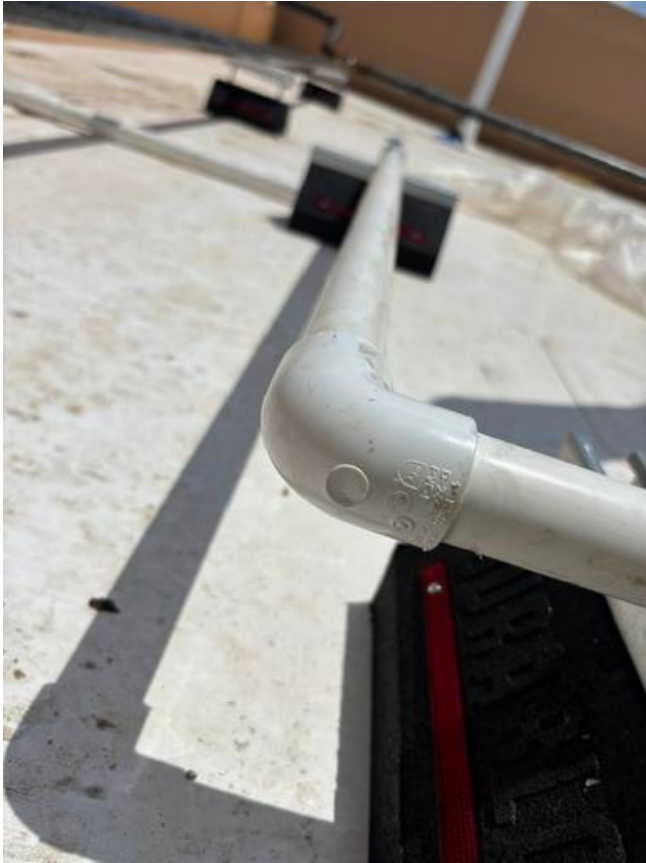
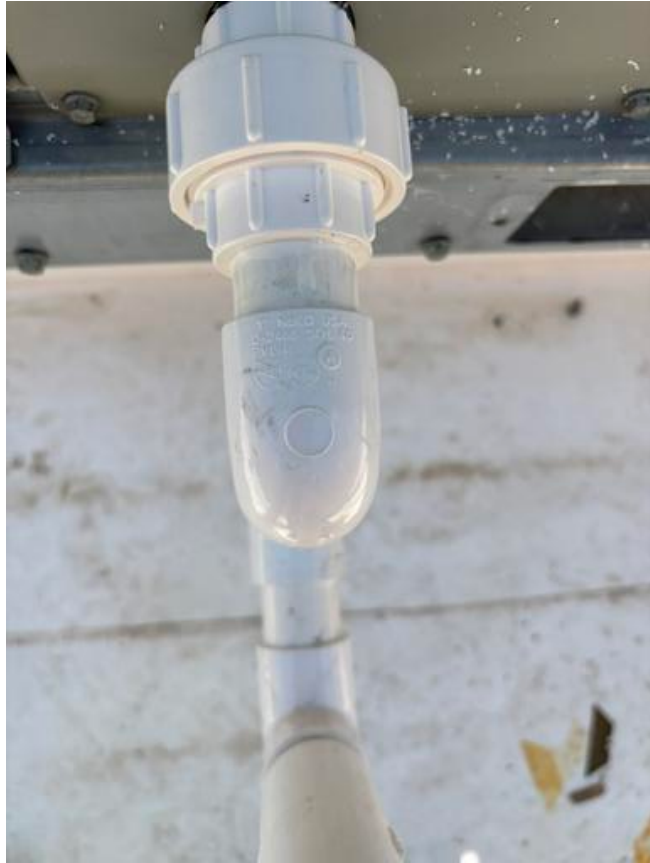
#25 [UNIT 517] [NEW] Condensate piping construction.

Condensate piping does not all match the sizes shown on the plans. Drains are all 1" but should be 1-1/4" in places. For instance connection at AC-3 and where drains are piped off of the roof.

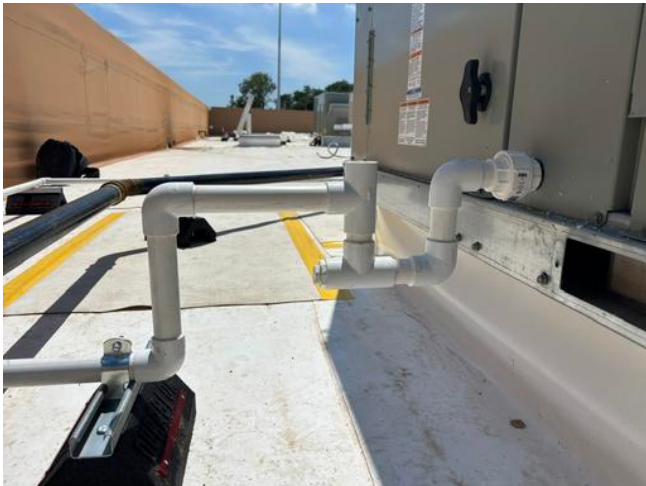
IMG_3037

#24 [UNIT 517] [NEW] Condensate piping construction.

AC's P-traps are not installed to design. There is a Union missing at the leaving side of the trap. There also needs to be 2" difference between the connection at unit and the leaving pipe of the trap. The trap should be 4" deep. See M502 detail 5.

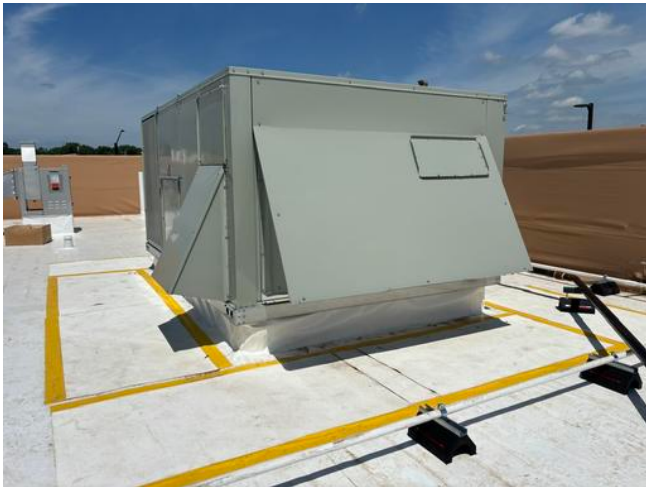
IMG_3036

#23 [UNIT 521] [NEW] Equipment is missing specified options.

Powered exhaust is specified on AC's 1, 2, 3 but is not installed.

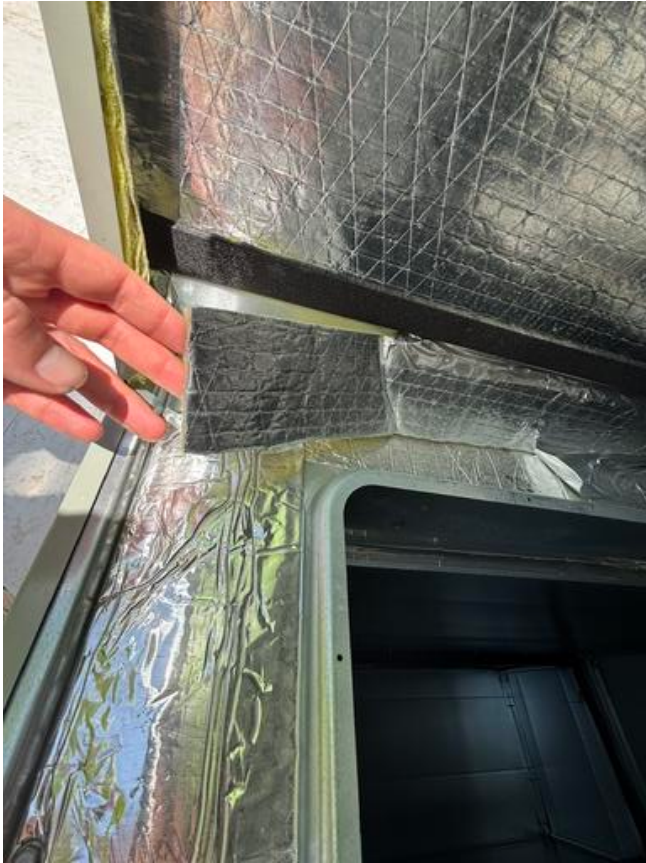
IMG_3029

#22 [UNIT 525] [NEW] Equipment insulation.

AC-3 has insulation falling off in the supply cabinet and should be resecured.

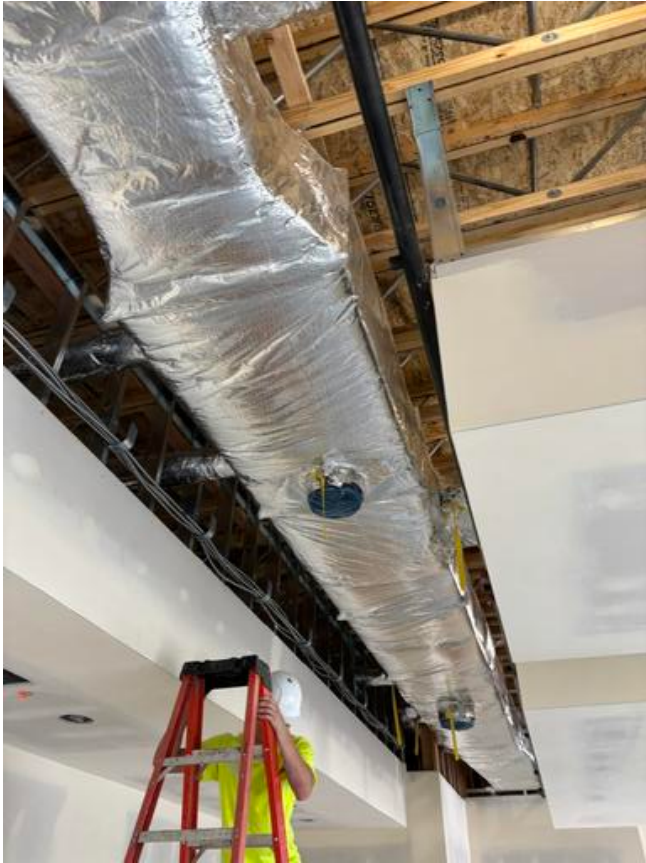
IMG_3122

#20 [DUCT 501] [NEW] Insulation stick pins.

External insulation on bottom of ducts 24" or wider is to be supported by stick pins 18" on center. Cut pins and apply tape or mastic over stick pin washers.

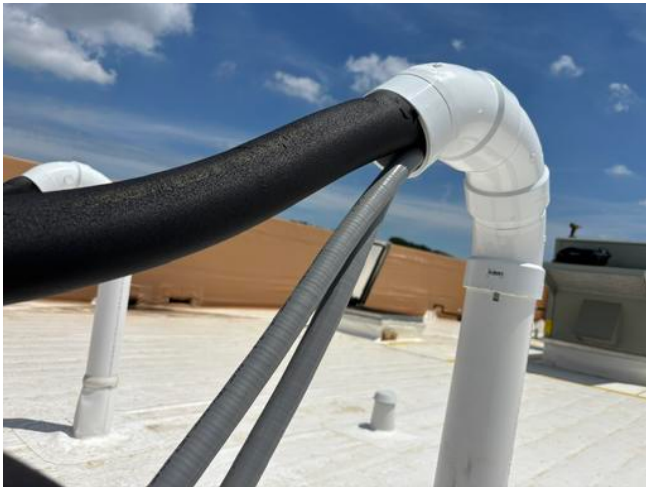
IMG_3091

#19 [REFG 511] [NEW] PVC pipe chase (gooseneck) installation.

PVC pipe chase risers need spray foam cut flush and then caulked over.

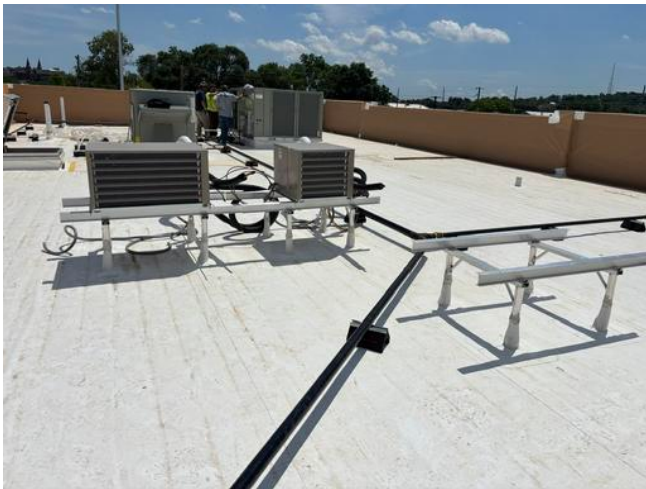
IMG_3094

#18 [REFG 999] [NEW] Orientation of condensers

Orientation of condensers on the roof do not match the plans. Seek engineer and Chick-fil-A approval.
