Report: TAB Report
Function: Test, Adjust, & Balance
Date: 07/03/2024

06-24-24 WAWA #5413 SARASOTA, FL

Project: 06-24-24 WAWA #5413 SARASOTA, FL

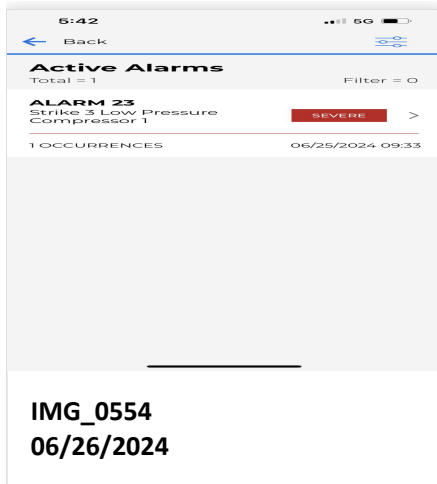
Issue Name : RTU 1 - compressor 1 fault
Description : RTU 1 has a persistent error on the CORE interface, stating that compressor 1 is not running as intended. Recommend inspecting compressor for possible damage.
Created By : National TAB **Assigned To :** National TAB - Mark Johnson
Status : Open
Priority : High **Asset Tag :**
Originated Date : 06/26/2024 - Mark Johnson - National TAB

RTU 1 has "Alarm 23 - Strike 3 Low Pressure Compressor 1" occurring intermittently.

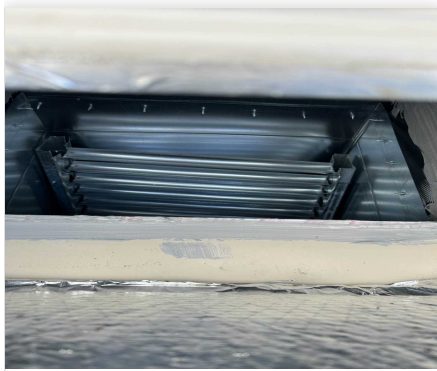
IMG_0557
06/30/2024

Issue Name : RTU turning vanes not installed correctly
Description : The turning vanes located in the supply drops of the RTUs are not fully installed, sitting loose inside the duct. Recommend installing.
Created By : National TAB **Assigned To :** National TAB - Mark Johnson
Status : Open
Priority : Low **Asset Tag :**
Originated Date : 06/30/2024 - Mark Johnson - National TAB
