**Report: TAB Report**  
**Function: Test, Adjust, & Balance**  
**Date: 06/27/2024**

**PROJECT**  
**06-24-24 WAWA #5413 SARASOTA, FL**

Project: 06-24-24 WAWA #5413 SARASOTA, FL

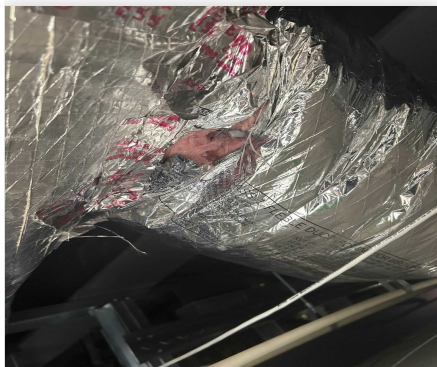
**Issue Name :** Diffuser 2-1 - damper missing wing nut  
**Description :** Diffuser 2-1 currently has an airflow of 677 CFM (135% of design) and cannot be lowered because the damper will not hold the required position; it is missing a wing nut opposite the handle. Recommend repairing damper to allow for airflow adjustment.  
**Created By :** National TAB                      **Assigned To :** National TAB - Mark Johnson  
**Status :** Open  
**Priority :** High                                      **Asset Tag :**  
**Originated Date :** 06/26/2024 - Mark Johnson - National TAB

- **06/30/2024 National TAB - Mark Johnson**
  - Mechanical clarified that damper design does not require second wing nut, and tightened handle to allow for adjustment. Could not re-adjust on site under time constraint.

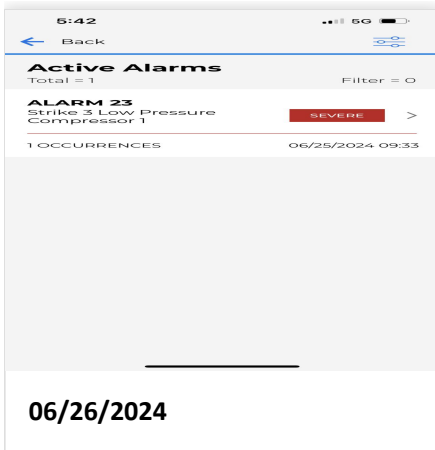
**Issue Name :** RTU 1 - compressor 1 fault  
**Description :** RTU 1 has a persistent error on the CORE interface, stating that compressor 1 is not running as intended. Recommend inspecting compressor for possible damage.  
**Created By :** National TAB                      **Assigned To :** National TAB - Mark Johnson  
**Status :** Open  
**Priority :** High                                      **Asset Tag :**  
**Originated Date :** 06/26/2024 - Mark Johnson - National TAB

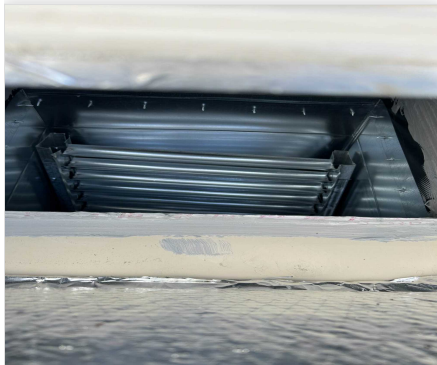
**Issue Name :** RTU turning vanes not installed correctly  
**Description :** The turning vanes located in the supply drops of the RTUs are not fully installed, sitting loose inside the duct. Recommend installing.  
**Created By :** National TAB                      **Assigned To :** National TAB - Mark Johnson  
**Status :** Open  
**Priority :** Low                                      **Asset Tag :**  
**Originated Date :** 06/30/2024 - Mark Johnson - National TAB
