Report: TAB Report
Function: Test, Adjust, & Balance
Date: 07/03/2024

06-24-24 WAWA #5413 SARASOTA, FL

Project: 06-24-24 WAWA #5413 SARASOTA, FL

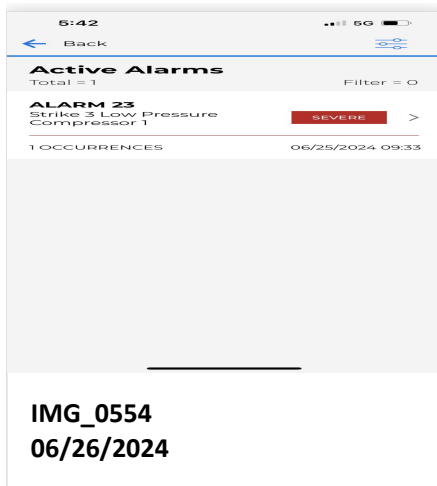
Issue Name : RTU 1 - compressor 1 fault
Description : RTU 1 has a persistent error on the CORE interface, stating that compressor 1 is not running as intended. Recommend inspecting compressor for possible damage.
Created By : National TAB **Assigned To :** National TAB - Mark Johnson
Status : Open
Priority : High **Asset Tag :**
Originated Date : 06/26/2024 - Mark Johnson - National TAB

RTU 1 has "Alarm 23 - Strike 3 Low Pressure Compressor 1" occurring intermittently.
