# PlanGrid Task Report - Aug 30, 2024

**L05622\_Marion (IL) FSU**

2820 Joseph Cannon Way, Marion, Illinois

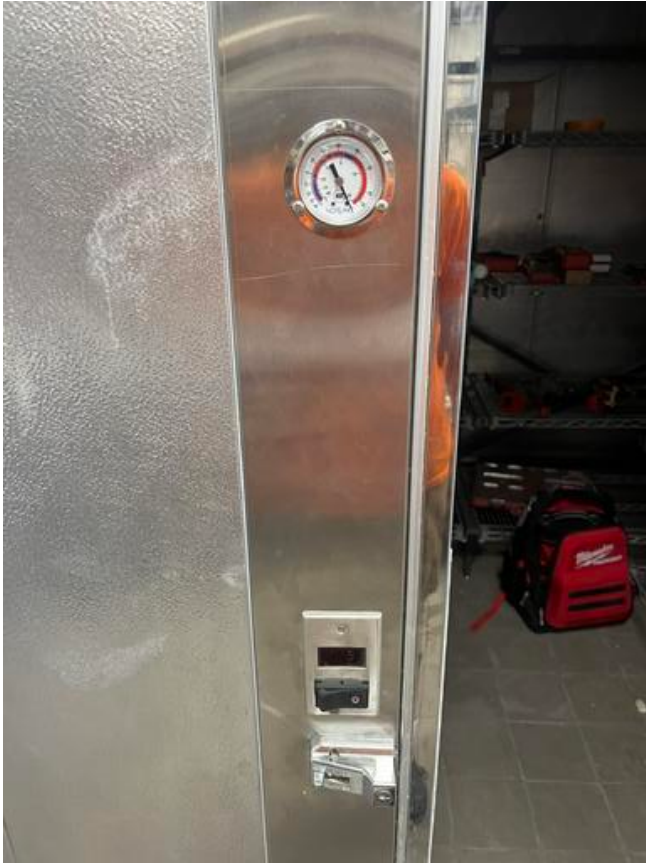
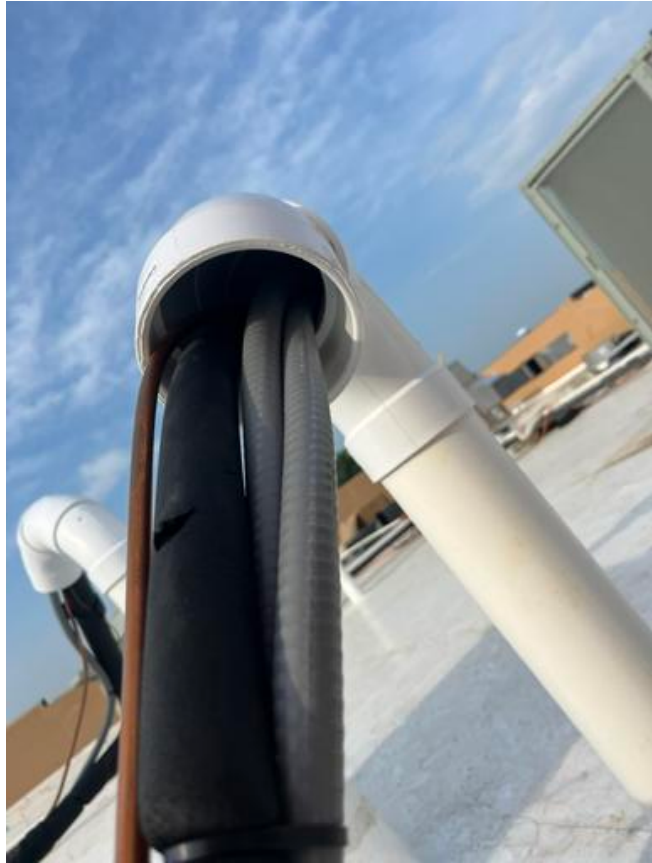
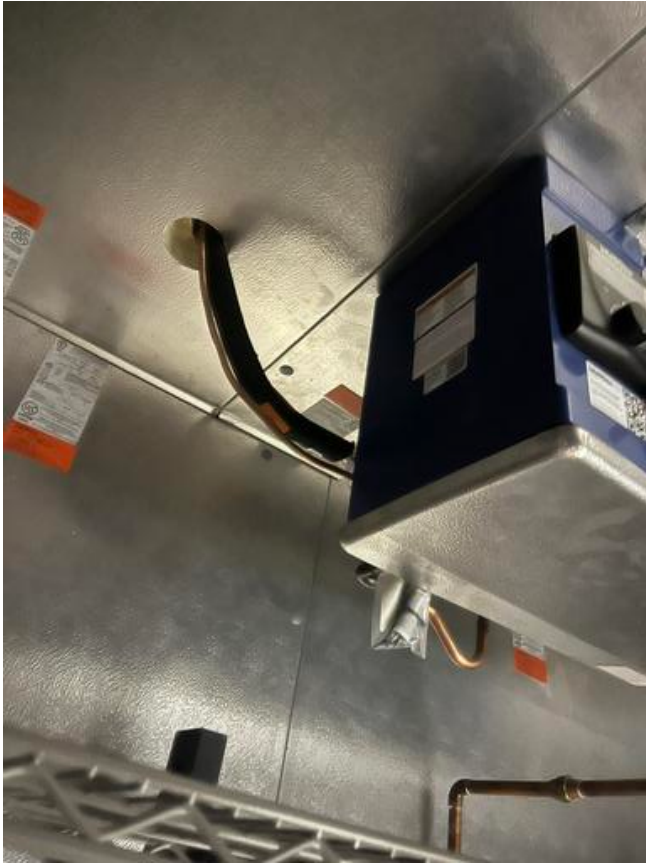
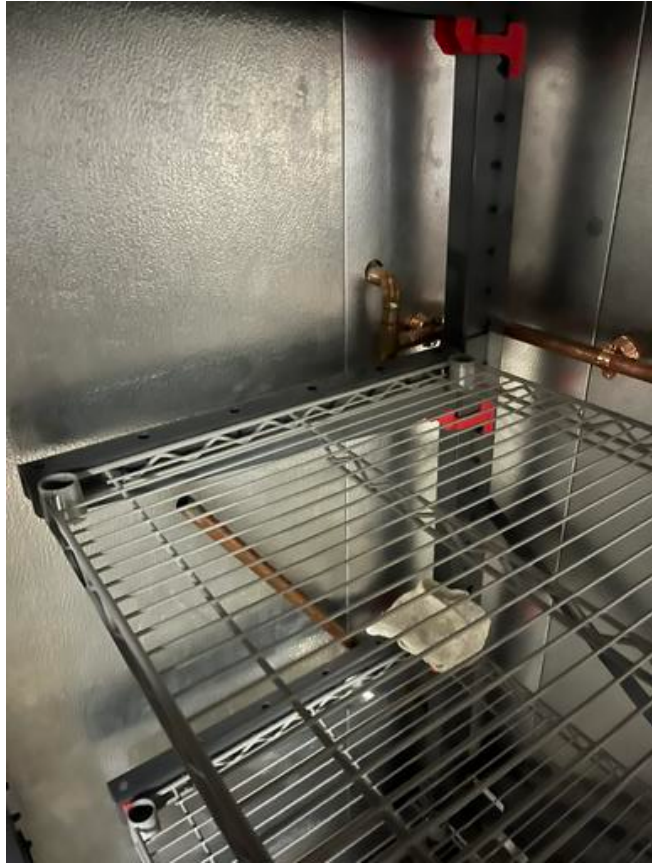
WIC/WIF installation  
incomplete at time of TAB.  
Unable to complete  
inspection. Penetrations not  
sealed, units not running.

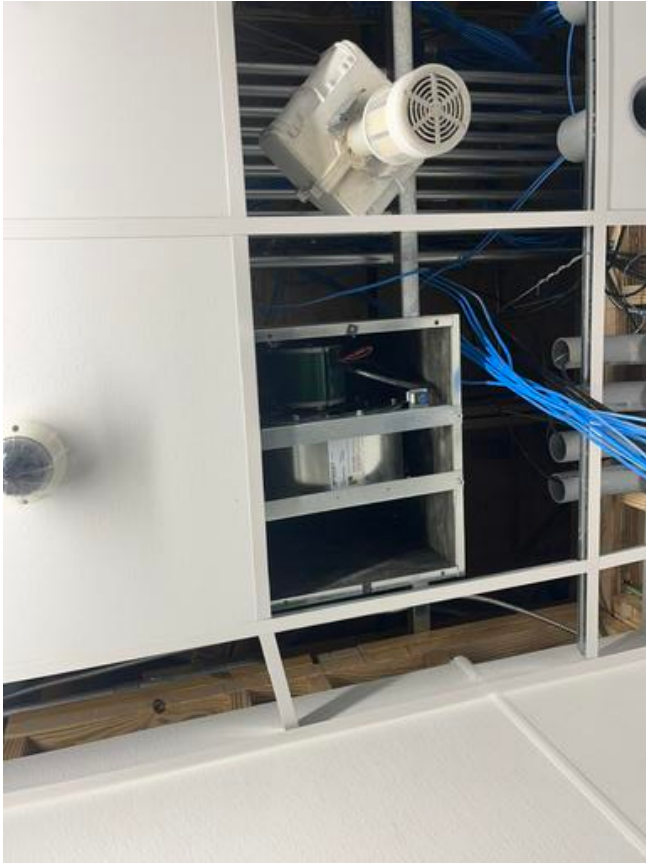
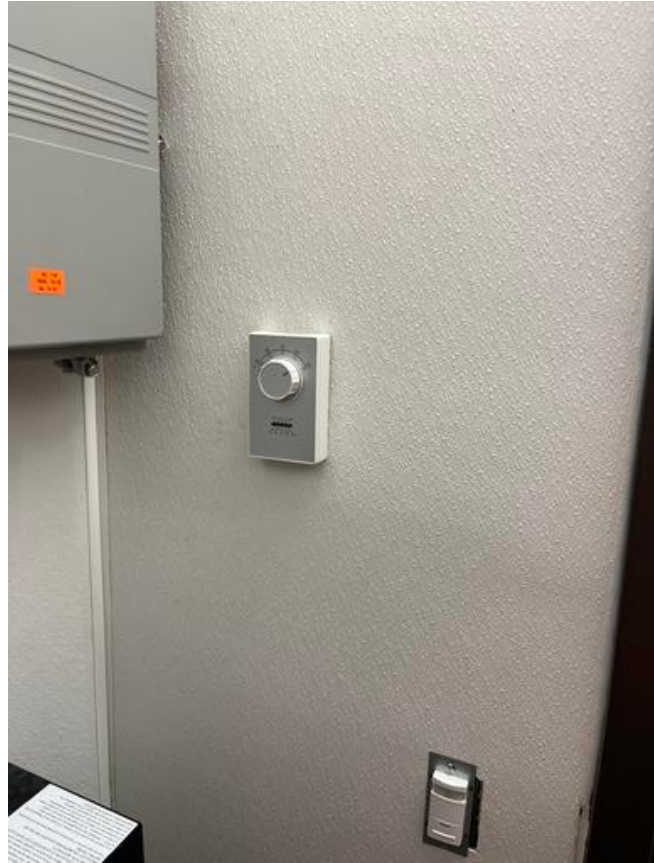
Fan not operational at time  
of TAB, could not verify  
functionality.

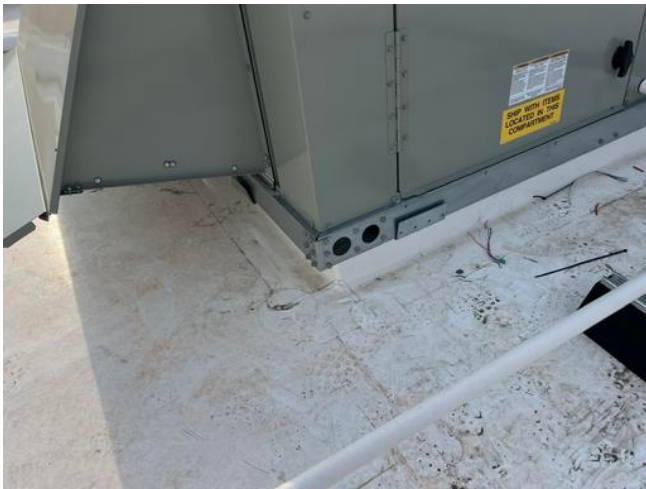
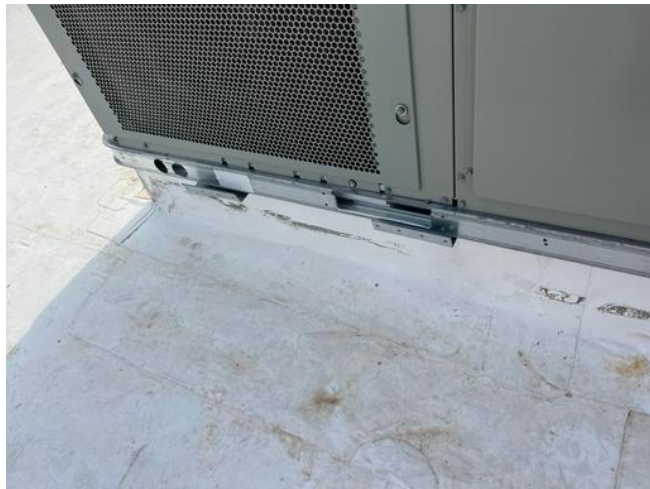
Seismic clips on AC units not secured at time of TAB

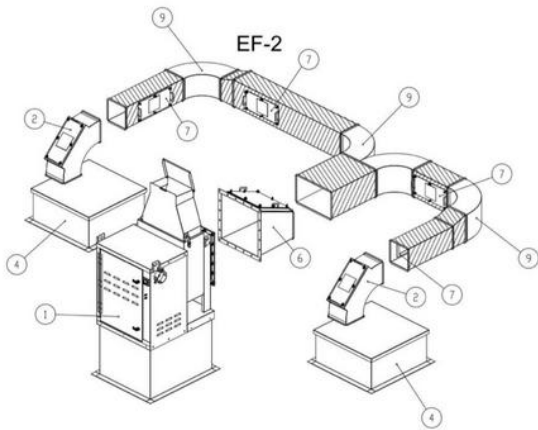
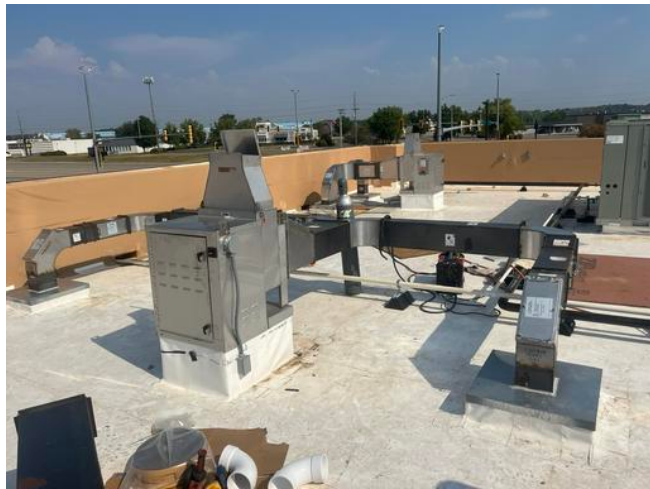
Access doors are missing on  
EF-2 grease duct.

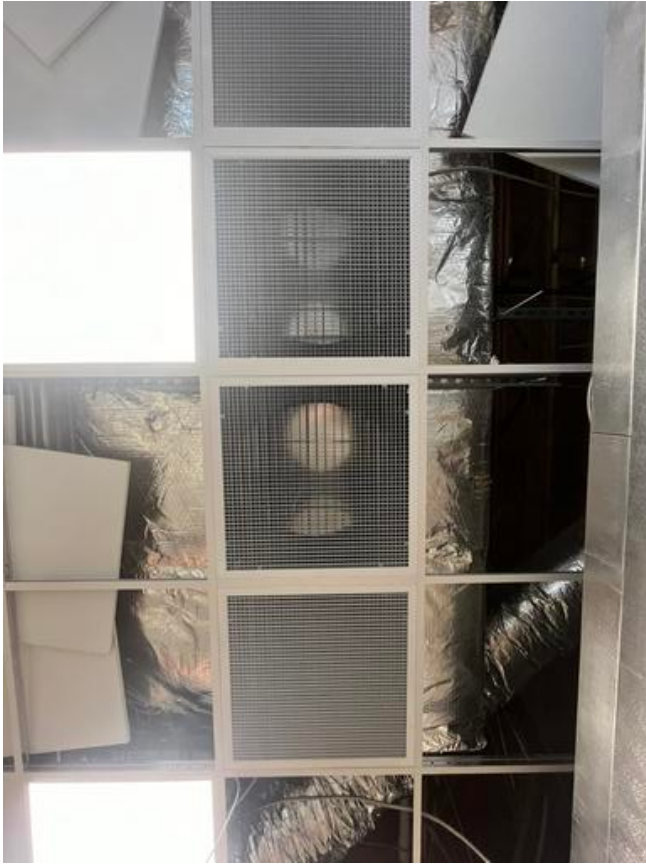
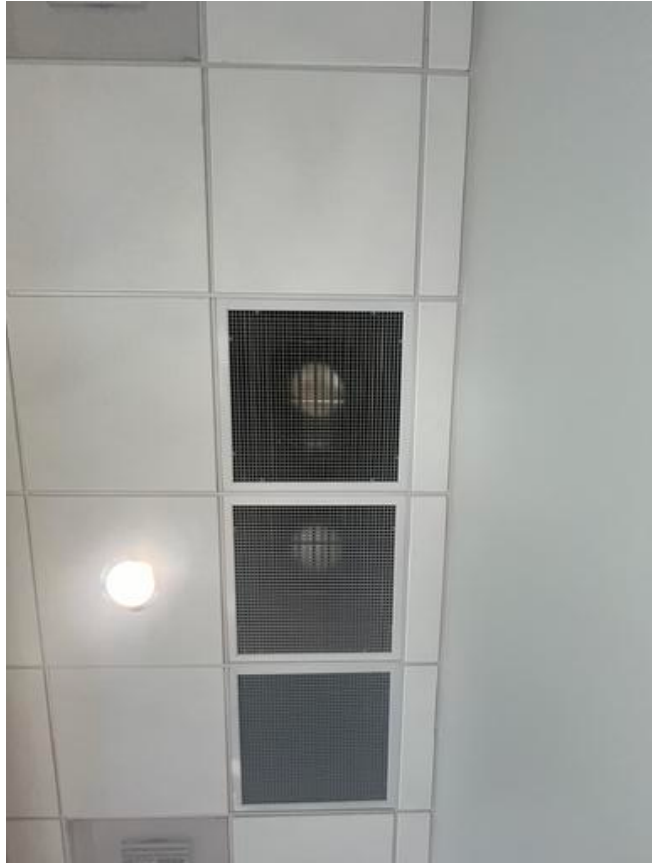
OBD dampers are installed in returns on AC-1 and AC-3. This appears due to the duct being hung too low relative to the ceiling height; there is not enough room for correct dampers. Recommend OBDs are removed as they will eventually fail closed and restrict airflow.

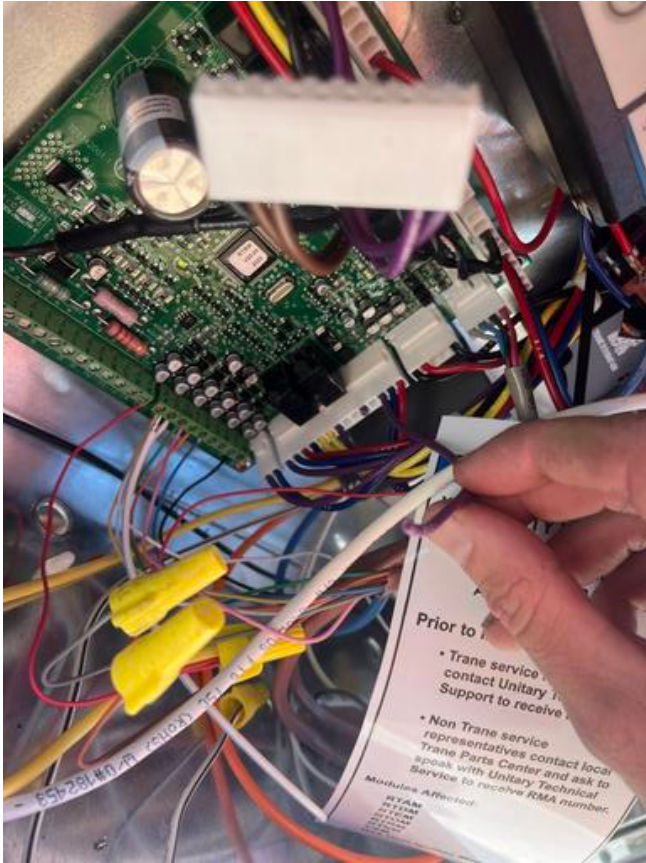
AC-4 control board wire appears cut. Recommend inspecting/diagnosing/service.

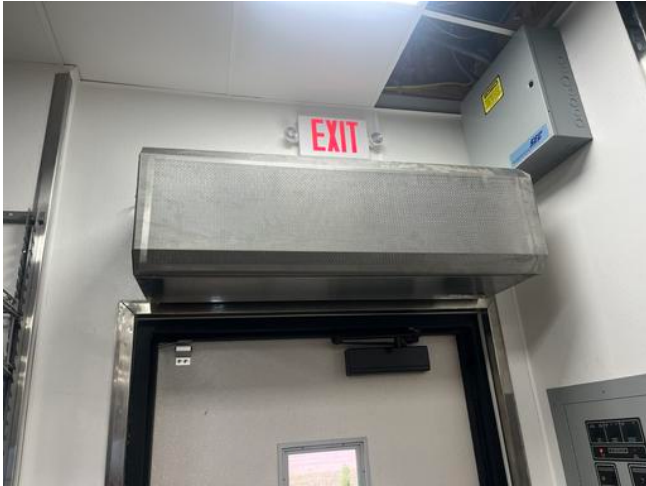
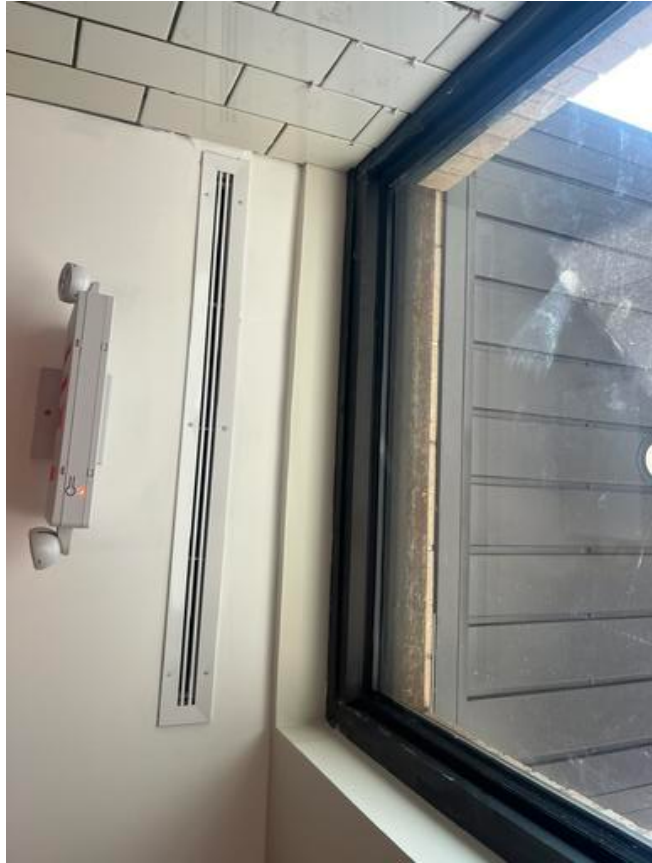
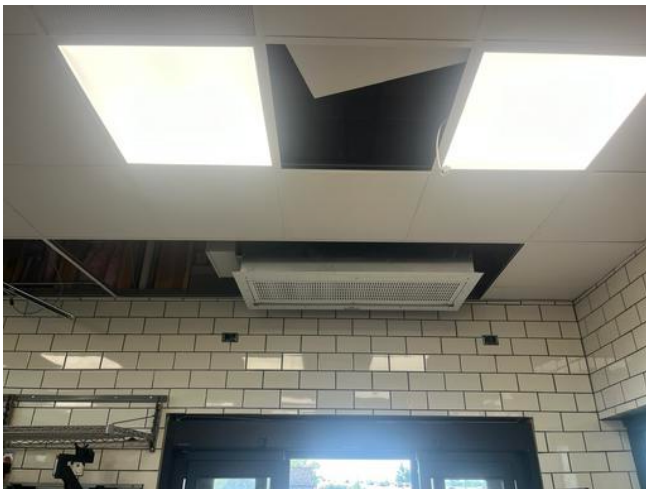
Drive-thru, Side door, and rear door air curtains not functional at time of TAB.

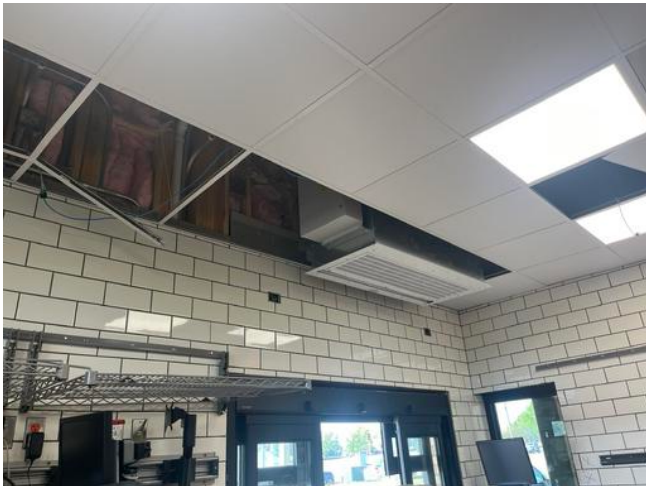
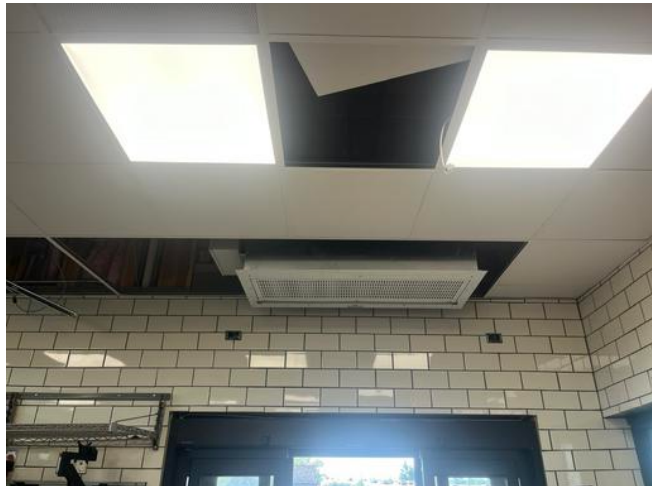
Drive-thru Air Curtain not installed at correct elevation. Diverter box is not yet installed and curtain is not functional.

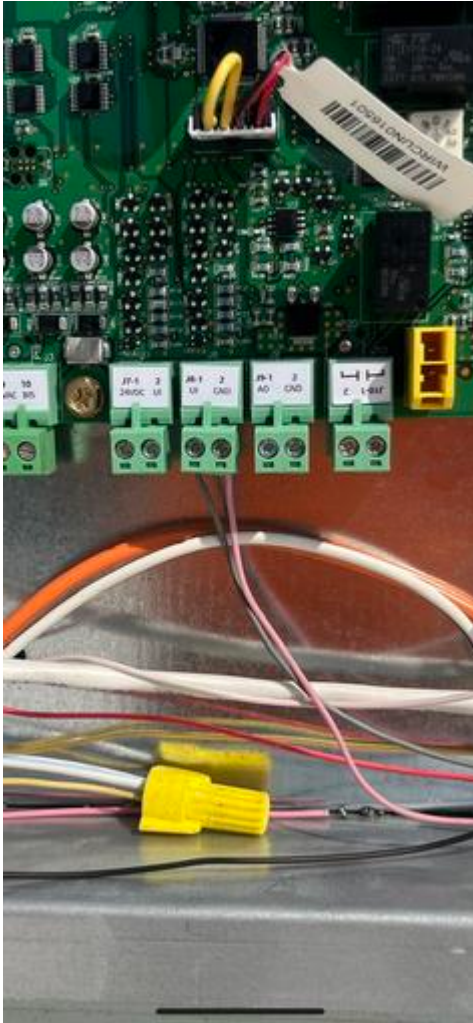
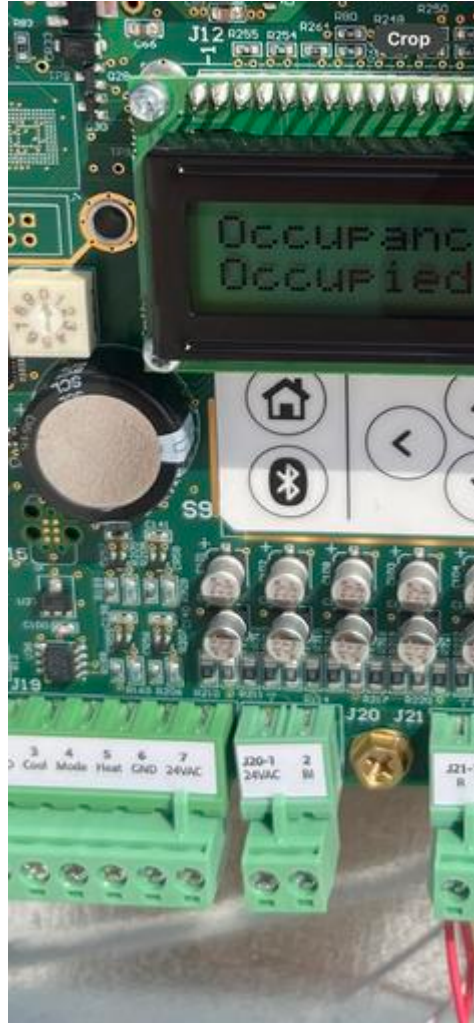
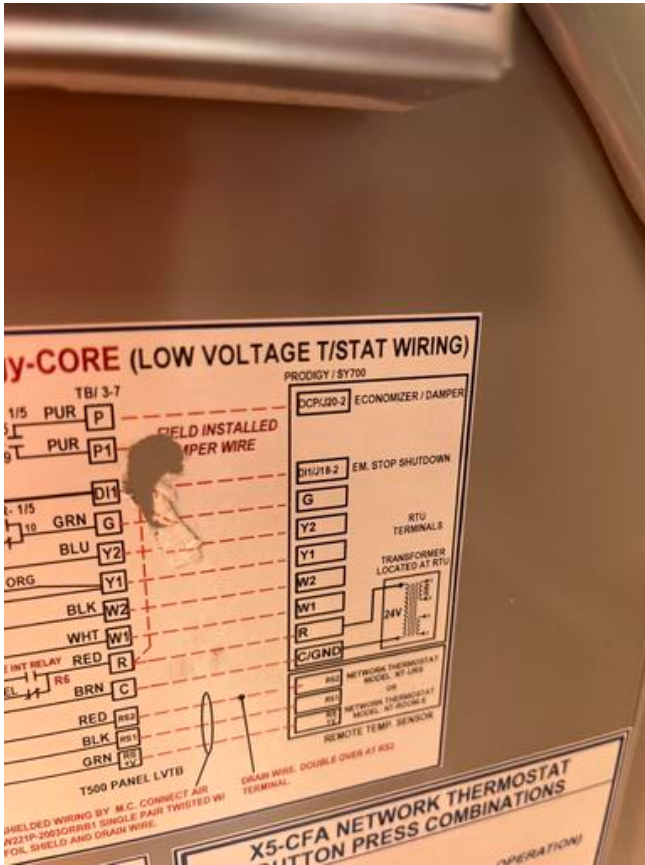
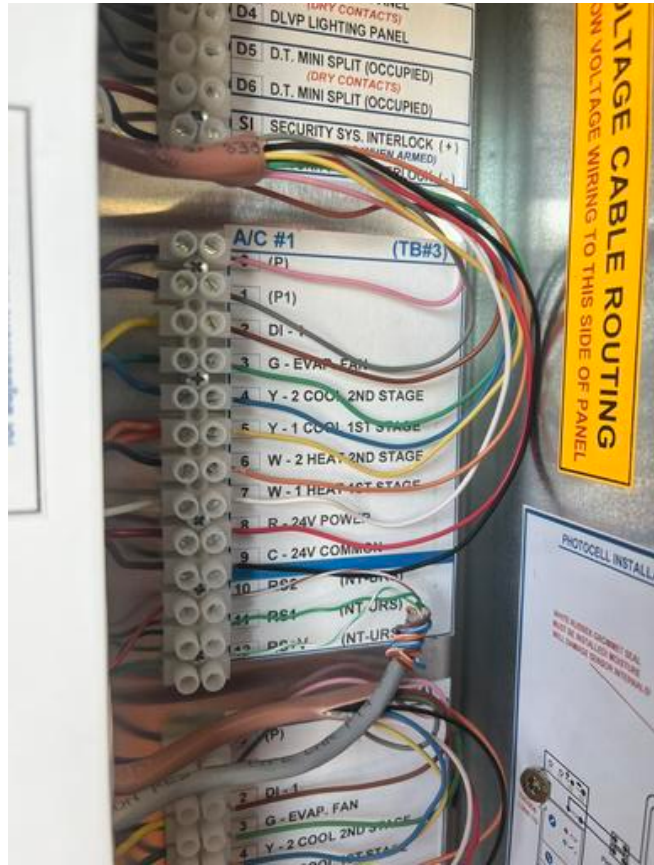
Thermostat wiring does not include correct wiring for occupancy on AC-1,2,3. Jumper from P1 to R is not installed in SEC. P should terminate at J20-2 on main Symbio board. Currently P1 and P terminate at J8-1/2 on CCM. Units always occupied. Alternatively P1 can terminate at J20-1 for 24vac. MSET and SEC wiring diagrams conflict.

Wiring corrected, occupancy operating correctly

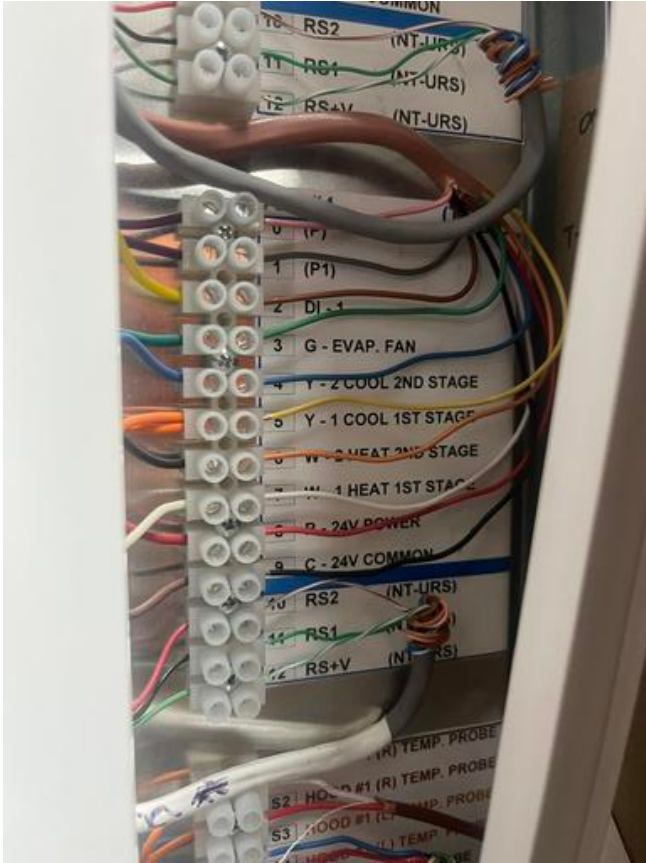
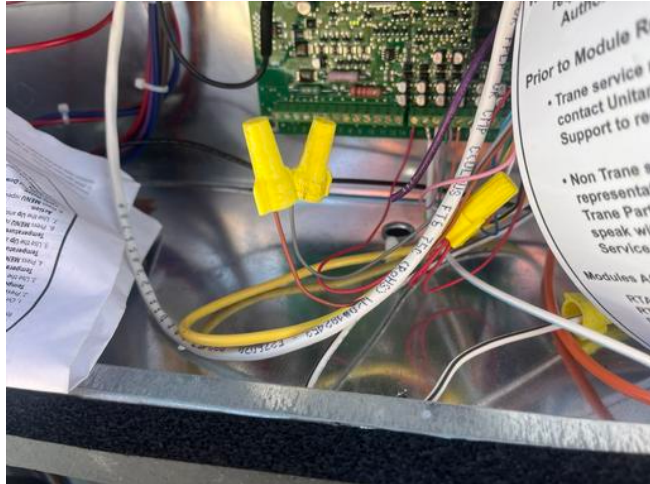
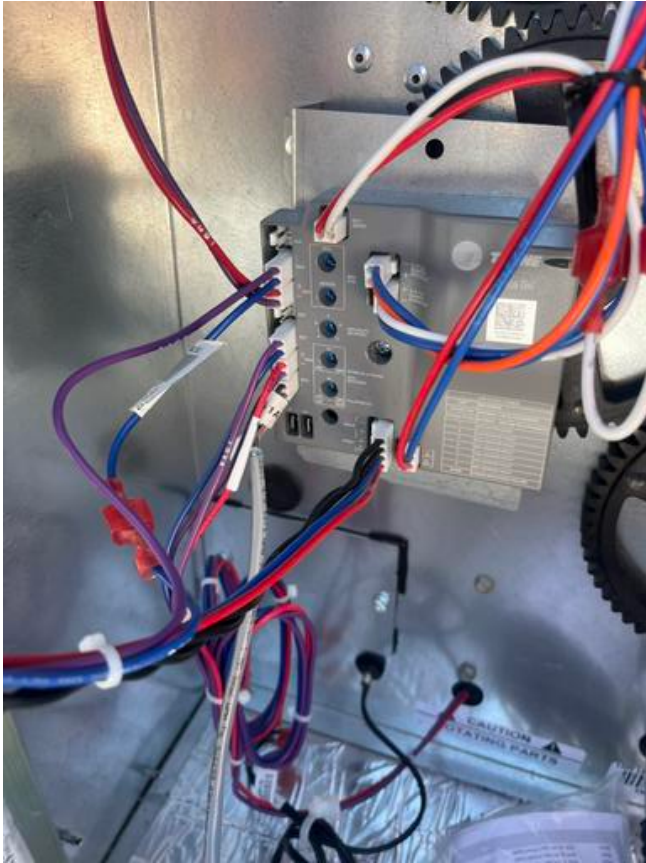
Thermostat wiring does not include correct wiring for occupancy. Nothing landed on P1/P at economizer module. P1 from SEC is wire nuted at unit. P appears wired to G. Unit always occupied.

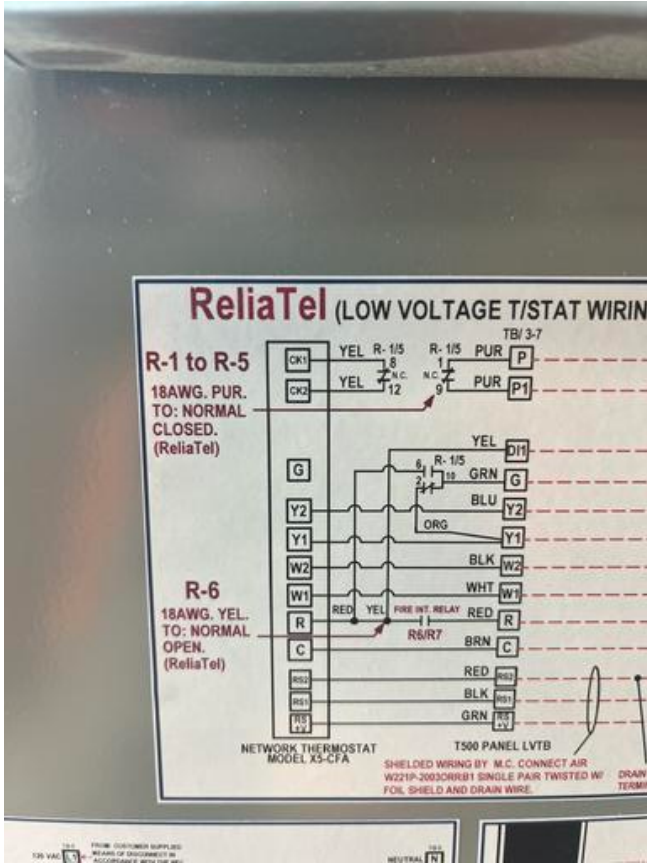
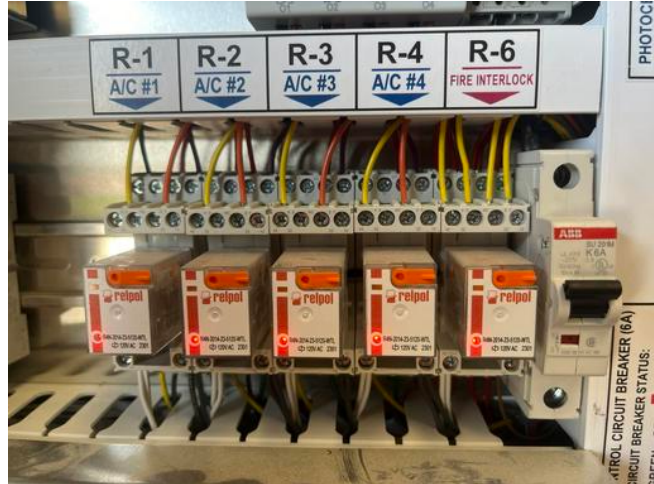
R-1, R-2, R-3 relay improperly wired for occupancy on Symbio units. 18AWG purple should be on normally closed. Purple on R-1,2,3 needs to be moved to front row for occupancy to be properly controlled. See also: Issue 47 AC-4 thermostat terminations.

Corrected by mc

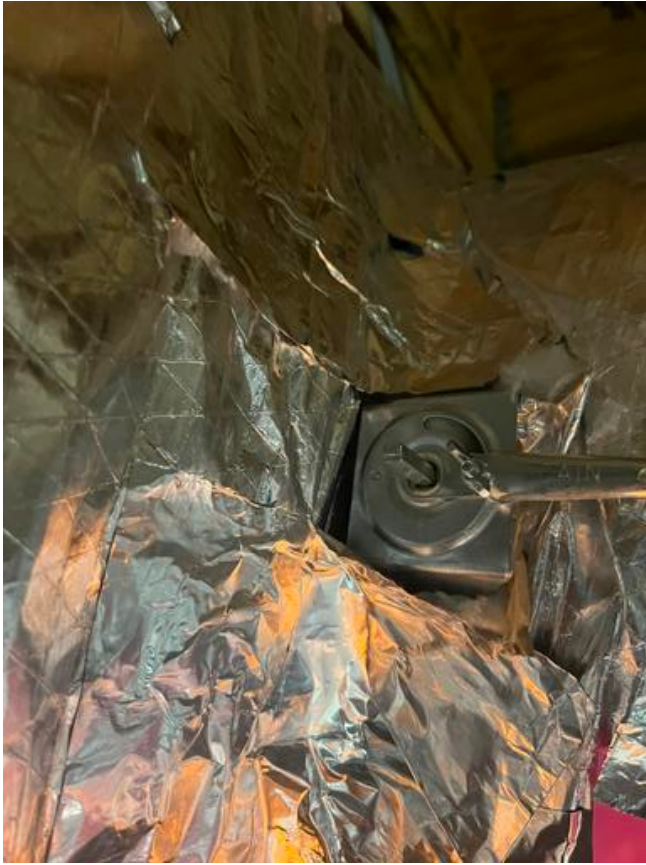
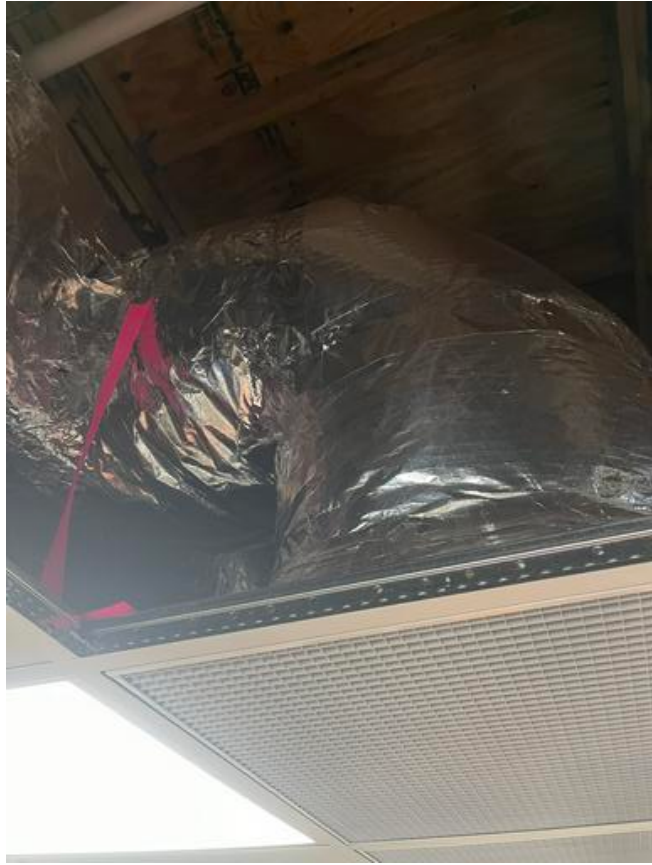
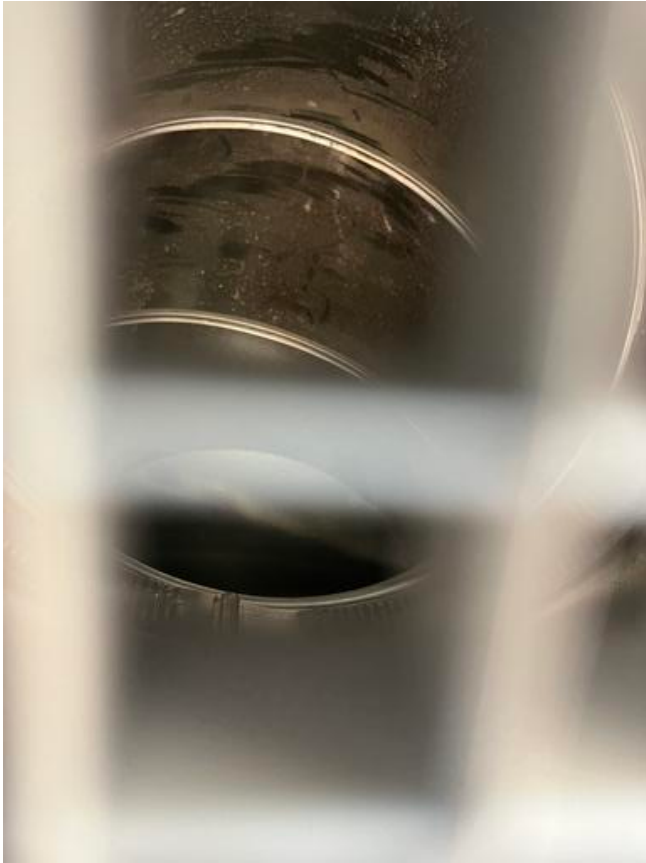
AC-2 Return Dampers positioned in duct so they are creating noise, restricting airflow. Unable to position damper inline with airflow. Damper located on side of duct (correctly), but is installed in the rigid 90 on an angle.

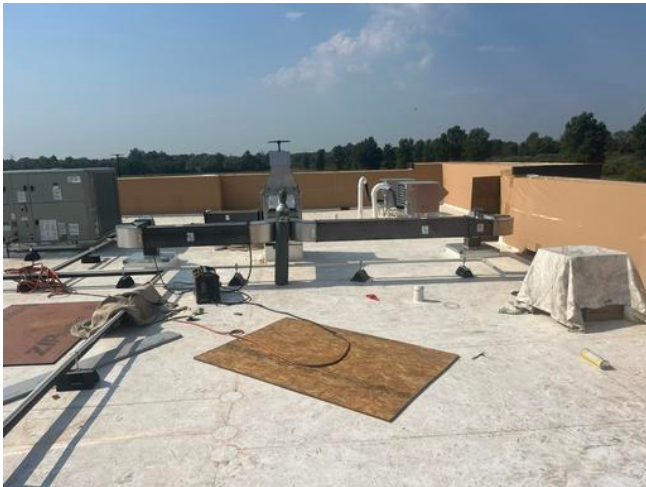
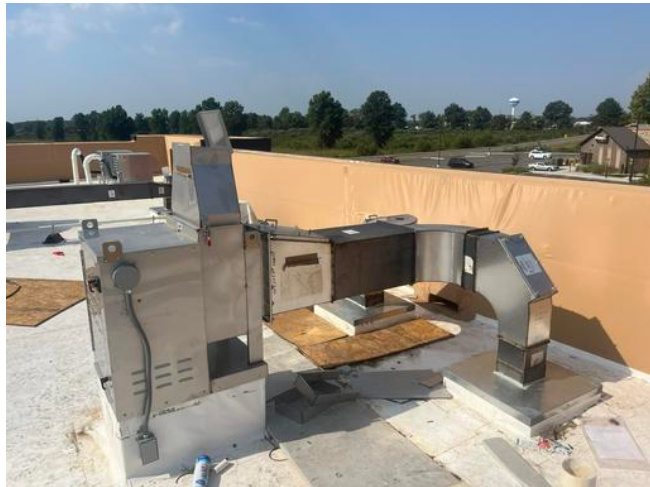
Exposed grease duct is to be painted per specification on hood exhaust detail.

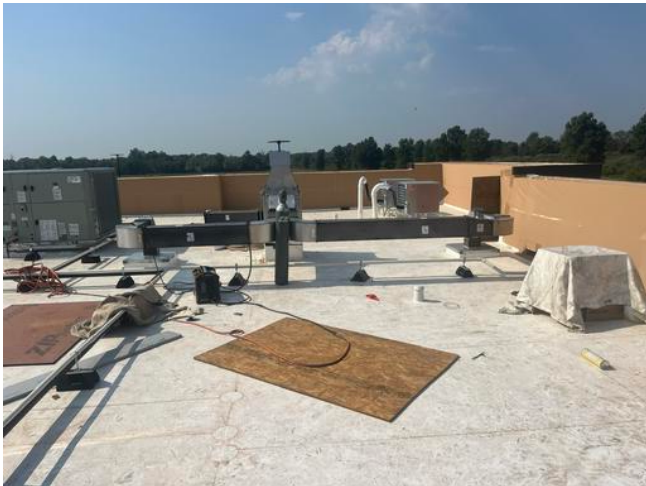
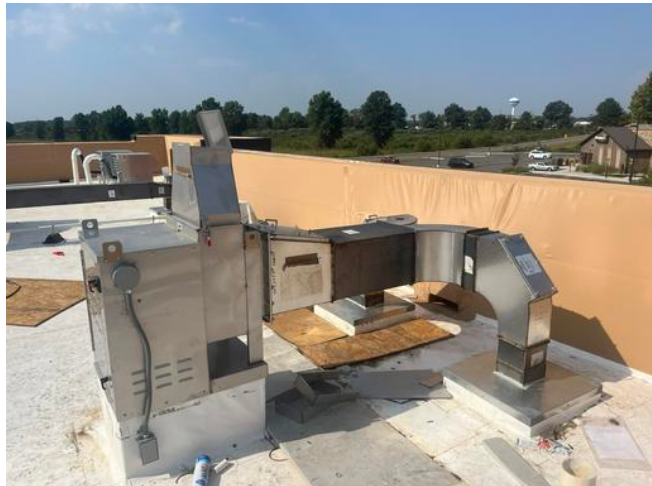
Exhaust duct to be supported per kitchen hood exhaust detail. On 6'0" centers and at roof penetrations.

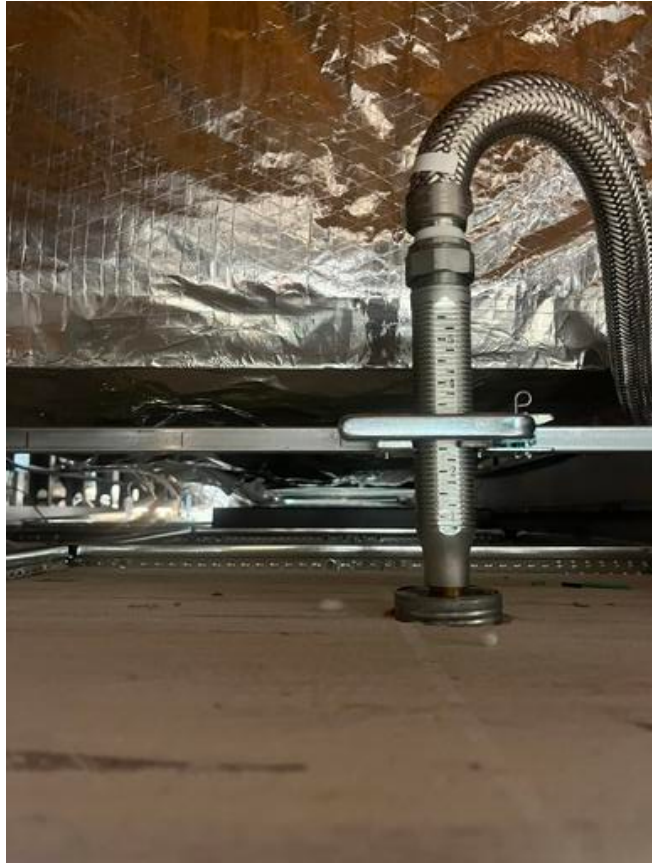
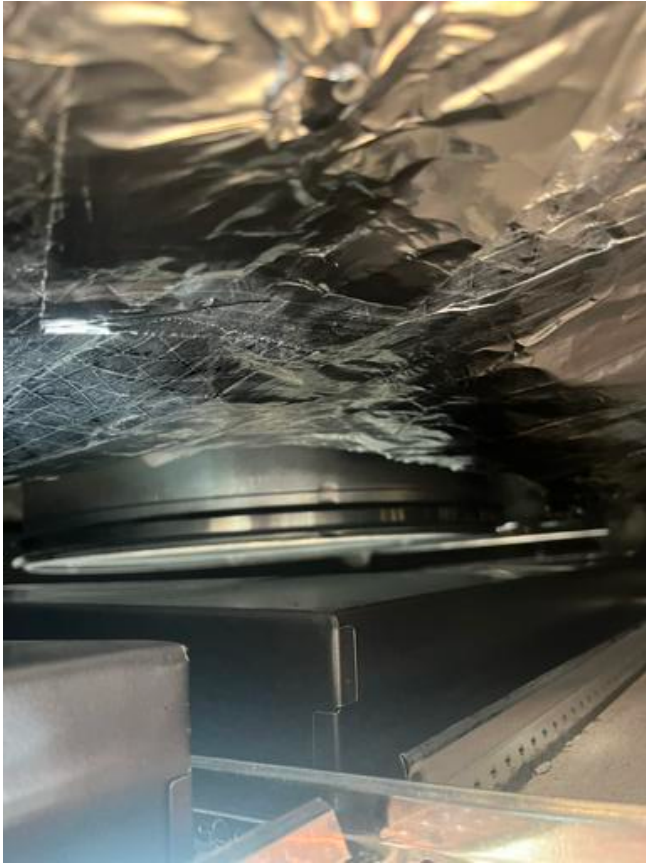
Returns are not ducted to  
return grilles and pulling from  
ceiling space.

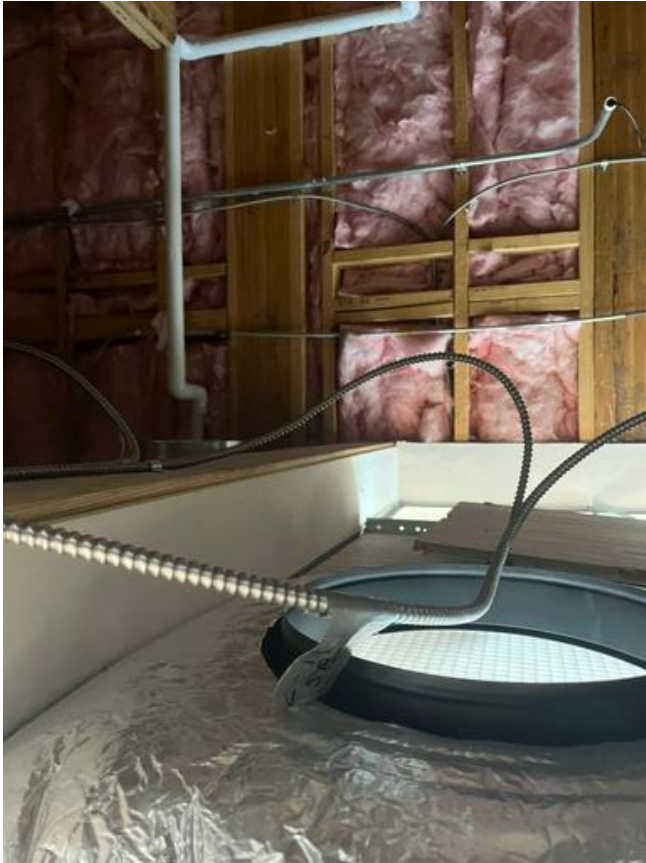
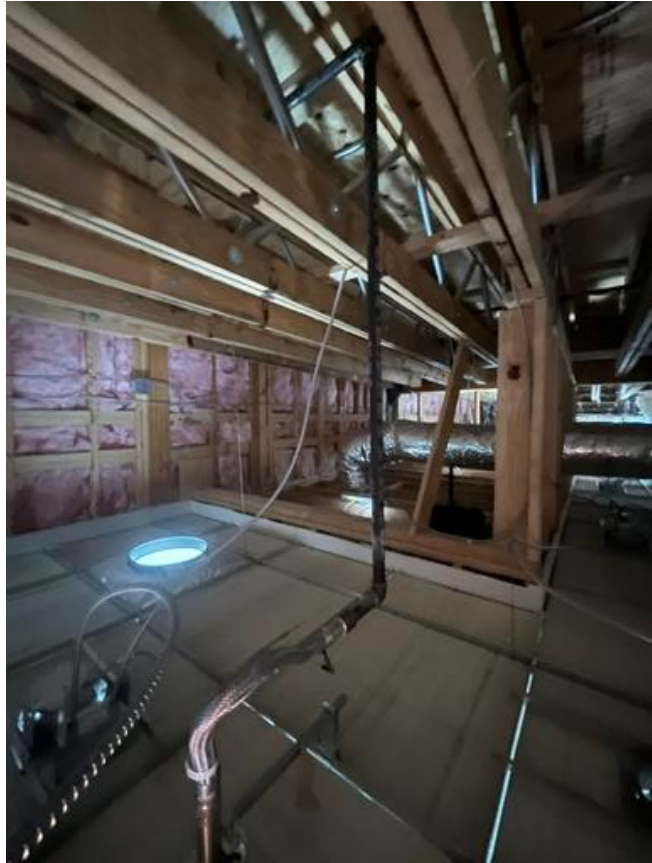
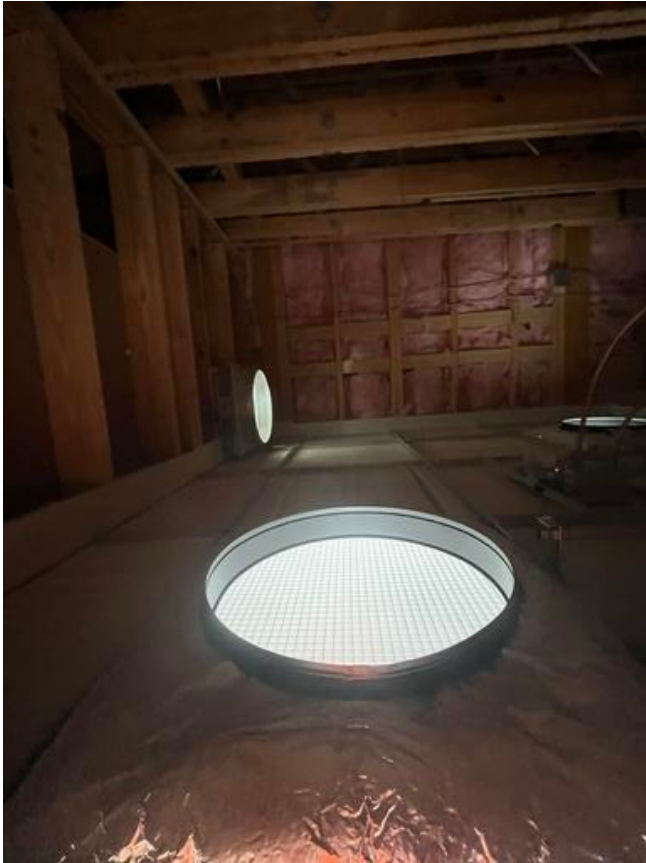
Grilles are installed for pass-thrus, but they are not ducted. Incomplete.

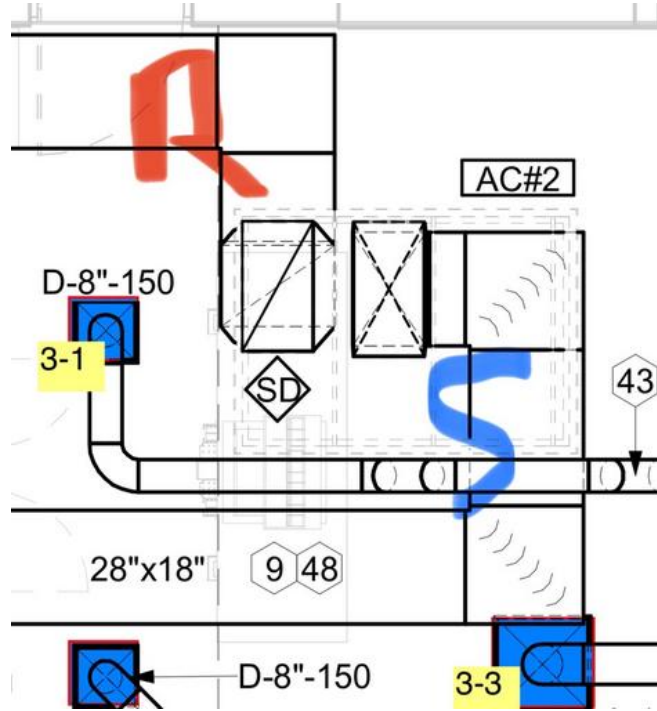
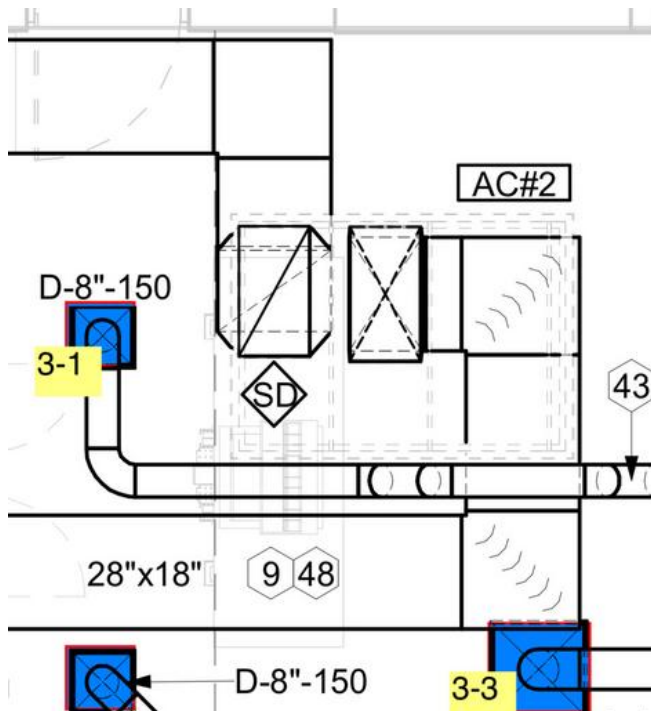
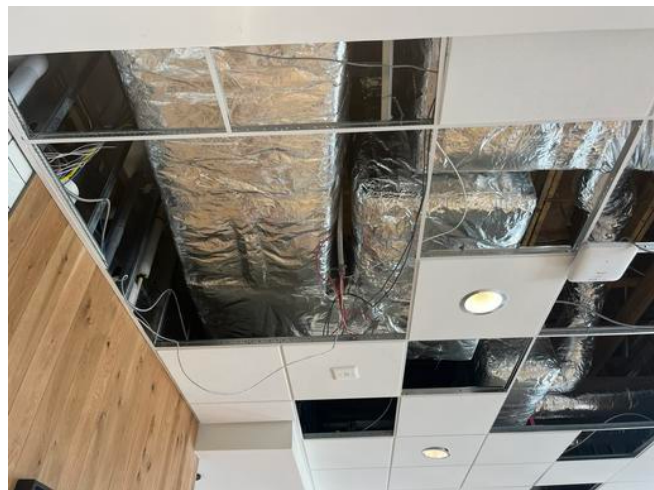
Duct is constructed in a way that impedes airflow. Unit was rotated opposite from plans on roof because EF-1 proximity to fresh air intake. Supply and Return locations swapped. Additional 90 added to return. Return static pressure measured at -1.00" WC. Unit achieving design airflow however has slight vibration, economizer dampers have rattle, and return dampers are making noise in drive-thru area. SEEK APPROVAL.

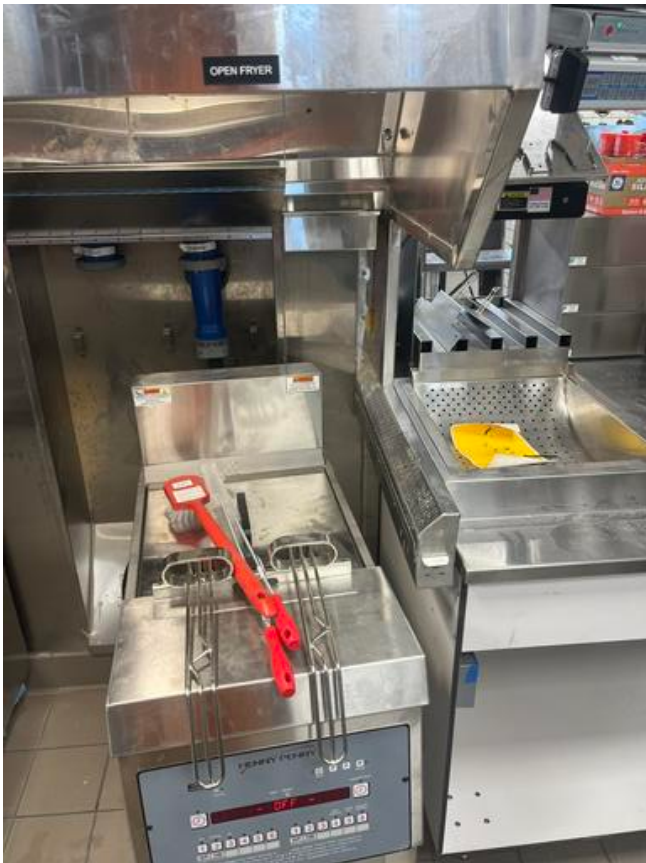
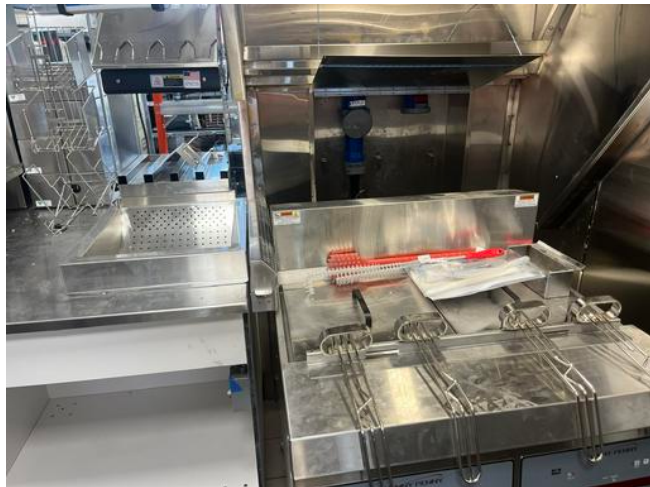
HD-2 and HD-3 missing fry chutes, could not be located.

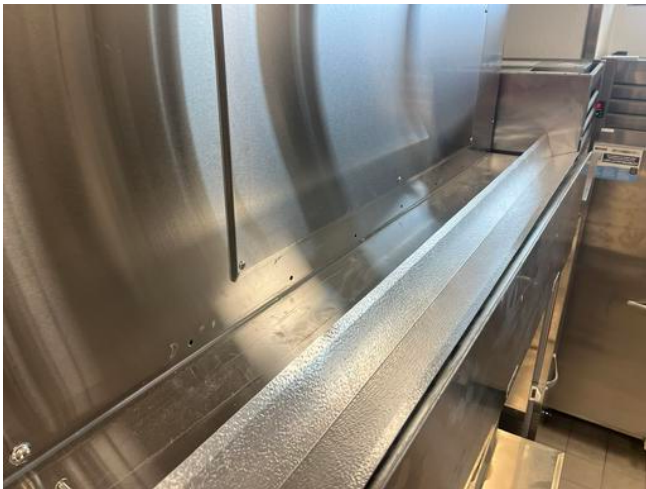
Several screws missing on hoods front panels. Recommend they are located and installed.

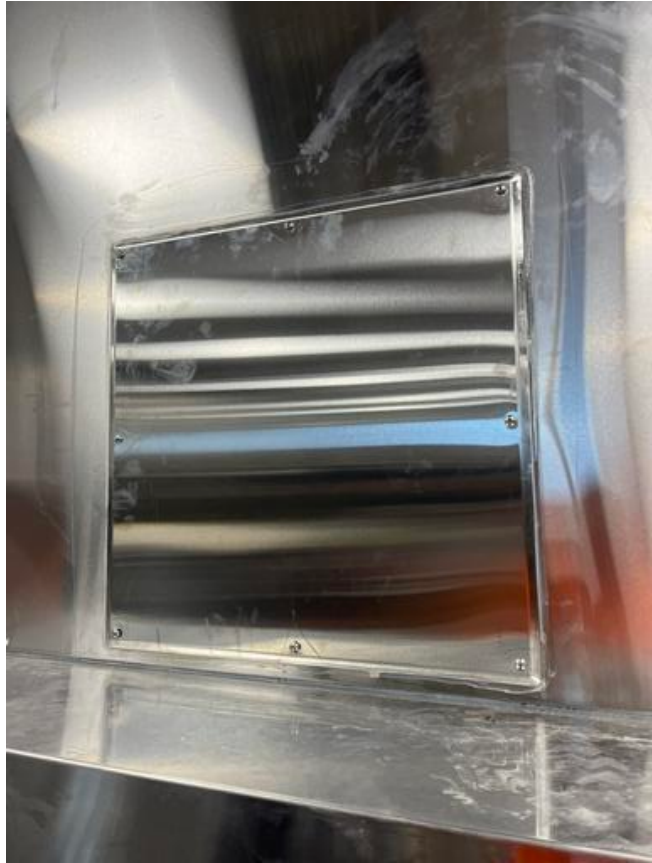
Appears caulk was applied to access door on HD-3. Recommend residue is removed.
