# PlanGrid Task Report - Aug 30, 2024

**L05622\_Marion (IL) FSU**

2820 Joseph Cannon Way, Marion, Illinois

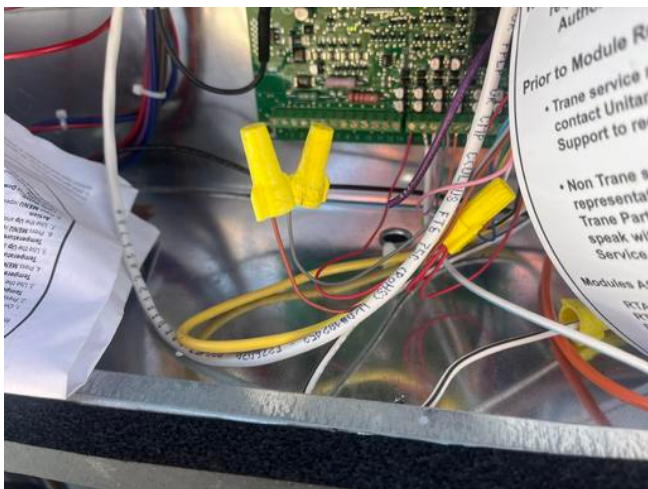
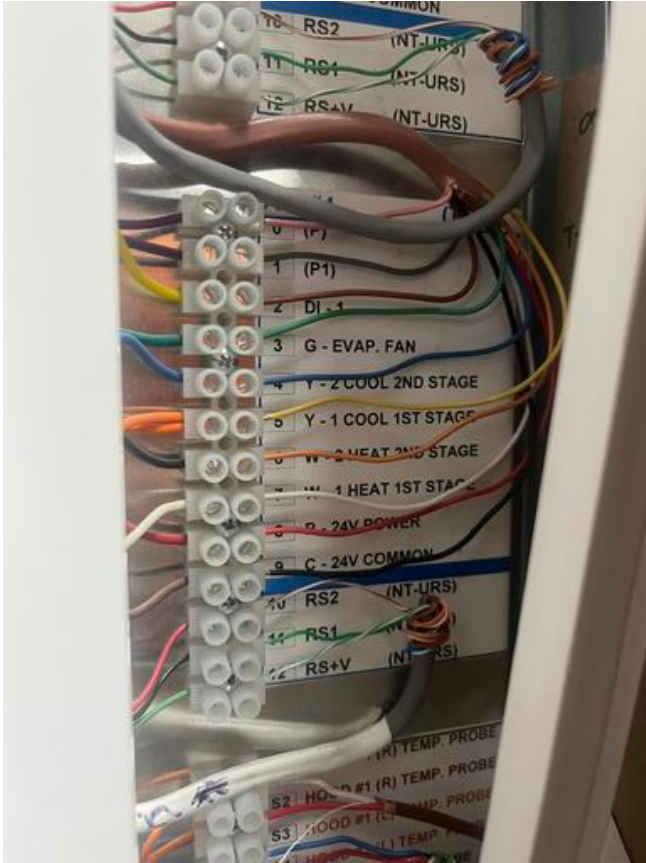
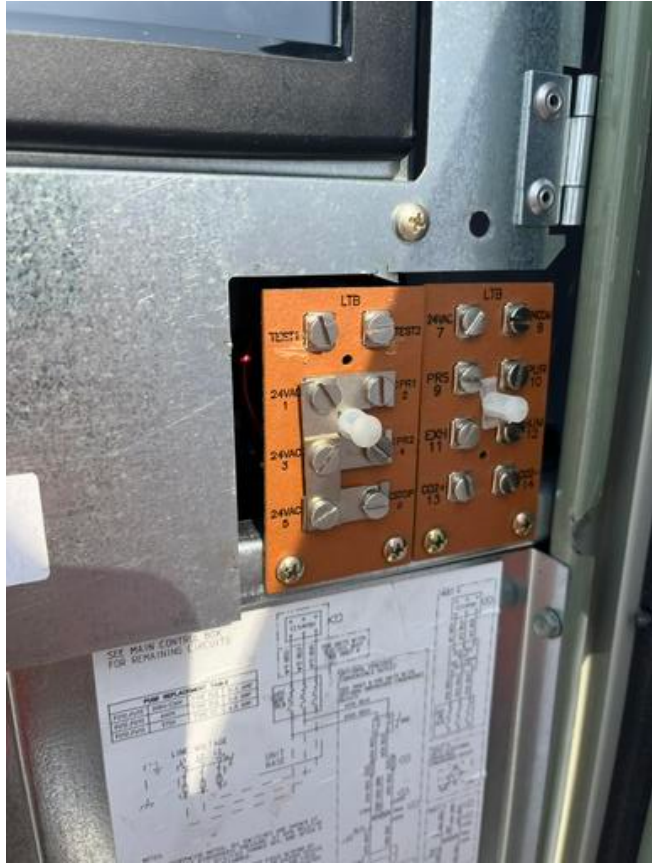
AC-4 thermostat wiring not terminated correctly. Per plans, DI-1 to terminate at LTB 6-estop, and jumper between 5-6 to be removed. DI-1 currently wire nutted in unit.

Corrected by controls/tab. Fire interlock on ac-4 had to be swapped

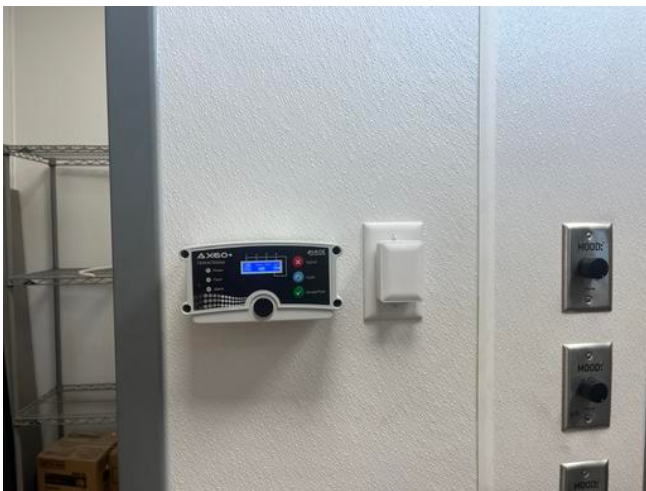
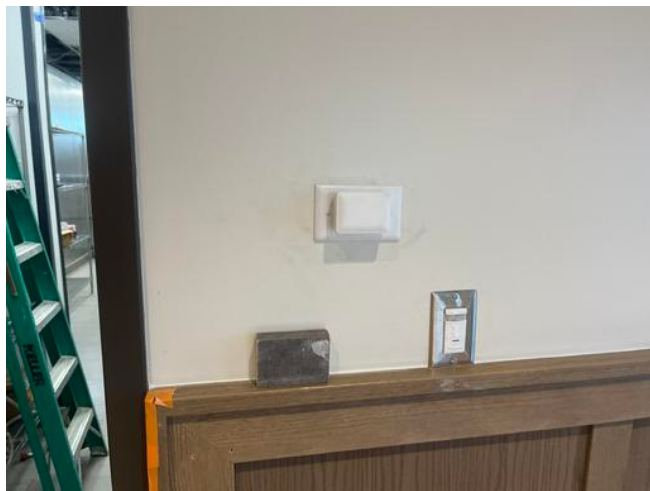
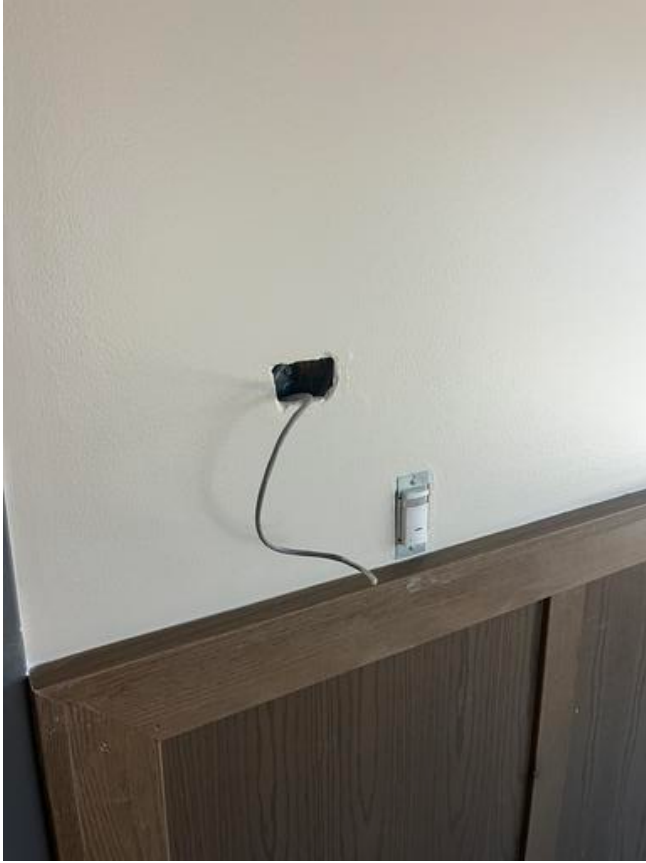
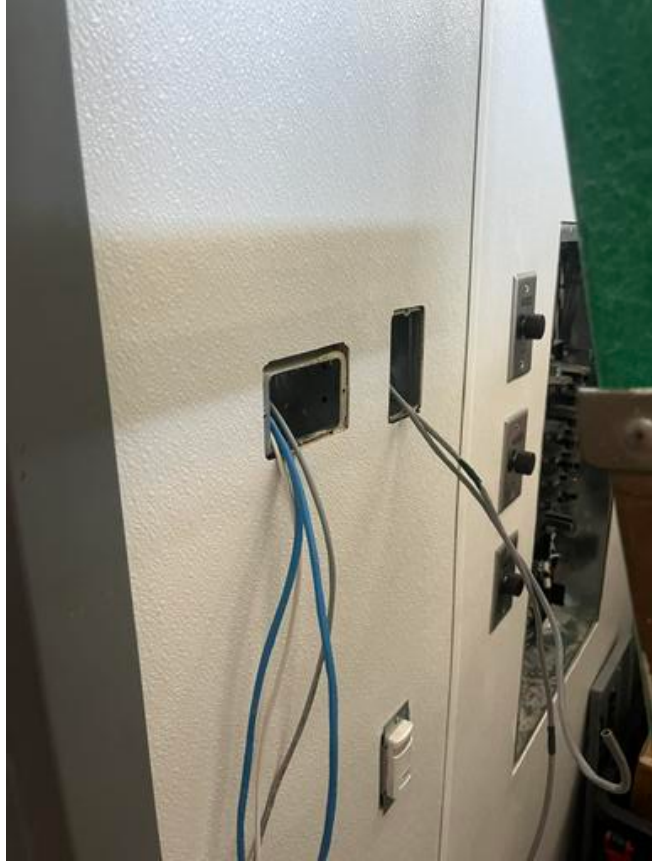
Avg. sensors for AC-4 are not installed. Only temp sensor 1 is installed.

Additional sensors installed and wired by controls contractor.

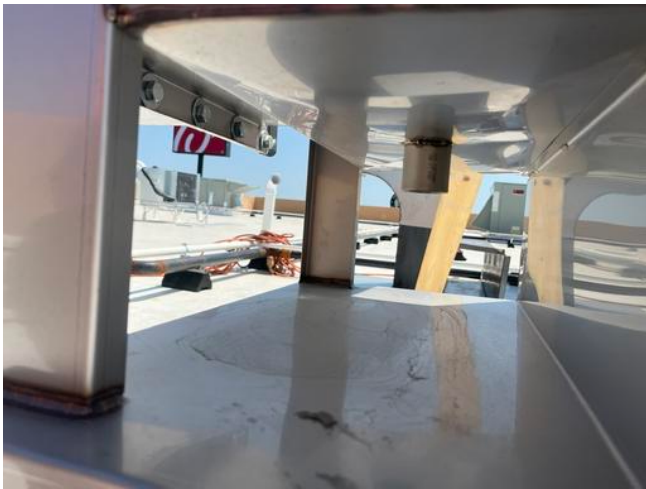
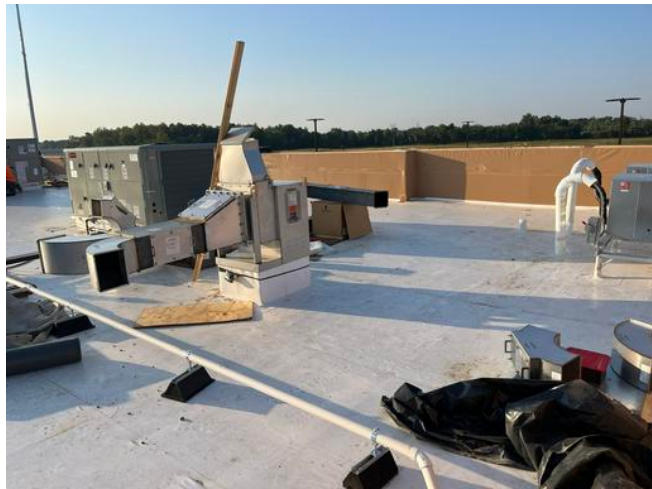
Exhaust fan G2 Drip Guards  
not installed for n EF-1/2

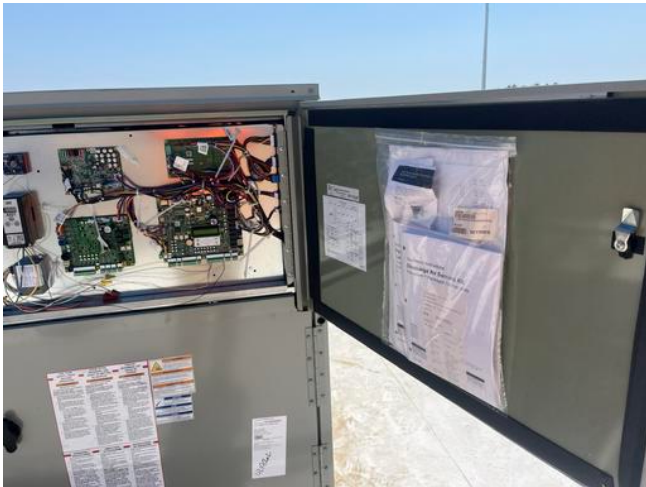
Equipment missing laminated copy of control wiring diagram.

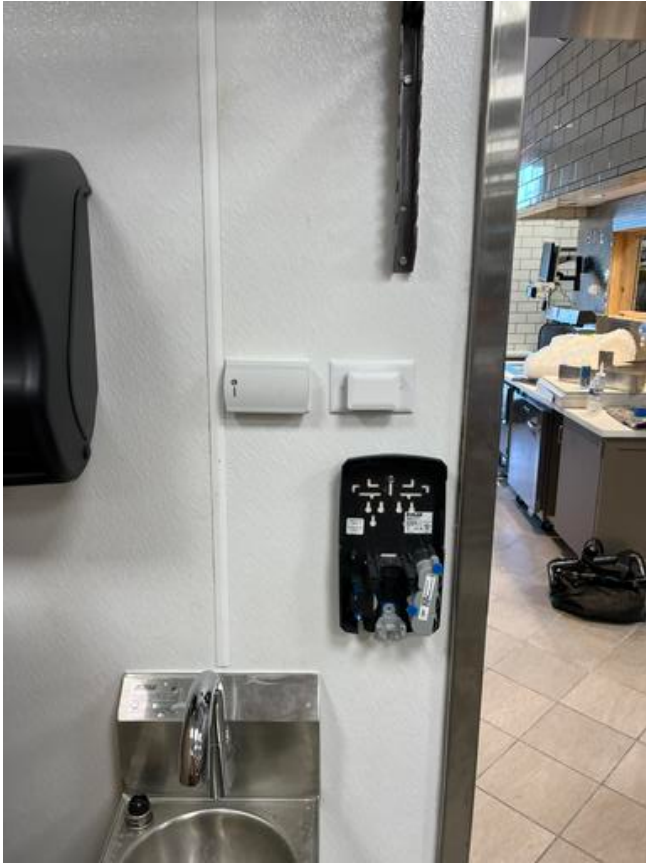
See note 35 on M-101:  
“mount humidity sensor  
above temperature sensor.”  
Sensor is not mounted  
above temp sensor and is  
mounted horizontally. All  
sensors mounted in this  
manner.

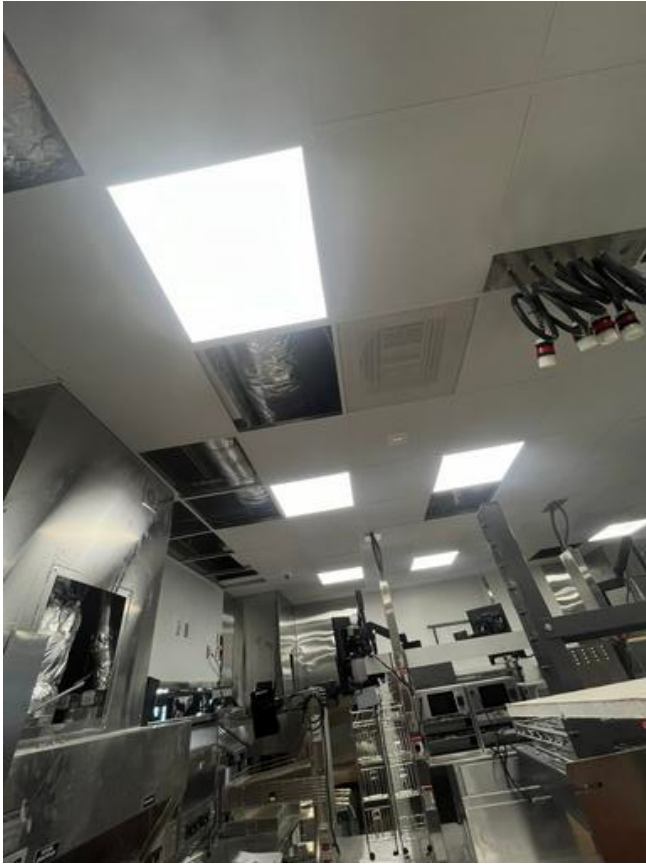
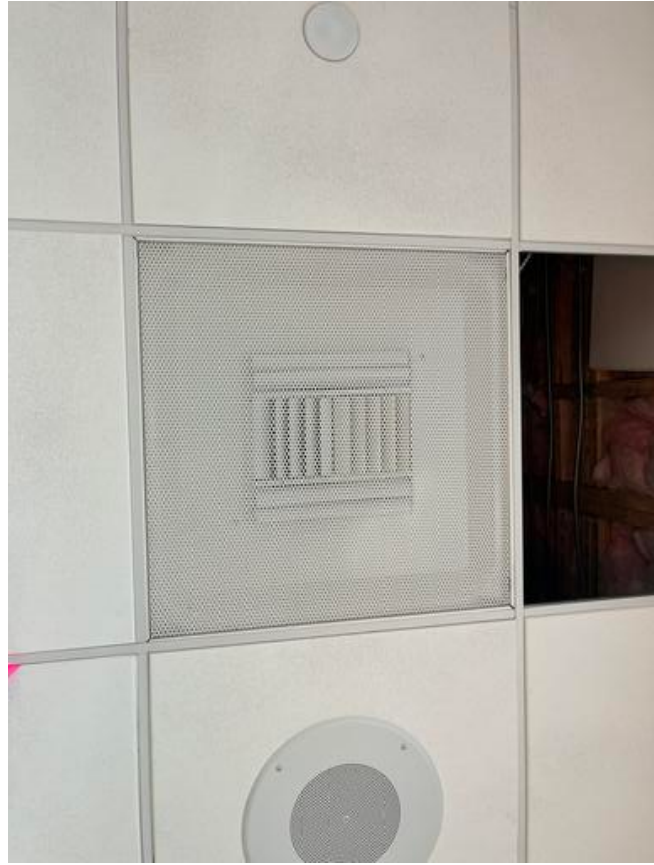
Air pattern deflectors need adjustment by MC per plans. Dining room diffusers and kitchen diffusers near hoods need adjustment as noted on plans.

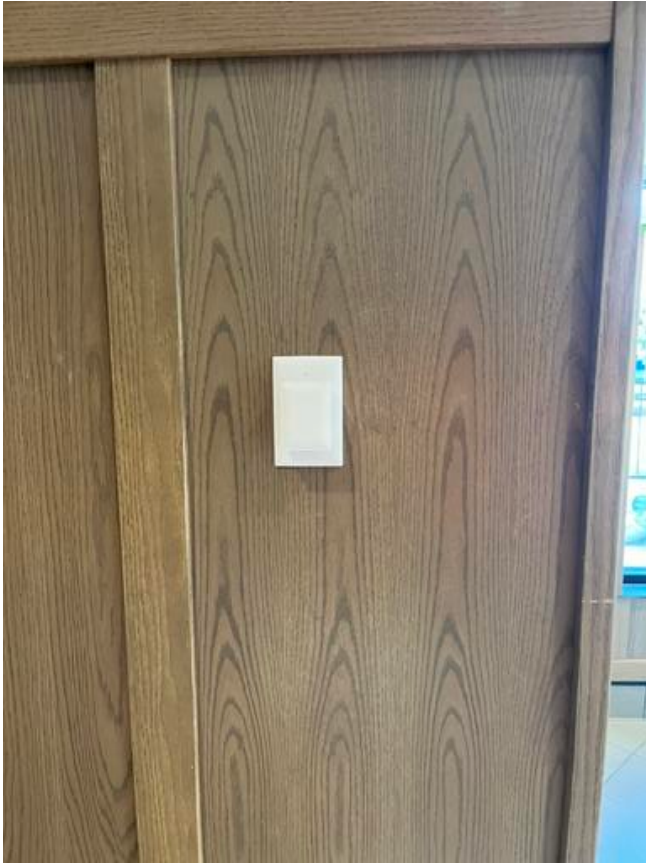
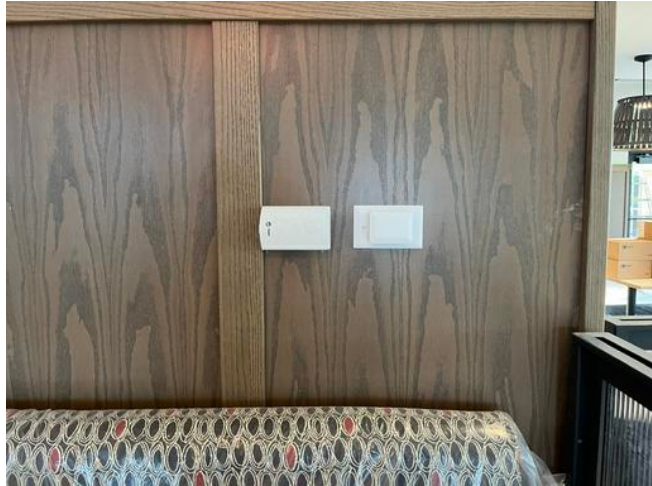
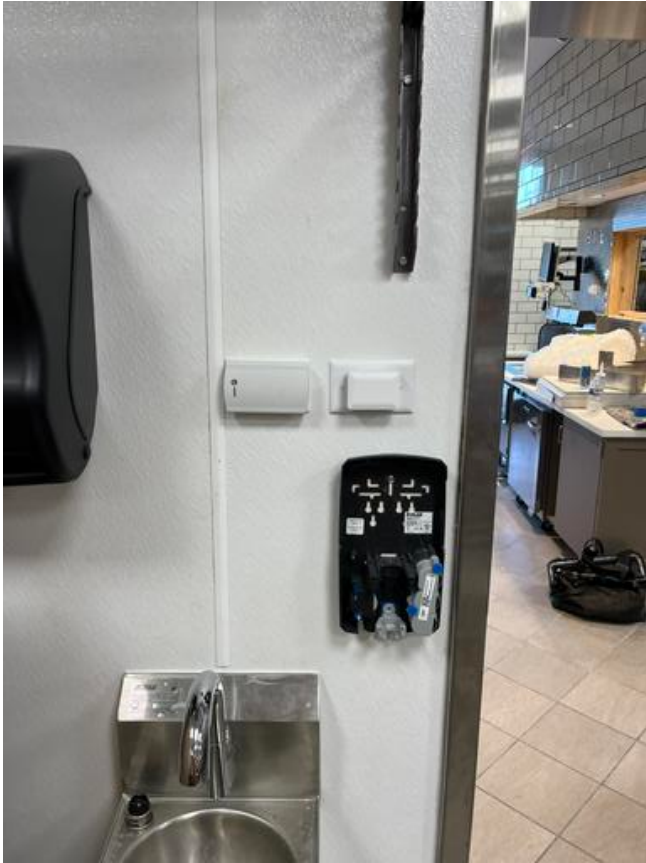
Label all sensors, humidistats, thermostats, smoke Annunciators for which piece of equipment they serve.

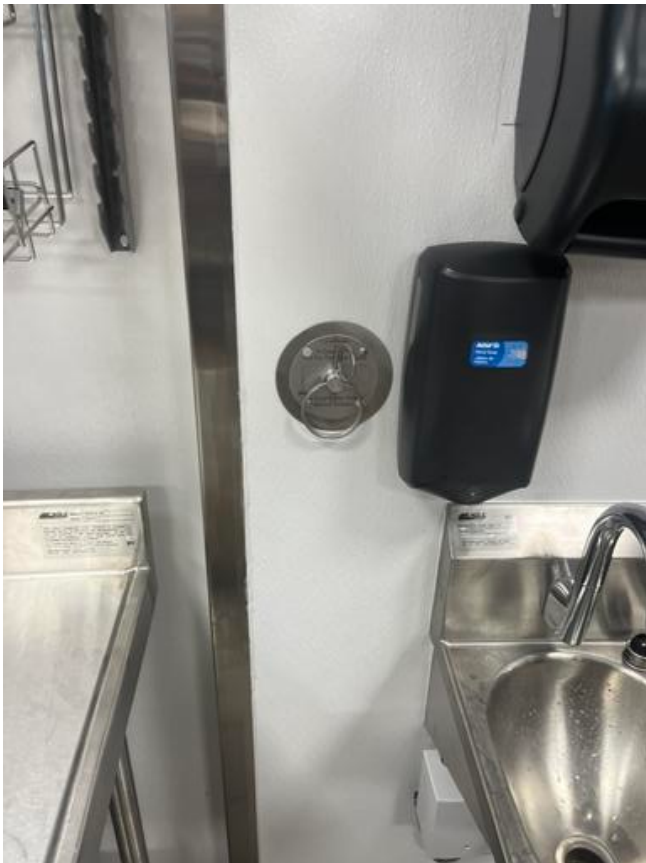
Label all Ansul pull stations for hood they serve

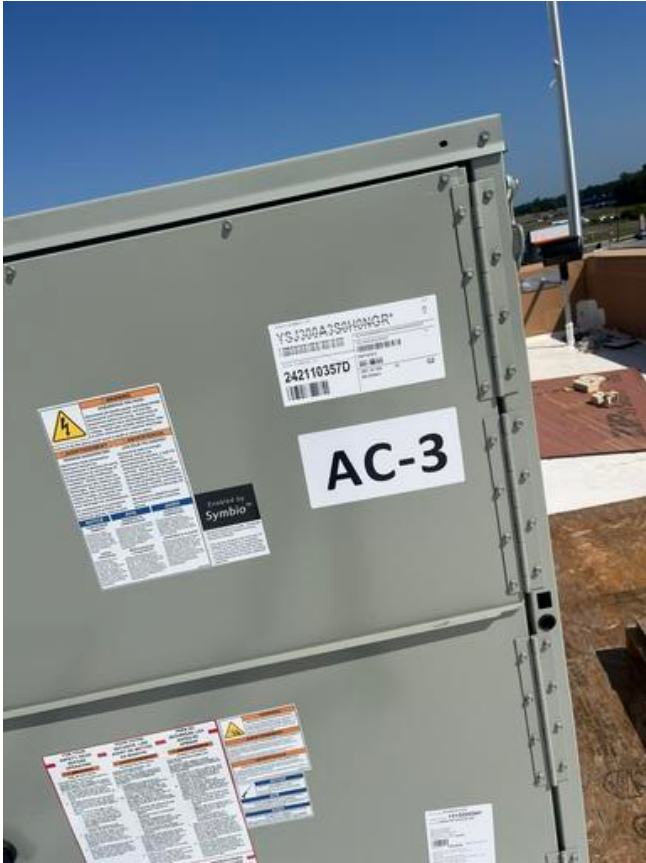
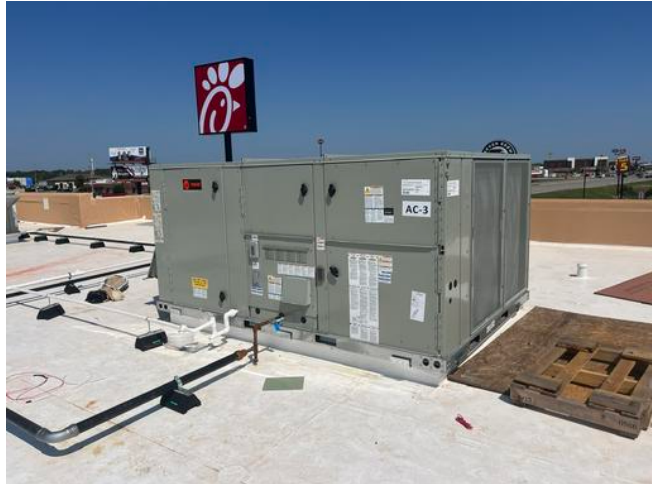
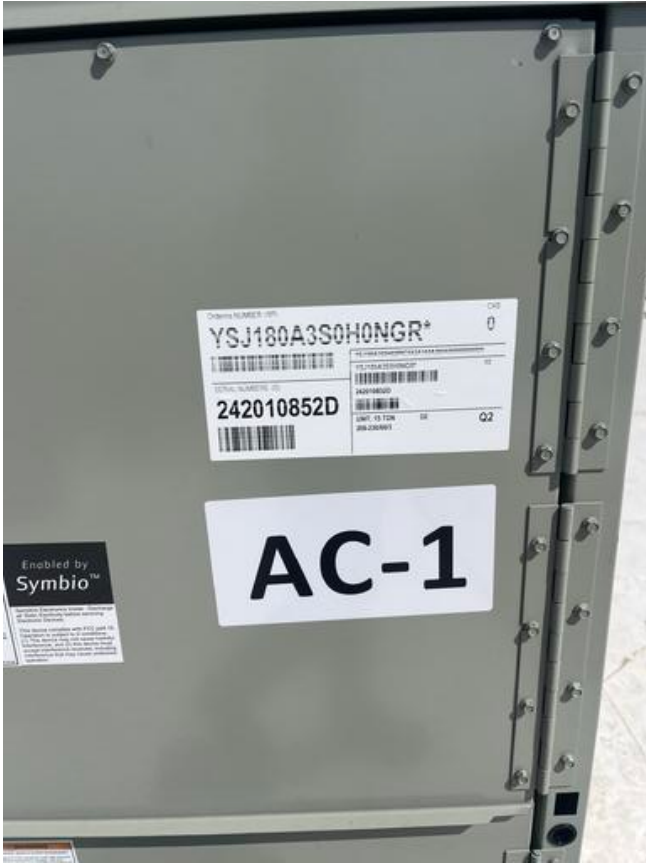
ACs found to be installed on wrong curbs and will need to be swapped to continue with TAB. AC-1 installed in AC-3 location and vice versa.
