**National TAB  
1329 E. KEMPER ROAD  
SUITE 4210  
CINCINNATI, OH 45246**

**Report: FINAL TAB REPORT  
Function: Test, Adjust, & Balance  
Date: 10/11/2022**

**PROJECT  
10-03 FREDDY'S HAMPTON, VA**

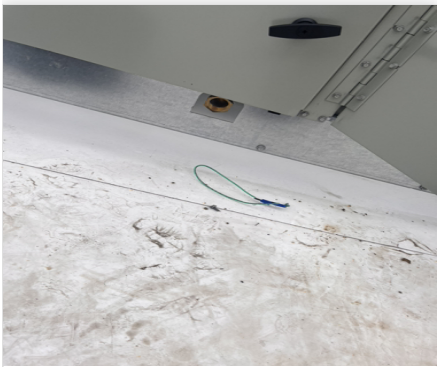
**Issue Name :** RTU-1 Condensate is not installed-W.I.P  
**Description :** RTU-1 condensate line is not installed .  
**Created By :** National TAB                      **Assigned To :** National TAB - Will Turnbough  
**Status :** Open  
**Originated Date :** 10/05/2022 - David Annan - National TAB

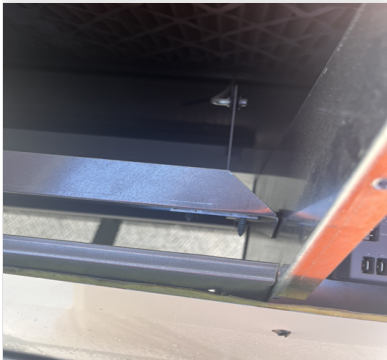
**Issue Name :** RTU-1 Low flow  
**Description :** RTU-1 total flow is about 80% of design. Motor sheave is already at 1 turn out (B belt).  
**Created By :** National TAB                      **Assigned To :** National TAB - Will Turnbough  
**Status :** Open  
**Originated Date :** 10/05/2022 - David Annan - National TAB

- **10/06/2022      National TAB - David Annan**
  - Result of the low flow could be from the return or OA dampers not opening up to provide more airflow.

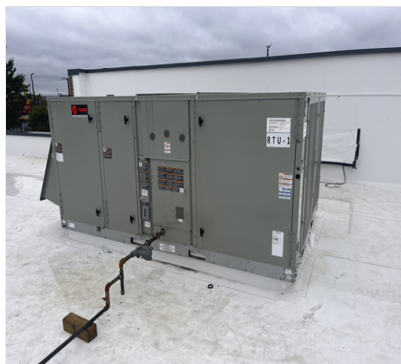
| Economizers are assembled and functional? | RTU-1 Economizer is not functional does not respond to various damper commands. |

| Do actual net building airflow, design net building airflow, and pressure coincide? If not why? (All three should either be positive or negative) | Yes, OA for RTU-1 is above design due to economizer not being functional. |
