**Report: TAB Report**  
**Function: Test, Adjust, & Balance**  
**Date: 11/26/2025**  
**Completed By: National TAB**

**PROJECT**  
**12-08-25 QT #1439 MESA, AZ**

9038 E. ELLIOT RD

QUIKTRIP  
4705 SOUTH 129TH EAST AVENUE  
TULSA, OK 74134

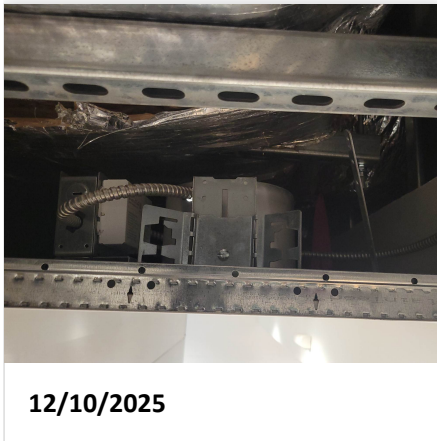
**Issue Name :** DAMPERS INACCESSIBLE  
**Description :** RTU3 dampers should be accessible for TAB to done properly. Tiles cannot be move due to proximity of light canisters to steel beams and the hood. They are installed too far in to be reached on either side of row of lights. Recommend not installing tiles until kitchen has been balanced.  
**Created By :** National TAB                      **Assigned To :** National TAB - Dan Hertenstein  
**Status :** Open  
**Priority :** High                                      **Asset Tag :** RT-3  
**Originated Date :** 12/10/2025 - Christine Weale - National TAB

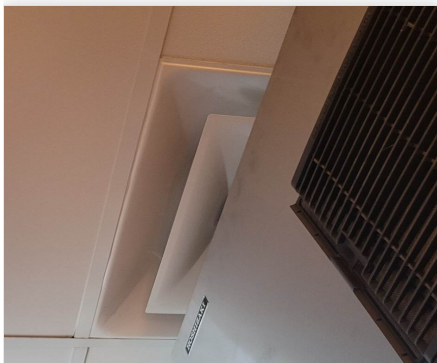
**Issue Name :** GRILLE INACCESSIBLE  
**Description :** RTU2-5 grille is in the wrong place and is inaccessible. Damper was closed, after I measured for total flow I opened it so the back area would be conditioned. Equipment is largely blocking airflow, however.  
**Created By :** National TAB                      **Assigned To :** National TAB - Dan Hertenstein  
**Status :** Open  
**Priority :** InfoOnly                                      **Asset Tag :** SGRD5  
**Originated Date :** 12/10/2025 - Christine Weale - National TAB

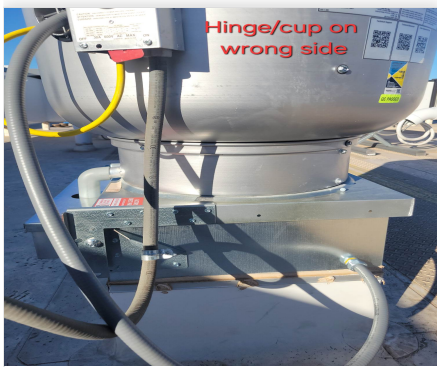
**Issue Name :** HINGE OR CUP INSTALLED ON WRONG SIDE  
**Description :** Hinge should be opposite of grease cup. Fan cannot be tilted all the way back.  
**Created By :** National TAB                      **Assigned To :** National TAB - Dan Hertenstein  
**Status :** Open  
**Priority :** Medium                                      **Asset Tag :** EF3  
**Originated Date :** 12/10/2025 - Christine Weale - National TAB

Yes, but it's not opposite grease cup. Needs to be fixed.

Flex isn't what's keeping it from being tilted back.

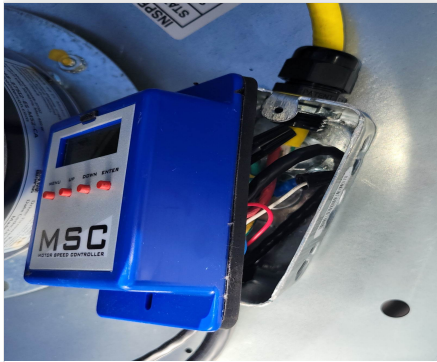
**Issue Name :** MSC NOT PROPERLY INSTALLED  
**Description :** Installer did not screw the cover for the MSC on, there were no spare screws of a correct size.  
**Created By :** National TAB                      **Assigned To :** National TAB - Dan Hertenstein  
**Status :** Open  
**Priority :** InfoOnly                              **Asset Tag :** EF3  
**Originated Date :** 12/10/2025 - Christine Weale - National TAB

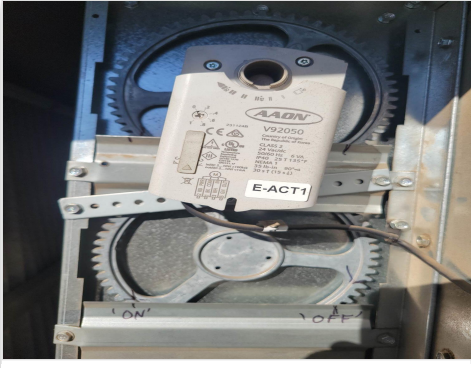
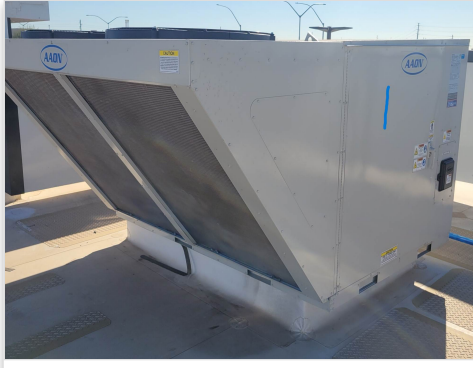
Asset: RT-1

WOMEN'S BATHROOM AIRFLOW EXTREMELY LOW. HVAC SHOULD LOOK INTO CAUSE. DAMPER INACCESSIBLE DUE TO SHELVES.

UNIT PRESSURES ARE PRETTY HIGH, SOME REGISTERS READ LOW, AND UNITS ARE RUNNING AT MAX - RECOMMEND HVAC CHECK ALL DAMPERS/DUCT FOR RTU1&2.

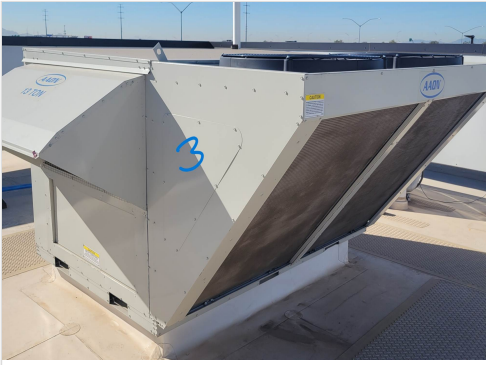
Asset: RT-3

Notes:  
DAMPERS INACCESSIBLE, SEE REMARKS.

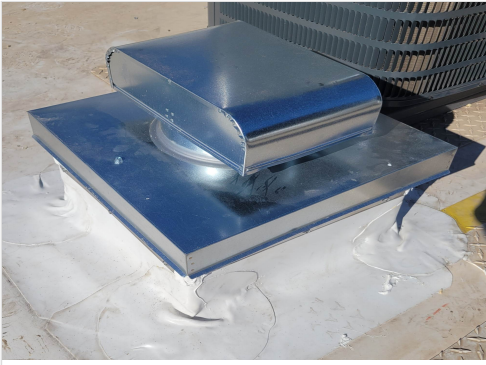
Asset: EF2

Notes:  
EXHAUST FAN IN CEILING, INACCESSIBLE DUE TO COMBI-OVEN, REQUESTED INFO NOT GIVEN.
