**Report: TAB Report**  
**Function: Test, Adjust, & Balance**  
**Date: 11/26/2025**  
**Completed By: National TAB**

**PROJECT**  
**12-08-25 QT #1439 MESA, AZ**

QUIKTRIP  
4705 SOUTH 129TH EAST AVENUE  
TULSA, OK 74134

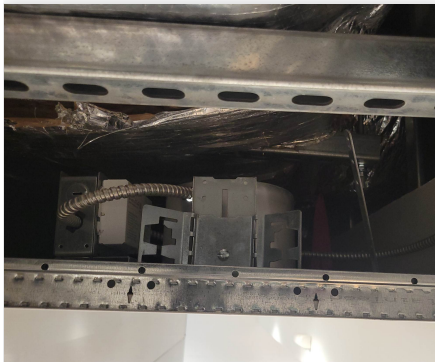
**Issue Name :** DAMPERS INACCESSIBLE  
**Description :** RTU3 dampers should be accessible for TAB to done properly. Tiles cannot be move due to proximity of light canisters to steel beams and the hood. They are installed too far in to be reached on either side of row of lights. Recommend not installing tiles until kitchen has been balanced.  
**Created By :** National TAB                      **Assigned To :** National TAB - Dan Hertenstein  
**Status :** Open  
**Priority :** High                                      **Asset Tag :** RT-3  
**Originated Date :** 12/10/2025 - Christine Weale - National TAB

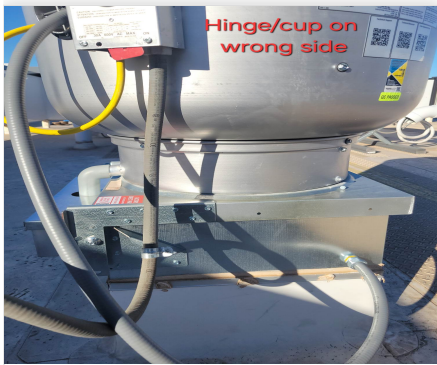
**Issue Name :** HINGE OR CUP INSTALLED ON WRONG SIDE  
**Description :** Hinge should be opposite of grease cup. Fan cannot be tilted all the way back.  
**Created By :** National TAB      **Assigned To :** National TAB - Dan Hertenstein  
**Status :** Open  
**Priority :** Medium      **Asset Tag :** EF3  
**Originated Date :** 12/10/2025 - Christine Weale - National TAB

Yes, but it's not opposite grease cup. Needs to be fixed.

Flex isn't what's keeping it from being tilted back.

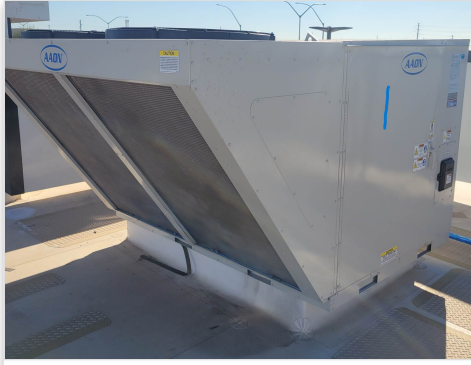
WOMEN'S BATHROOM AIRFLOW EXTREMELY LOW. HVAC SHOULD LOOK INTO CAUSE. DAMPER INACCESSIBLE DUE TO SHELVES.

UNIT PRESSURES ARE PRETTY HIGH, SOME REGISTERS READ LOW, AND UNITS ARE RUNNING AT MAX - RECOMMEND HVAC CHECK ALL DAMPERS/DUCT FOR RTU1&2.

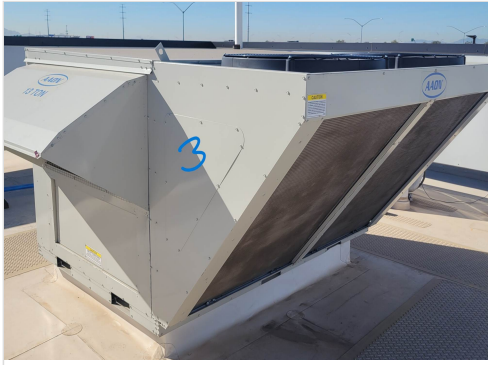
Notes:  
DAMPERS INACCESSIBLE, SEE REMARKS.
