**Report: TAB Report**  
**Function: Test, Adjust, & Balance**  
**Date: 11/26/2025**  
**Completed By: National TAB**

**PROJECT**  
**12-08-25 QT #1439 MESA, AZ**

QUIKTRIP  
4705 SOUTH 129TH EAST AVENUE  
TULSA, OK 74134

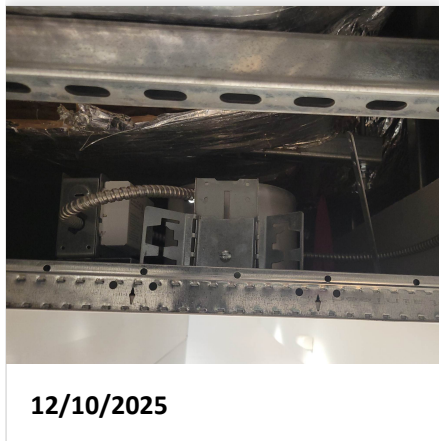
**Issue Name :** RTU-3 DAMPERS INACCESSIBLE  
**Description :** RTU3 dampers should be accessible for TAB. Unable to access dampers and unable to balance kitchen diffusers as result. Tiles cannot be move due to proximity of light canisters to steel beams and the hood. They are installed too far in to be reached on either side of row of lights. Recommend not installing tiles until kitchen has been balanced.  
**Created By :** National TAB                      **Assigned To :** National TAB - Dan Hertenstein  
**Status :** Open  
**Priority :** High                                      **Asset Tag :** RT-3  
**Originated Date :** 12/10/2025 - Christine Weale - National TAB

Notes:  
DAMPERS INACCESSIBLE, SEE REMARKS.
