Report: TAB Report
Function: Test, Adjust, & Balance
Date: 11/26/2025
Completed By: National TAB

PROJECT
12-08-25 QT #1439 MESA, AZ

Project: 12-08-25 QT #1439 MESA, AZ

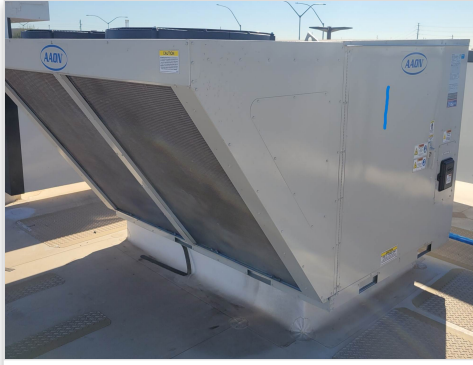
Asset: RT-1

WOMEN'S BATHROOM AIRFLOW EXTREMELY LOW. HVAC SHOULD LOOK INTO CAUSE. DAMPER INACCESSIBLE DUE TO SHELVES.

UNIT PRESSURES ARE PRETTY HIGH, SOME REGISTERS READ LOW, AND UNITS ARE RUNNING AT MAX - RECOMMEND HVAC CHECK ALL DAMPERS/DUCT FOR RTU1&2.

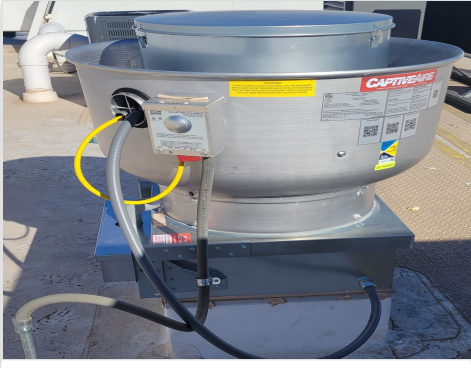
Asset: EF3

Yes, but it's not opposite grease cup. Needs to be fixed.

Flex isn't what's keeping it from being tilted back.
