**Report: TAB Report**  
**Function: Test, Adjust, & Balance**  
**Date: 11/26/2025**  
**Completed By: National TAB**

**PROJECT**  
**12-08-25 QT #1439 MESA, AZ**

9038 E. ELLIOT RD

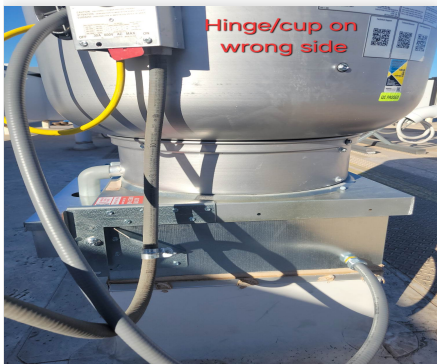
**Issue Name :** EF-3 INSTALLATION  
**Description :** Fan cannot be tilted all the way back, blocked by grease cup. Hinge should be opposite of grease cup. Additionally, electrical conduit is routed up through the curb to the fan and may also inhibit the fan from tilting back for cleaning. Recommend this is corrected.  
**Created By :** National TAB                      **Assigned To :** National TAB - Dan Hertenstein  
**Status :** Open  
**Priority :** Medium                                      **Asset Tag :** EF3  
**Originated Date :** 12/10/2025 - Christine Weale - National TAB

Yes, but it's not opposite grease cup. Needs to be fixed.

Flex isn't what's keeping it from being tilted back.

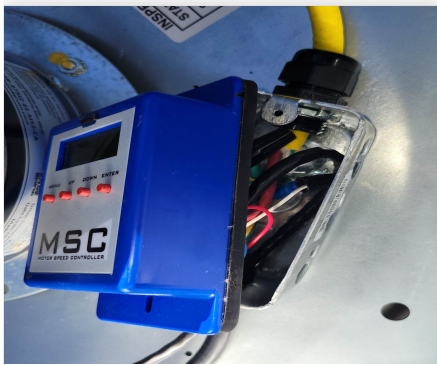
**Issue Name :** EF-3 MSC CONTROLLER  
**Description :** Installer did not screw the cover for the MSC on, there were no spare screws of a correct size.  
**Created By :** National TAB                      **Assigned To :** National TAB - Dan Hertenstein  
**Status :** Open  
**Priority :** InfoOnly                                      **Asset Tag :** EF3  
**Originated Date :** 12/10/2025 - Christine Weale - National TAB

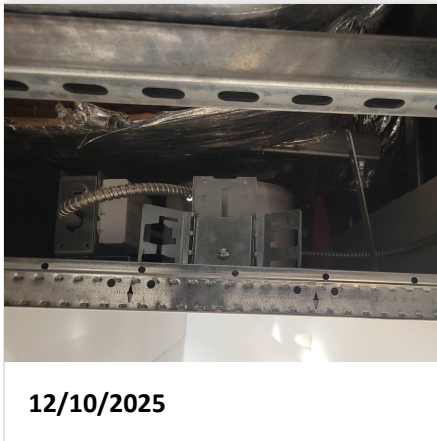
**Issue Name :** RTU-3 DAMPERS INACCESSIBLE  
**Description :** RTU3 dampers should be accessible for TAB. Unable to access dampers and unable to balance kitchen diffusers as result. Tiles cannot be move due to proximity of light canisters to steel beams and the hood. They are installed too far in to be reached on either side of row of lights. Recommend not installing tiles until kitchen has been balanced.  
**Created By :** National TAB                      **Assigned To :** National TAB - Dan Hertenstein  
**Status :** Open  
**Priority :** High                                      **Asset Tag :** RT-3  
**Originated Date :** 12/10/2025 - Christine Weale - National TAB

Notes:  
DAMPERS INACCESSIBLE, SEE REMARKS.

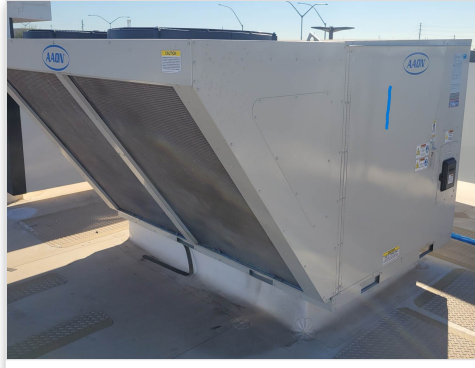
Asset: RT-1

WOMEN'S BATHROOM AIRFLOW EXTREMELY LOW. HVAC SHOULD LOOK INTO CAUSE. DAMPER INACCESSIBLE DUE TO SHELVES.

UNIT PRESSURES ARE PRETTY HIGH, SOME REGISTERS READ LOW, AND UNITS ARE RUNNING AT MAX - RECOMMEND HVAC CHECK ALL DAMPERS/DUCT FOR RTU1&2.
