Report: TAB Report
Function: Test, Adjust, & Balance
Date: 11/26/2025
Completed By: National TAB

PROJECT
12-08-25 QT #1439 MESA, AZ

Project: 12-08-25 QT #1439 MESA, AZ

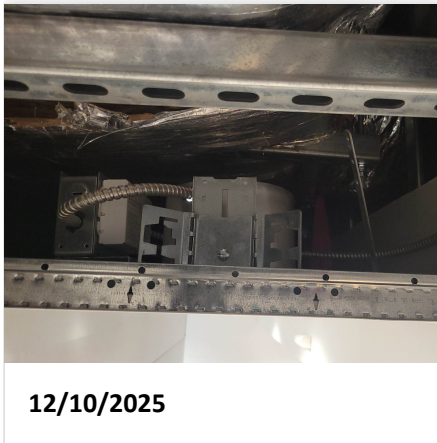
Issue Name : DAMPERS INACCESSIBLE
Description : RTU3 dampers should be accessible for TAB to done properly. Tiles cannot be move due to proximity of light canisters to steel beams and the hood. They are installed too far in to be reached on either side of row of lights. Recommend not installing tiles until kitchen has been balanced.
Created By : National TAB **Assigned To :** National TAB - Dan Hertenstein
Status : Open
Priority : High **Asset Tag :** RT-3
Originated Date : 12/10/2025 - Christine Weale - National TAB
