**Report: TAB Report**  
**Function: Test, Adjust, & Balance**  
**Date: 11/26/2025**  
**Completed By: National TAB**

**PROJECT**  
**12-08-25 QT #1439 MESA, AZ**

QUIKTRIP  
4705 SOUTH 129TH EAST AVENUE  
TULSA, OK 74134

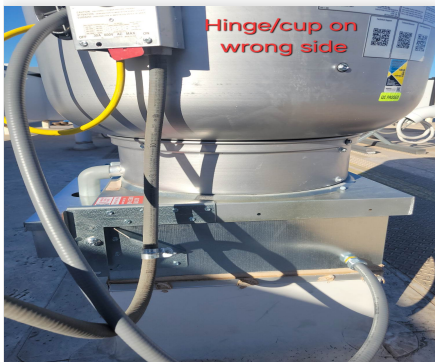
**Issue Name :** EF-3 INSTALLATION  
**Description :** Fan cannot be tilted all the way back, blocked by grease cup. Hinge should be opposite of grease cup. Additionally, electrical conduit is routed up through the curb to the fan and may also inhibit the fan from tilting back for cleaning. Recommend this is corrected.  
**Created By :** National TAB                      **Assigned To :** National TAB - Dan Hertenstein  
**Status :** Open  
**Priority :** Medium                      **Asset Tag :** EF3  
**Originated Date :** 12/10/2025 - Christine Weale - National TAB

Yes, but it's not opposite grease cup. Needs to be fixed.

Flex isn't what's keeping it from being tilted back.

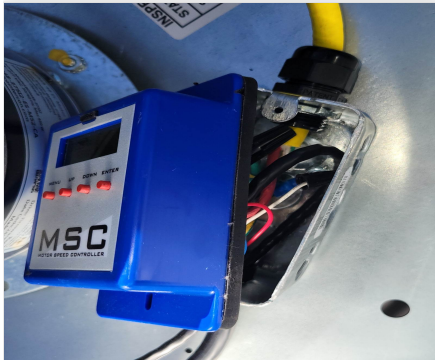
**Issue Name :** EF-3 MSC CONTROLLER  
**Description :** Installer did not screw the cover for the MSC on, there were no spare screws of a correct size.  
**Created By :** National TAB      **Assigned To :** National TAB - Dan Hertenstein  
**Status :** Open  
**Priority :** InfoOnly      **Asset Tag :** EF3  
**Originated Date :** 12/10/2025 - Christine Weale - National TAB

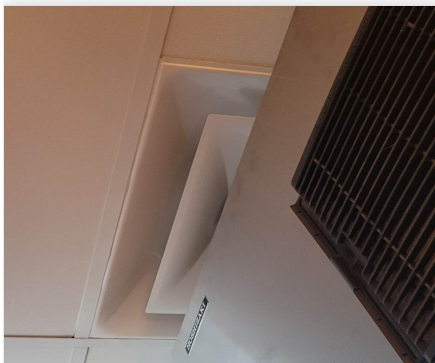
**Issue Name :** RTU-2 SUPPLY GRILLE INACCESSIBLE  
**Description :** RTU2-5 grille is in the wrong place and is inaccessible. Damper was closed, after I measured for total flow I opened it so the back area would be conditioned. Equipment is largely blocking airflow, however.  
**Created By :** National TAB                      **Assigned To :** National TAB - Dan Hertenstein  
**Status :** Open  
**Priority :** InfoOnly                      **Asset Tag :** SGRD5  
**Originated Date :** 12/10/2025 - Christine Weale - National TAB

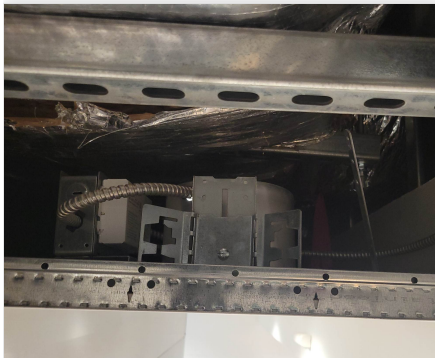
**Issue Name :** RTU-3 DAMPERS INACCESSIBLE  
**Description :** RTU3 dampers should be accessible for TAB. Unable to access dampers and unable to balance kitchen diffusers as result. Tiles cannot be move due to proximity of light canisters to steel beams and the hood. They are installed too far in to be reached on either side of row of lights. Recommend not installing tiles until kitchen has been balanced.  
**Created By :** National TAB      **Assigned To :** National TAB - Dan Hertenstein  
**Status :** Open  
**Priority :** High      **Asset Tag :** RT-3  
**Originated Date :** 12/10/2025 - Christine Weale - National TAB

Notes:  
DAMPERS INACCESSIBLE, SEE REMARKS.

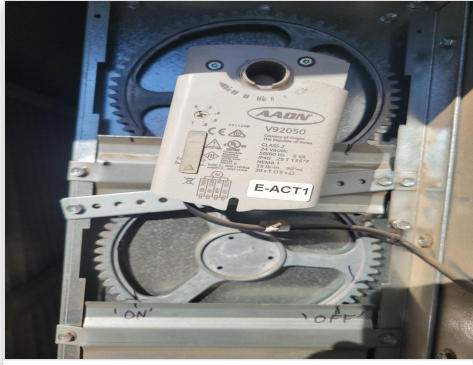
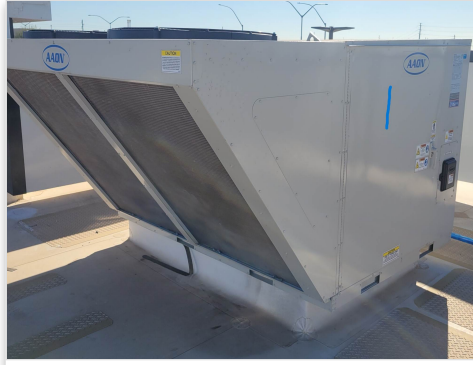
WOMEN'S BATHROOM AIRFLOW EXTREMELY LOW. HVAC SHOULD LOOK INTO CAUSE. DAMPER INACCESSIBLE DUE TO SHELVES.

UNIT PRESSURES ARE PRETTY HIGH, SOME REGISTERS READ LOW, AND UNITS ARE RUNNING AT MAX - RECOMMEND HVAC CHECK ALL DAMPERS/DUCT FOR RTU1&2.

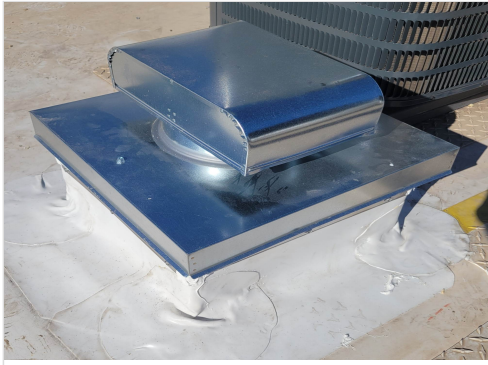
PER GC, INLINE FAN ADDED TO SERVE COMBI-OVEN GRILLE. FAN IS NOT ACCESSIBLE. UNABLE TO LOWER COMBI-OVEN GRILLE TO DESIGN, NOT ANTICIPATED TO CAUSE ANY ISSUE.
