Report: TAB Survey
Function: Test, Adjust, & Balance
Date: 10/13/2025
Completed By: National TAB

**10-06-25 BOJANGLES #1012 COLLEGE
PARK, GA**

Budderfly

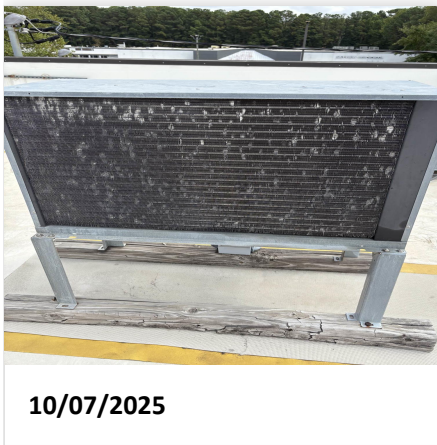
Issue Name : CONDENSERS 4 AND 5 DAMAGED FINS
Description : Condensers 4 and 5 have damage to external fins. Replacing is recommended.
Created By : National TAB **Assigned To :** National TAB - Will Turnbough
Status : Open
Priority : Medium **Asset Tag :**
Originated Date : 10/07/2025 - Sagar Patel - National TAB

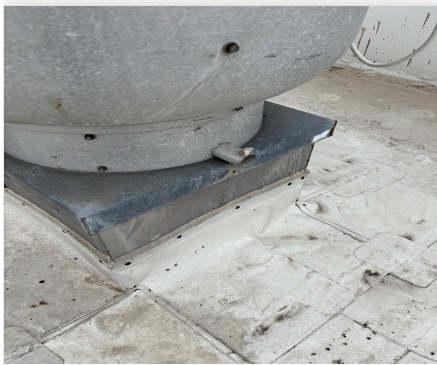
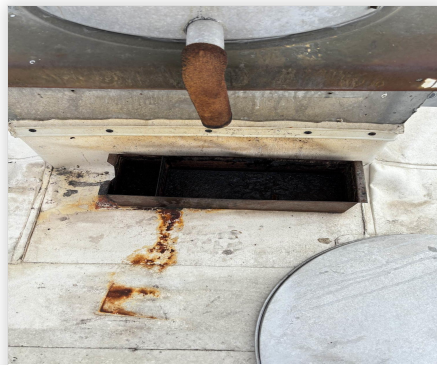
Issue Name : EF 1 AND 3 GREASE CATCH NOT ATTACHED
Description : The grease catch on RTU 1 is not attached. Grease catch on RTU 3 is missing.
Created By : National TAB **Assigned To :** National TAB - Will Turnbough
Status : Open
Priority : High **Asset Tag :**
Originated Date : 10/07/2025 - Sagar Patel - National TAB

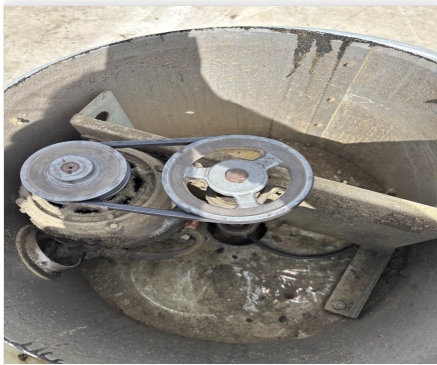
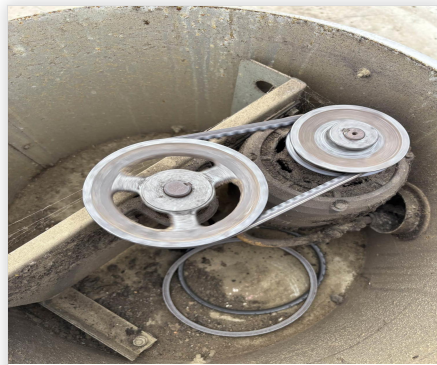
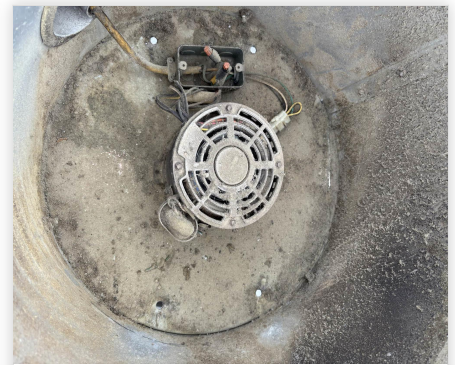
Issue Name : EF 1, 2, AND 3 DIRTY MOTOR COMPARTMENT
Description : The motor compartment is dirty in Exhaust Fans 1, 2, and 3. Cleaning is recommended.
Created By : National TAB **Assigned To :** National TAB - Will Turnbough
Status : Open
Priority : High **Asset Tag :**
Originated Date : 10/07/2025 - Sagar Patel - National TAB

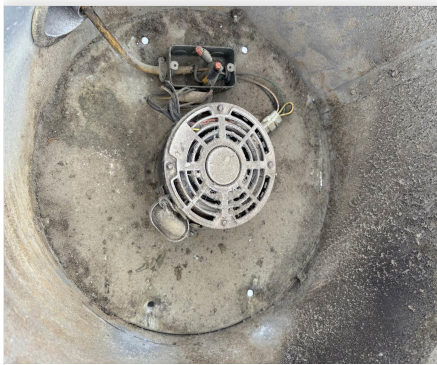
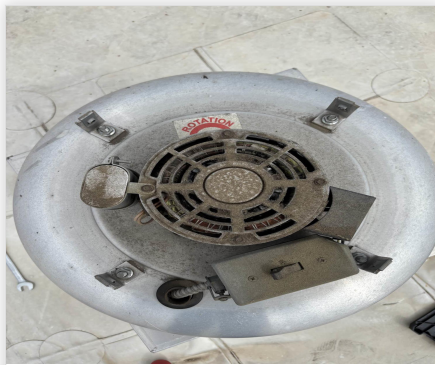
Issue Name : EF 3 AND 4 MISSING SPEED CONTROL
Description : Exhaust fans 3 and 4 are missing speed controls/ are unable to be located.
Created By : National TAB **Assigned To :** National TAB - Will Turnbough
Status : Open
Priority : High **Asset Tag :**
Originated Date : 10/07/2025 - Sagar Patel - National TAB

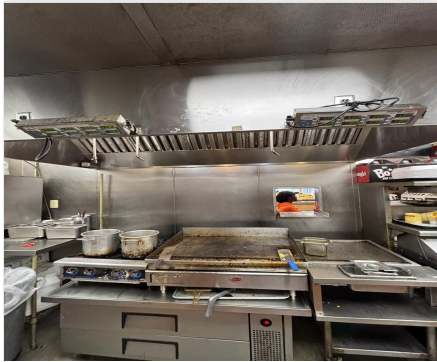
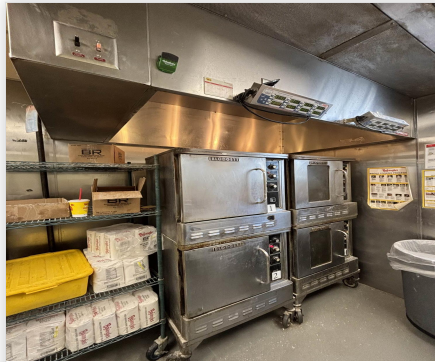
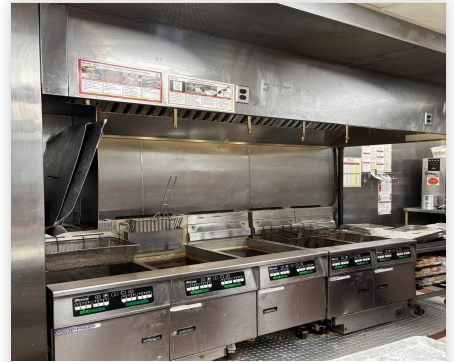
Issue Name : HOOD END PANELS NOT INSTALLED
Description : Hood 1 is missing right side end panel. Hood 2 is missing both end panels. Hood 3 is missing left end panel.
Created By : National TAB **Assigned To :** National TAB - Will Turnbough
Status : Open
Priority : Medium **Asset Tag :**
Originated Date : 10/08/2025 - Sagar Patel - National TAB

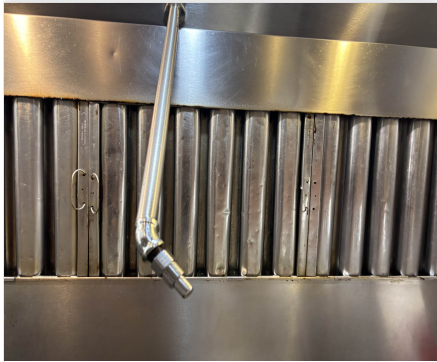
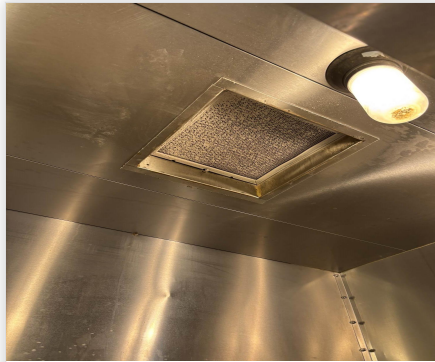
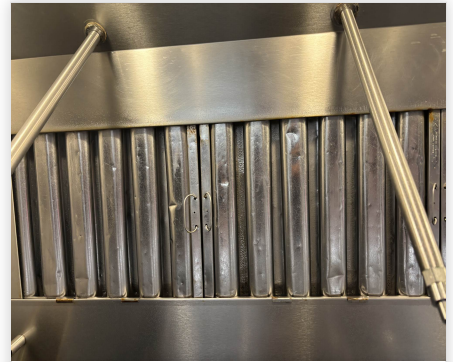
Issue Name : HOOD FILTERS ARE DAMAGED AND DIRTY
Description : All hood filters are dirty and some are damaged. Cleaning and replacing filters are recommended.
Created By : National TAB **Assigned To :** National TAB - Will Turnbough
Status : Open
Priority : High **Asset Tag :**
Originated Date : 10/07/2025 - Sagar Patel - National TAB

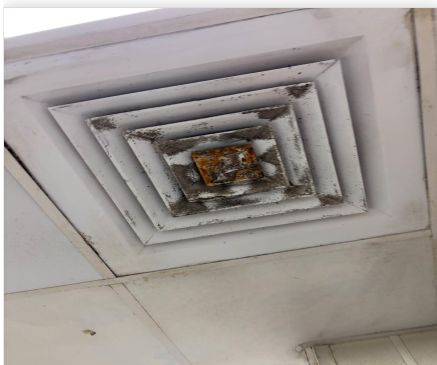
Issue Name : KITCHEN DIFFUSERS ARE RUSTY
Description : The kitchen diffusers are rusty. Cleaning or replacing is recommended.
Created By : National TAB **Assigned To :** National TAB - Will Turnbough
Status : Open
Priority : High **Asset Tag :**
Originated Date : 10/07/2025 - Sagar Patel - National TAB

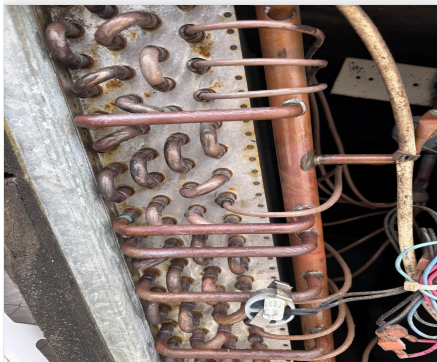
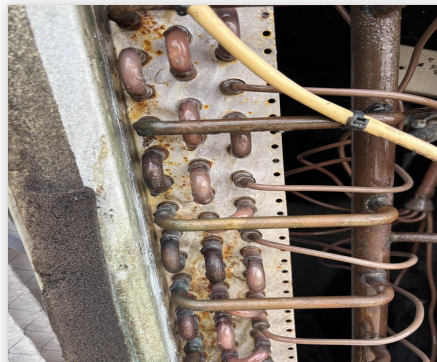
Issue Name : RTU 2 AND 3 CONDENSATE COILS DIRTY
Description : Condensate coils are dirty on RTU 2 and 3. Cleaning is recommended.
Created By : National TAB **Assigned To :** National TAB - Will Turnbough
Status : Open
Priority : High **Asset Tag :**
Originated Date : 10/07/2025 - Sagar Patel - National TAB

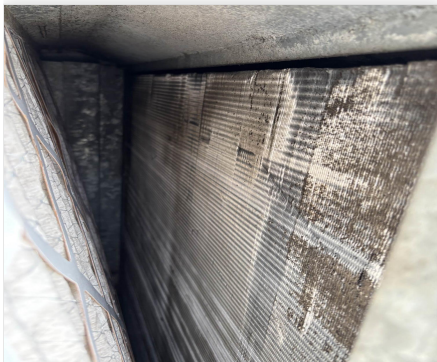
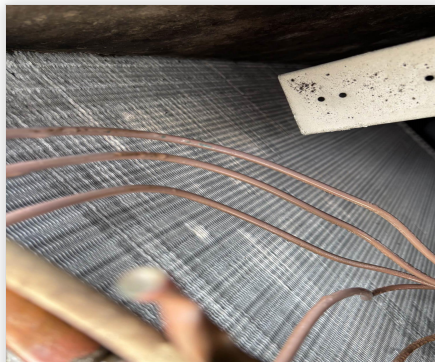
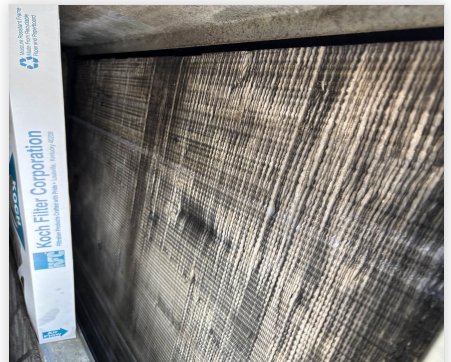
Issue Name : RTU 2 AND 3 EVAPORATOR FINS DIRTY
Description : RTU 2 and 3 evaporator fins are dirty. Cleaning is recommended.
Created By : National TAB **Assigned To :** National TAB - Will Turnbough
Status : Open
Priority : High **Asset Tag :**
Originated Date : 10/07/2025 - Sagar Patel - National TAB

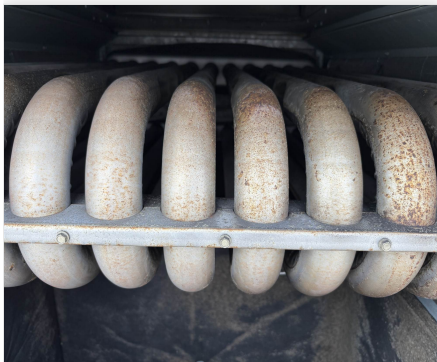
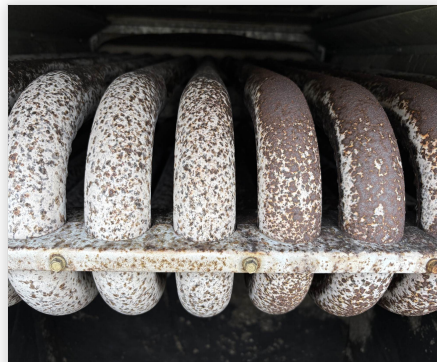
Issue Name : RTU 2 AND 3 HEAT EXCHANGERS ARE RUSTING
Description : Rust is developing on heat exchangers.
Created By : National TAB **Assigned To :** National TAB - Will Turnbough
Status : Open
Priority : Medium **Asset Tag :**
Originated Date : 10/07/2025 - Sagar Patel - National TAB

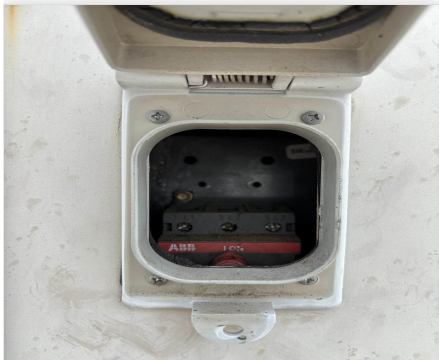
Issue Name : RTU 3 POWER SWITCH NOT ACCESSIBLE
Description : The power switch on RTU 3 is not aligned with power switch cover
Created By : National TAB **Assigned To :** National TAB - Will Turnbough
Status : Open
Priority : Medium **Asset Tag :**
Originated Date : 10/07/2025 - Sagar Patel - National TAB

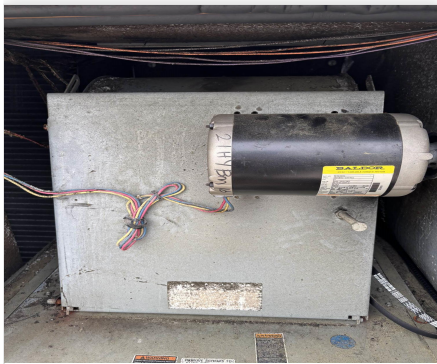
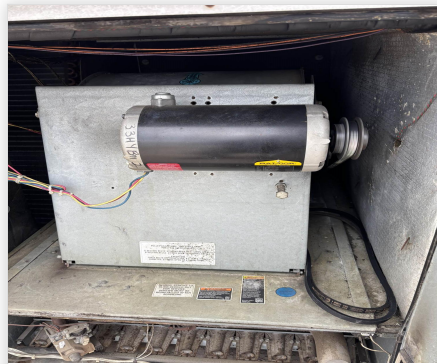
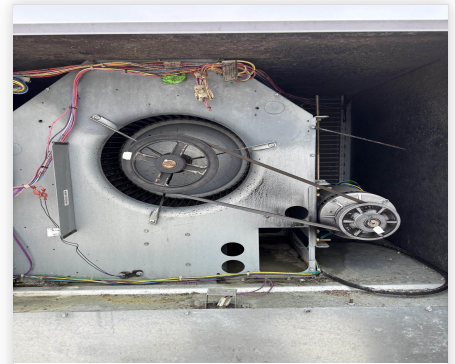
Issue Name : RTUs BLOWER COMPARTMENT DIRTY
Description : All RTU Blower Compartments are dirty. Cleaning is recommended.
Created By : National TAB **Assigned To :** National TAB - Will Turnbough
Status : Open
Priority : Medium **Asset Tag :**
Originated Date : 10/07/2025 - Sagar Patel - National TAB

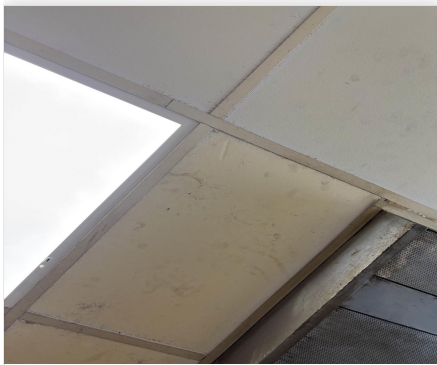
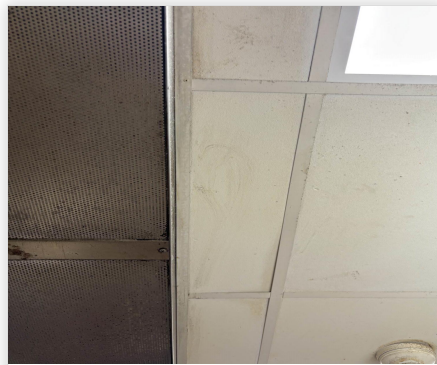
Issue Name : STAINED CEILING TILES AROUND HOODS
Description : The ceiling tiles around each hood is stained. Indicates hoods are not capturing
Created By : National TAB **Assigned To :** National TAB - Will Turnbough
Status : Open
Priority : Medium **Asset Tag :**
Originated Date : 10/08/2025 - Sagar Patel - National TAB

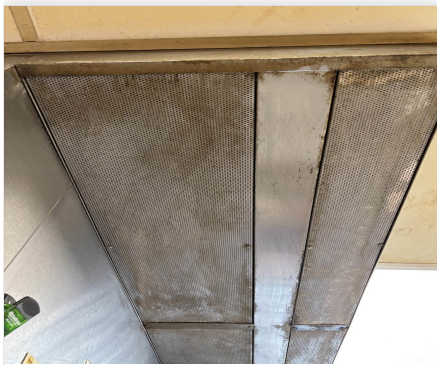
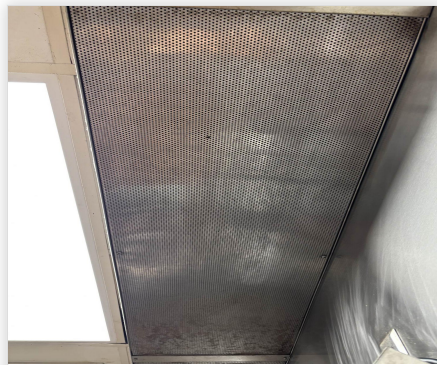
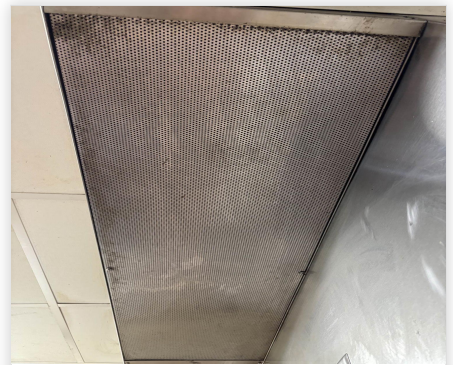
Issue Name : SUPPLY PLENUM AND ACPSP ARE DIRTY
Description : The supply plenum on all hoods and acpssp on hood 3 are dirty. Cleaning is recommended. The plenums need to be dropped and the tops of the plenums cleaned.
Created By : National TAB **Assigned To :** National TAB - Will Turnbough
Status : Open
Priority : High **Asset Tag :**
Originated Date : 10/08/2025 - Sagar Patel - National TAB

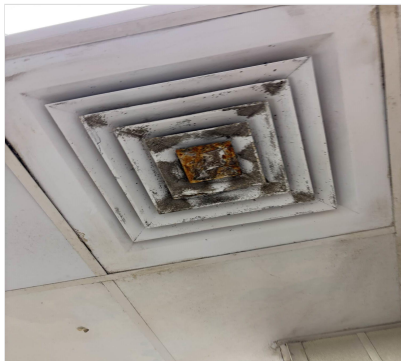
Any additional areas of concern (stained tiles, rusted diffusers, etc)

RUSTY DIFFUSERS
