Report: TAB REPORT
Function: Test, Adjust, & Balance
Date: 12/19/2024
Completed By: National TAB

PROJECT
12-16-24 CULVERS SAUK CITY, WI

Project: 12-16-24 CULVERS SAUK CITY, WI

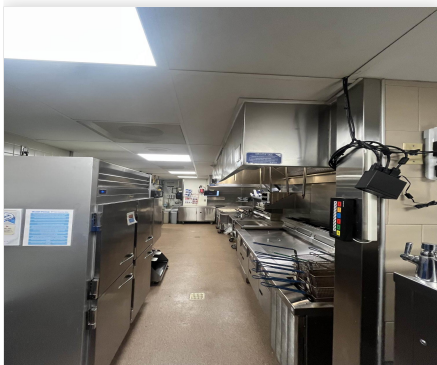
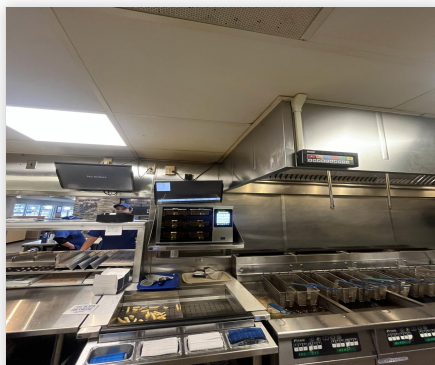
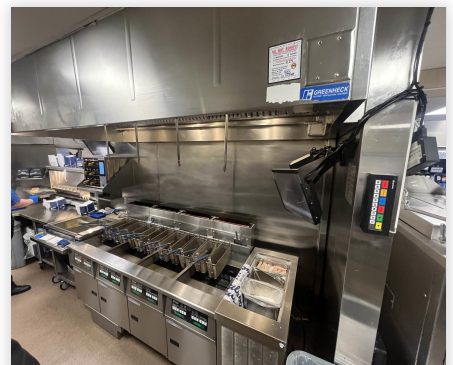
Issue Name : HD-2: Smoke Capture
Description : Once cooking began, slight Smoke loss was noticed on the left side of the fryer hood. Fryer has room to be moved over to the right, recommend it is moved over. Additionally, only 3 diffusers are installed on the cookline and each is outputting a high volume of air. Recommend 2 additional diffusers are added between hoods to improve capture.
Created By : National TAB **Assigned To :** National TAB - Michael McDonnell
Status : Open
Priority : Medium **Asset Tag :**
Originated Date : 12/19/2024 - Michael McDonnell - National TAB

Slight Smoke loss on left side of hood.

90%-slight loss out left side. Recommend fryer is moved over or additional cookline diffusers installed.

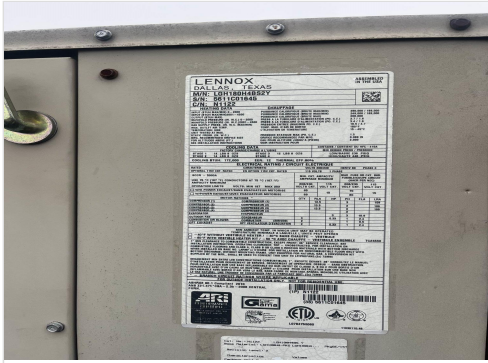
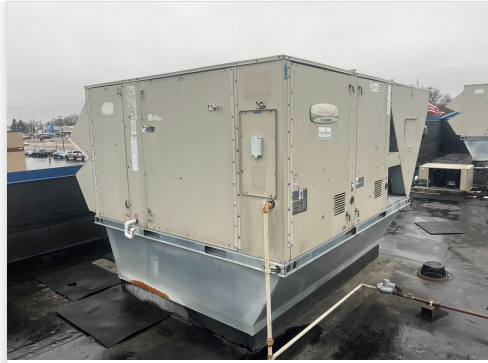
Asset: RTU2

- [1] UNIT INSTALLED ON CURB ADAPTER
- [2] EVAPORATOR COIL IN NEED OF CLEANING
- [3] ONLY 3 DIFFUSERS ON COOKLINE WITH HIGH AIRFLOW. RECOMMEND ADDITIONAL DIFFUSERS ADDED BETWEEN HOODS-SHOULD IMPROVE CAPTURE ON HD-2.
- [4] UNIT AT 327 CFM/TON-MOTOR OPERATING AT FLA.

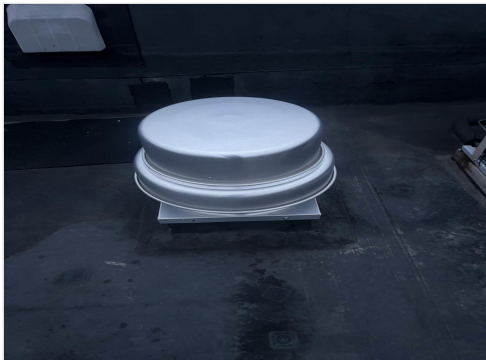
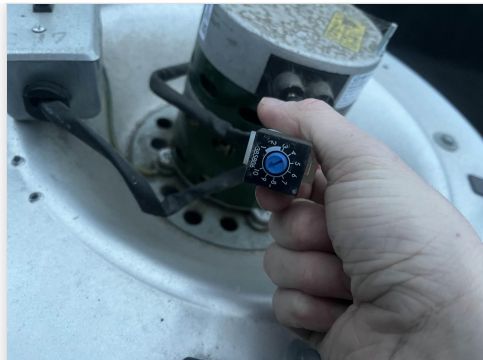
Asset: PRV1

[1] FAN SERVES BOTH CUSTOMER RR AND EMPLOYEE RR. CUSTOMER RR AT APPROPRIATE FLOW FOR NEGATIVE SPACE. EMPLOYEE RR HIGH ON EXHAUST (220CFM), NOT ANTICIPATED TO CAUSE ANY ISSUE.

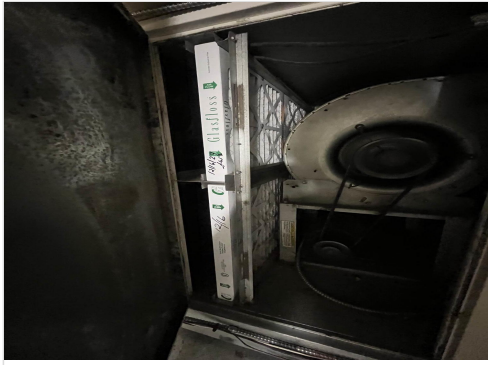
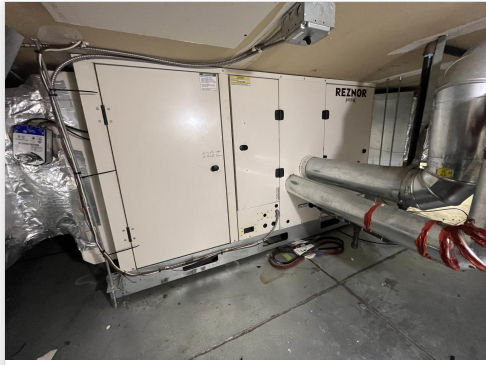
Asset: MAU1

[1] MAU IS CONDITIONED AND CONTROLLED VIA THERMOSTAT IN OFFICE. SERVES 3 GRILLES IN BOH.

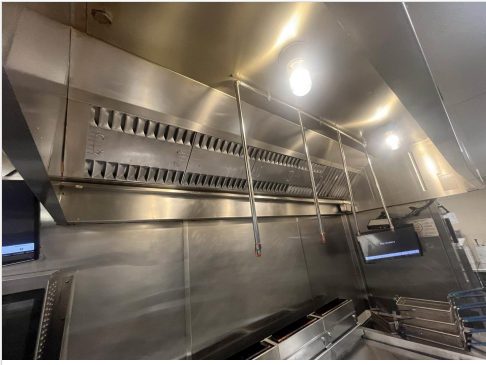
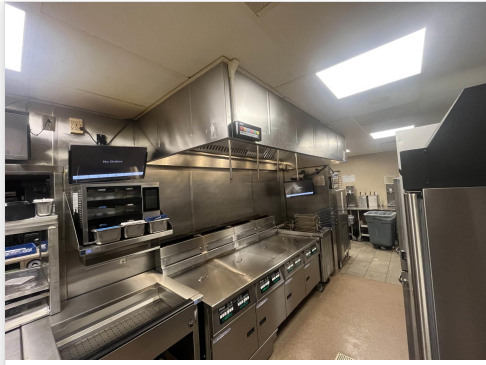
Asset: HD2

Notes:
[1] SLIGHT SMOKE LOSS ON LEFT SIDE- RECOMMEND FRYER IS MOVED TO RIGHT
