Report: TAB REPORT
Function: Test, Adjust, & Balance
Date: 12/19/2024
Completed By: National TAB

PROJECT
12-16-24 CULVERS SAUK CITY, WI

Project: 12-16-24 CULVERS SAUK CITY, WI

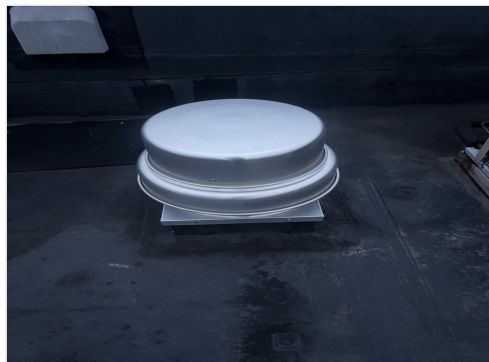
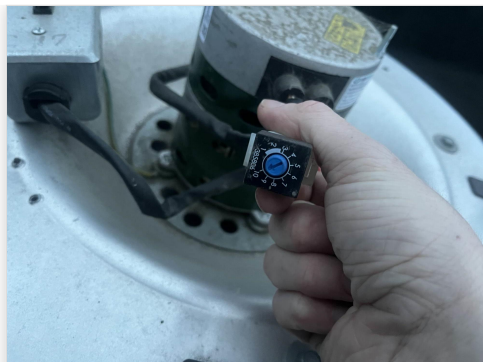
Asset: PRV1

[1] FAN SERVES BOTH CUSTOMER RR AND EMPLOYEE RR. CUSTOMER RR AT APPROPRIATE FLOW FOR NEGATIVE SPACE. EMPLOYEE RR HIGH ON EXHAUST (220CFM), NOT ANTICIPATED TO CAUSE ANY ISSUE.
