**Report: RENEW - 1122
Function: Test, Adjust, & Balance
Date: 11/09/2022**

**PROJECT
09-12 FIVE GUYS #1840 - THORTON, CO
(RENEW)**

14326 LINCOLN ST
THORNTON, CO 80233

Name : 5 GUYS HVAC PERFORMANCE EVALUATION **Status :** NotSubmitted
Assigned Organization : National TAB **Asset :**
Requesting Organization : National TAB

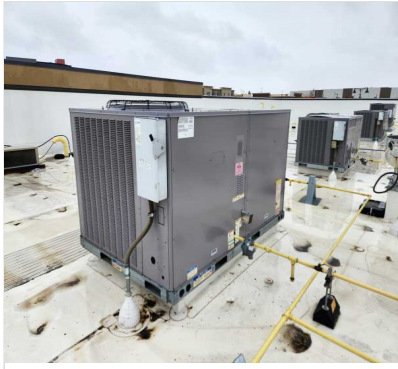
RTU1 (TAKE PICTURE OF UNIT)

MFG & MODEL NUMBER	CARRIER 48HCFD12B2M5A0B0A0
OA CFM	544 CFM
OA DAMPER POSITION	20% OPEN

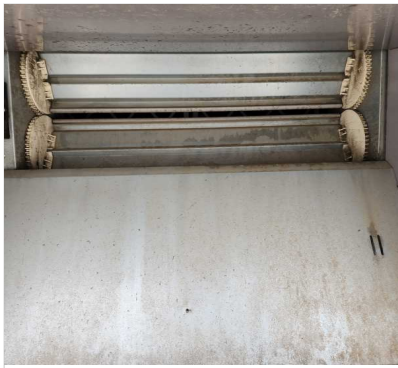
FAN SUCTION AND DISCHARGE PRESSURE	1.12" SUCTION 0.98" DISCHARGE
BLOWER MOTOR RLA / FLA	6.6/7.1/6.8 FLA 10.6

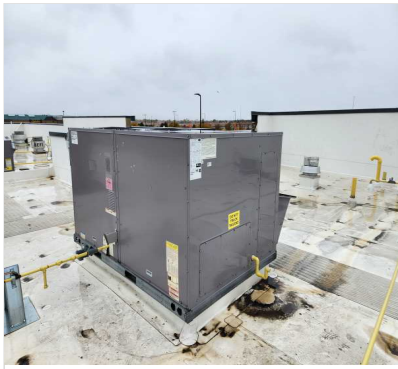
RTU2 (TAKE PICTURE OF UNIT)

MFG & MODEL NUMBER	CARRIER 48HCED08B2M5A0B0A0
OA CFM	217 CFM
OA DAMPER POSITION	10% OPEN

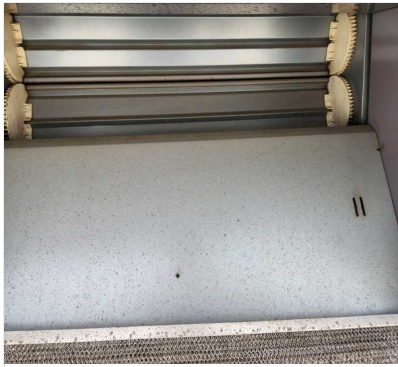
FAN SUCTION AND DISHCHARGE PRESSURE	-0.58" SUCTION 0.38" DISCHARGE
BLOWER MOTOR RLA / FLA	4.02/3.9/4.2 FLA 6.9/6.7

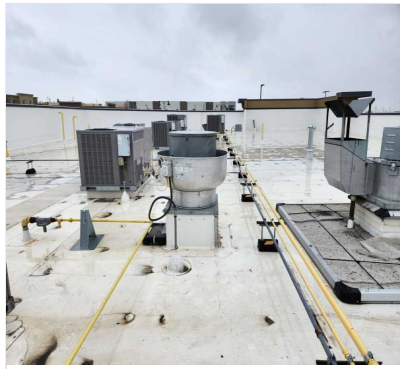
KEF1 - HOOD 1 (TAKE PICTURE OF UNIT)

MFG & MODEL NUMBER	CAPTIVEAIRE DU180HFA
EXH-CFM	2157 CFM
MOTOR RLA / FLA	2.8/2.9/2.8 FLA 9.5 3HP
KEF2 - HOOD 2 (TAKE PICTURE OF UNIT)

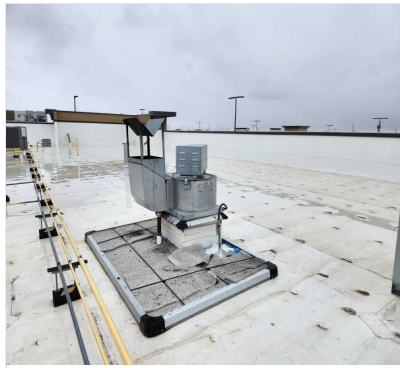
MFG & MODEL NUMBER	CAPTIVEAIRE CASRE18DD
EXH-CFM	1914 CFM
MOTOR RLA / FLA	3.1/3.1/2.1 FLA 8.7 3HP
MUA - ALL HOODS (TAKE PICTURE OF UNIT)

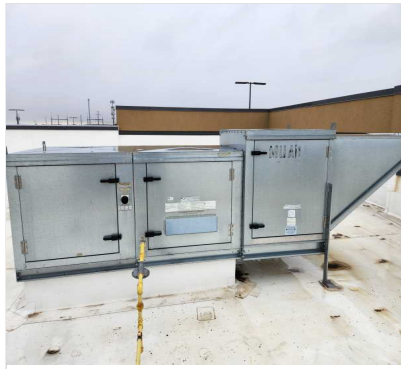
MFG & MODEL NUMBER	CAPTIVEAIRE A2-D.250-20D
MUA-CFM	0
MOTOR RLA/FLA	0 FLA 8.3 2 HP

MUA DOES NOT APPEAR FUNCTIONAL

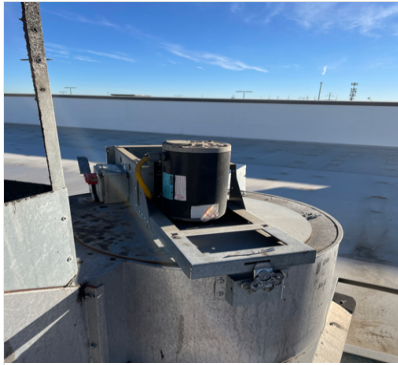
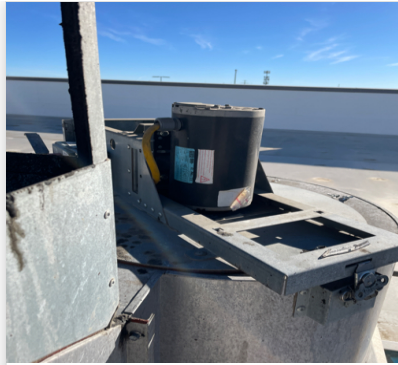
EXHAUST FAN KEF1 MOTOR HOUSING CLEANED

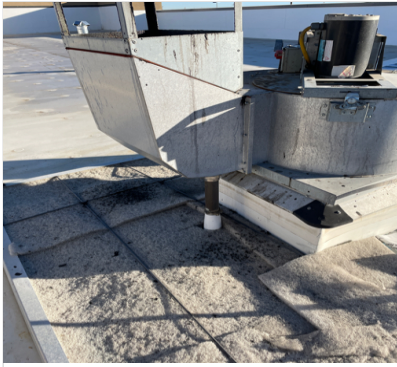
EXHAUST FAN KEF1 GREASE CUP PROPERLY INSTALLED

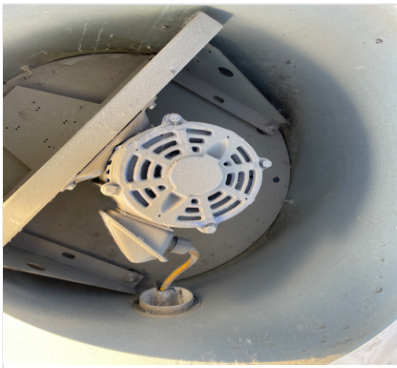
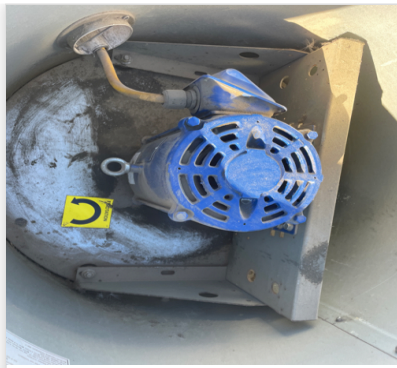
EXHAUST FAN KEF2 MOTOR HOUSING CLEANED

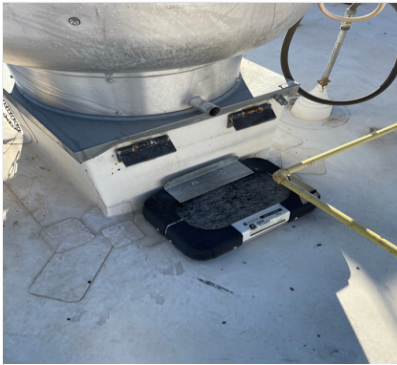
EXHAUST FAN KEF2 GREASE CUP PROPERLY INSTALLED
