Report: TAB Report
Function: Test, Adjust, & Balance
Date: 12/01/2025
Completed By: National TAB

PROJECT
11-17-25 WAWA #5454 LEESBURG, FL

Project: 11-17-25 WAWA #5454 LEESBURG, FL

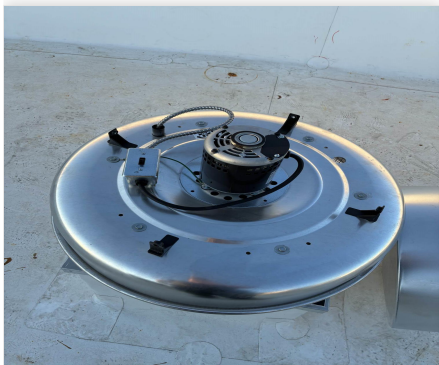
Issue Name : EF 1 Motor Driver
Description : Unable to locate a driver for EF 1 in motor compartment or in crawlspaces above ceiling.
Created By : National TAB **Assigned To :** National TAB - Dan Hertenstein
Status : Open
Priority : Urgent **Asset Tag :** EF1
Originated Date : 11/18/2025 - Jackson Gunnels - National TAB

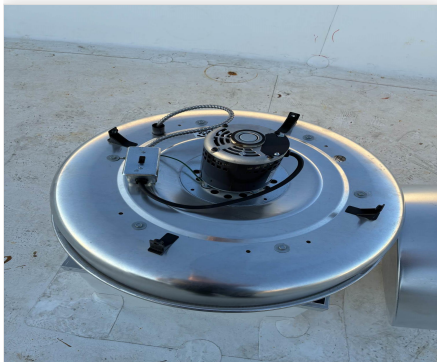
Issue Name : EF1 Not Operational
Description : EF1 is not receiving any power. Not operational.
Created By : National TAB **Assigned To :** National TAB - Dan Hertenstein
Status : Open
Priority : Urgent **Asset Tag :** EF1
Originated Date : 11/18/2025 - Jackson Gunnels - National TAB

Ef1 does not have power

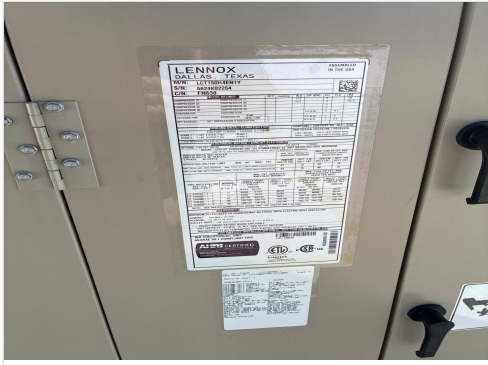
Asset: RTU2

GRD and MSET RTU schedule do not match. Diffuser 3 calls for 0 CFM.

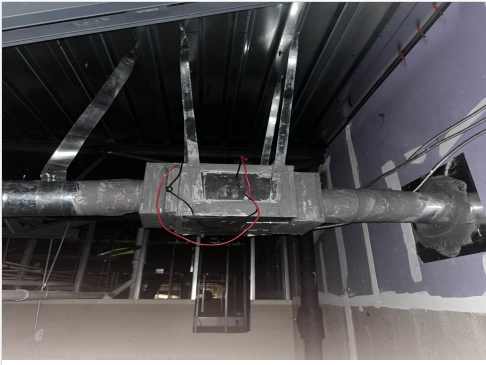
Asset: EF2

Issue Name :	EF2 CFM		
Description :	Was unable to set fan speed low enough to be within design CFM		
Created By :	National TAB	Assigned To :	National TAB - Dan Hertenstein
Status :	Open		
Priority :	Medium	Asset Tag :	EF2
Originated Date :	11/19/2025 - Jackson Gunnels - National TAB

Fan is at minimum speed.
