# PlanGrid Task Report - May 6, 2025

**L05401\_West Sanford FSU (FL)**

High Water Lane, Florida

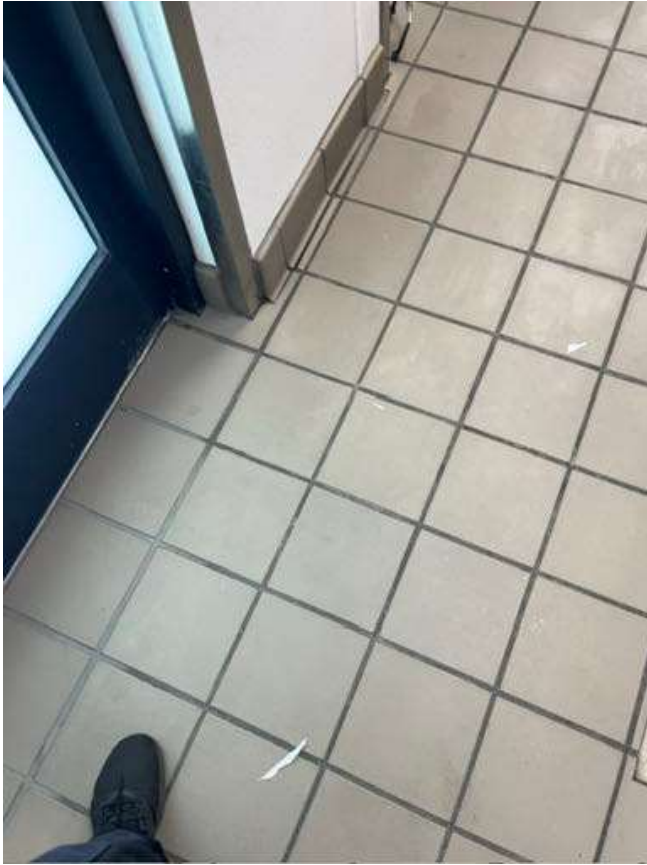
IMG\_6078

Air curtain #2 power does not cycle properly from local disconnect at time of TAB inspection.

Found to be not operational. Video uploaded.

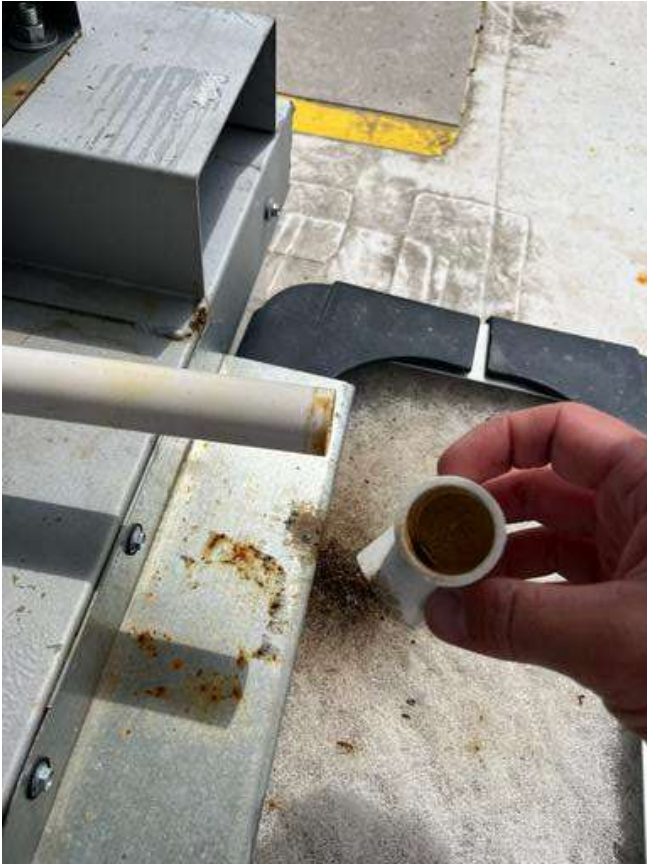
IMG\_6083

Exhaust fan drain is not properly installed. Drain need to be glued together.

Drains found to not be glued.
