Report: Issues

Function: Test, Adjust, & Balance

Date: 04/11/2023

CW 2999 - UTSW (DALLAS, TX)

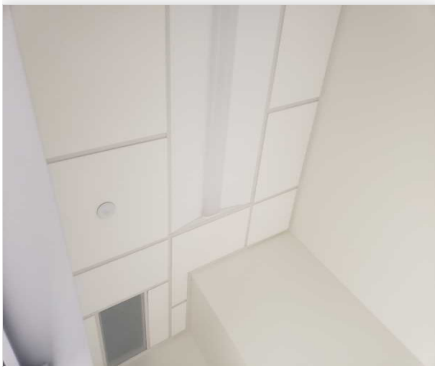
Issue Name : VRH-3-17

Description : Unit is missing diffusers 4. Unit cannot be balanced until this is added. This has been fixed and the unit is balanced.

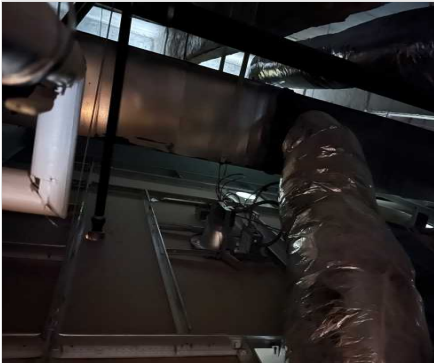
Issue Name : EF-11-1

Description : Overall CFM was low even after turning motor up to 60 HZ. Checked dampers and opened one or two with no large change. Also the duct leading to E11-1-14 is missing.

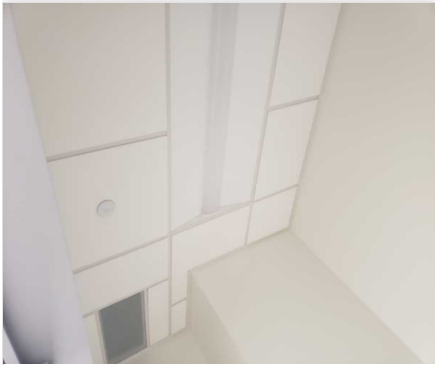
Issue Name : VRH-3-17

Description : Unit is missing diffusers 4. Unit cannot be balanced until this is added. This has been fixed and the unit is balanced.

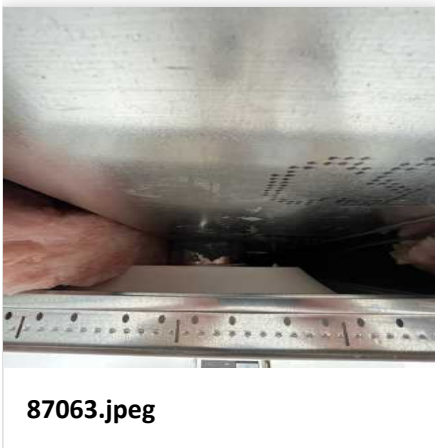
Issue Name : VRH-3-22

Description : Diffuser 4 does not have a damper and is thus extremely high on CFM. The diffusers is extremely close to the main duct as well.

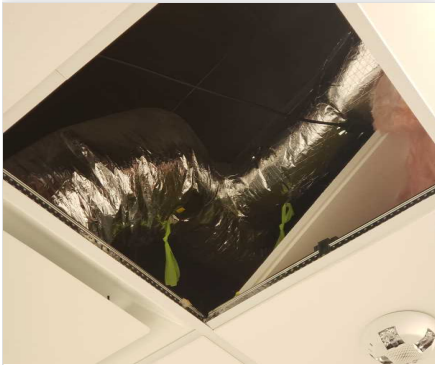
Issue Name : VRH-3-27

Description : Fully dampened diffusers 5 and 6 are still high. Diffuser 2 is low due to the duct work branching off diffuser 1's duct.

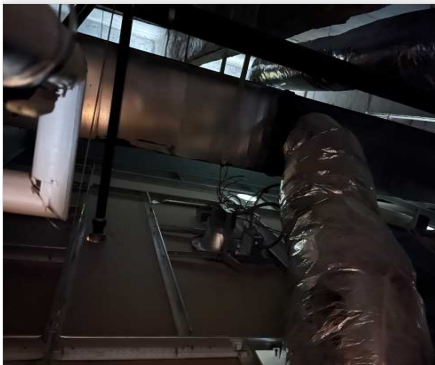
Issue Name : EF-11-1

Description : Overall CFM was low even after turning motor up to 60 HZ. Checked dampers and opened one or two with no large change. Also the duct leading to E11-1-14 is missing.

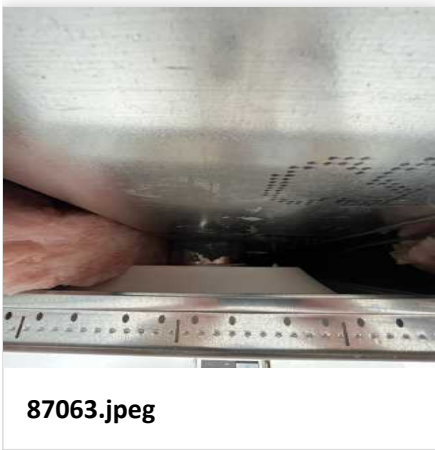
Issue Name : VRH-3-22

Description : Diffuser 4 does not have a damper and is thus extremely high on CFM. The diffusers is extremely close to the main duct as well.

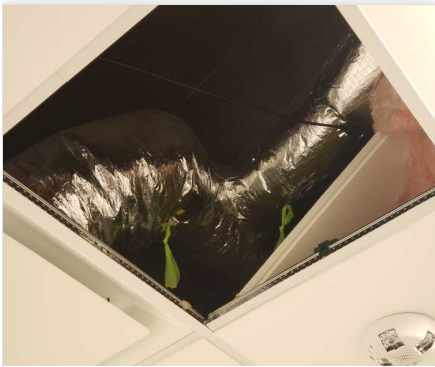
Issue Name : VRH-3-27

Description : Fully dampened diffusers 5 and 6 are still high. Diffuser 2 is low due to the duct work branching off diffuser 1's duct.
