**Report: Issues**

**Function: Test, Adjust, & Balance**

**Date: 04/11/2023**

## CW 2999 - UTSW (DALLAS, TX)

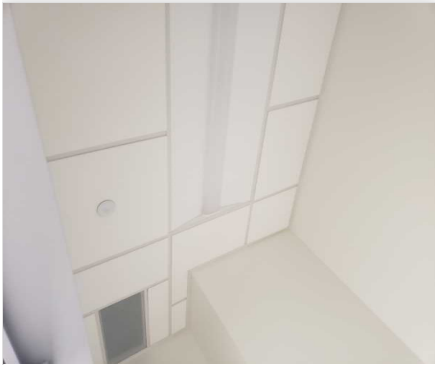
**Issue Name :** VRH-3-17

**Description :** Unit is missing diffusers 4. Unit cannot be balanced until this is added.

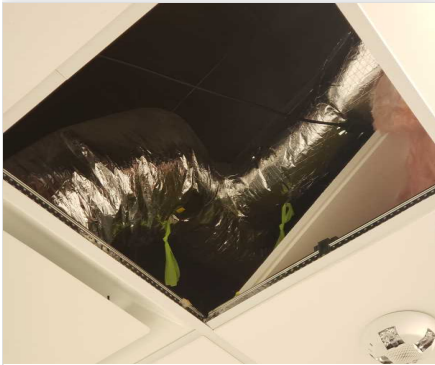
**Issue Name :** VRH-3-27

**Description :** Fully dampened diffusers 5 and 6 are still high. Diffuser 2 is low due to the duct work branching off diffuser 1's duct.

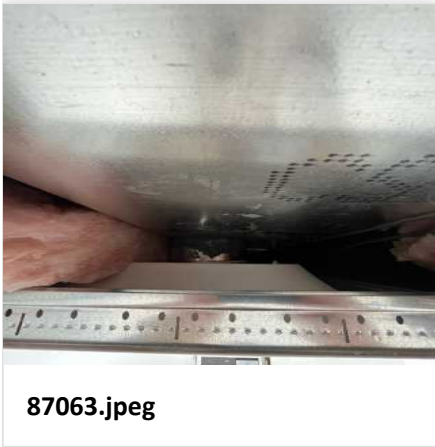
**Issue Name :** VRH-3-22

**Description :** Diffuser 4 does not have a damper and is thus extremely high on CFM. The diffusers is extremely close to the main duct as well.
