Report: TAB Punchlist
Function: Test, Adjust, & Balance
Date: 02/18/2025
Completed By: National TAB

PROJECT
02-17-25 CULVERS ALMA, MI

02-17-25 CULVERS ALMA, MI

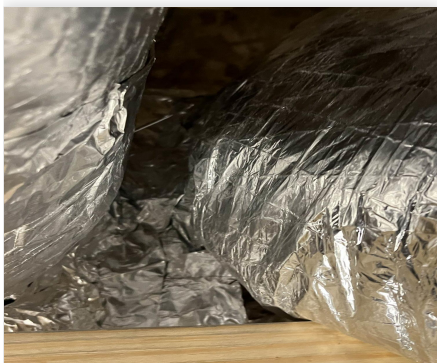
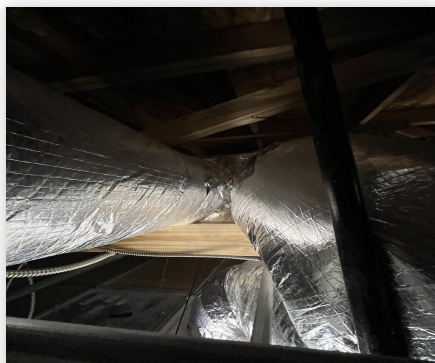
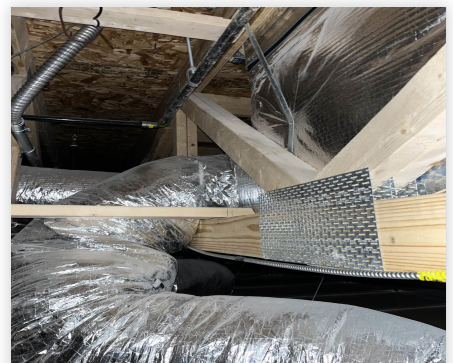
Issue Name : Missing dampers on RTU-2 (Kitchen)
Description : Diffuser 1-3,1-11,1-12 missing dampers. 1-3 is high on flow at 452/350CFM 1-11 is very high on flow at 753/350CFM unable to reduce airflow to these diffusers. Diffuser 1-12 was able to be restricted with duct straps to bring flow to design. Recommend Mechanical Contractor install dampers so these diffusers can be sufficiently balanced.
Created By : National TAB **Assigned To :** National TAB - Dylan Crisman
Status : Open
Priority : High **Asset Tag :**
Originated Date : 02/18/2025 - Dylan Crisman - National TAB

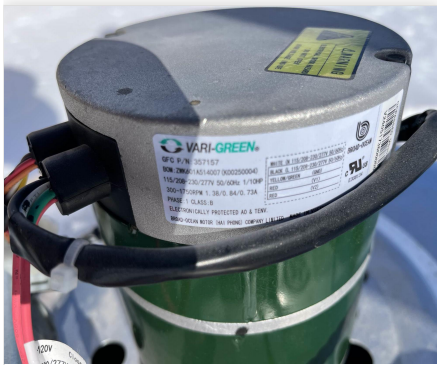
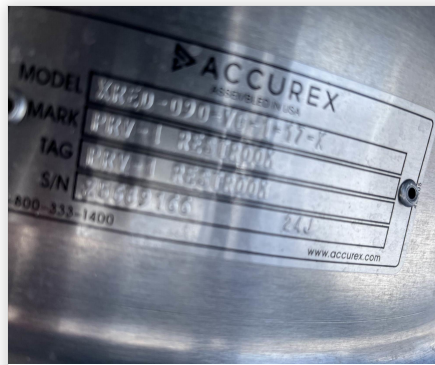
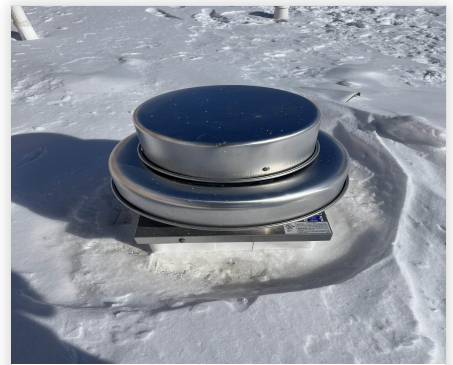
Issue Name : PRV-1 RR Exhaust not operational
Description : PRV-1 Restroom Exhaust fan is not operational. Getting voltage at the breaker as well as at the fan but fan will not operate, motor will not kick on. Recommend electrician/mechanical inspection to diagnose problems with PRV-1.

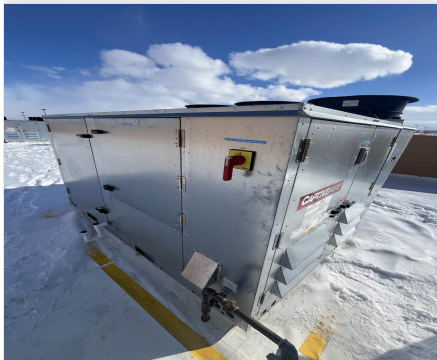
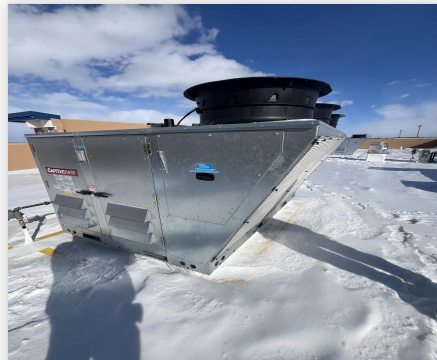
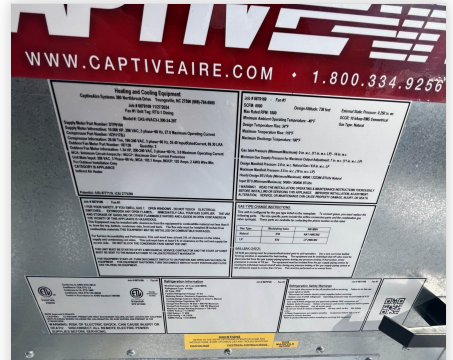
Issue Name : RTU-1 not operational
Description : RTU-1 (Dining Unit) is not operational due to an electrical wiring issue, the control board has shorted out. We were able to get an initial airflow reading before the unit shut down but were unable to balance diffusers, total airflow, and OA airflow to design. Captive aire is scheduled by the GC to be here tomorrow to diagnose and correct RTU-1.
