SE2

Monday, December 13, 2021

10 Remarks Identified

OAHU-SE2

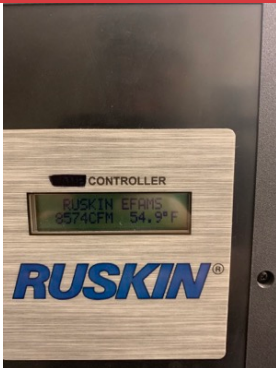
FLOW MONITOR

Measured flow via traverse: 10,388 CFM

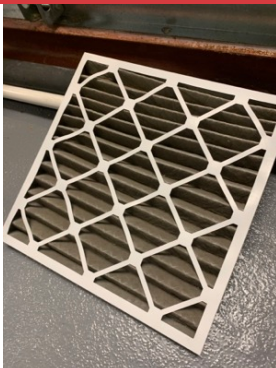
PREFILTER

Has some dirt buildup
