## GSA DC0021ZZ Central Office Headquarters (Washington, DC)

**AHU Measurement NOVA Third Party Contractor Fill Out. Measure and verify the building minimum and maximum outdoor air for each AHU providing outdoor air to the building.**

**GSA\_HQ\_OAHU-S1**

**Monday, December 13, 2021**

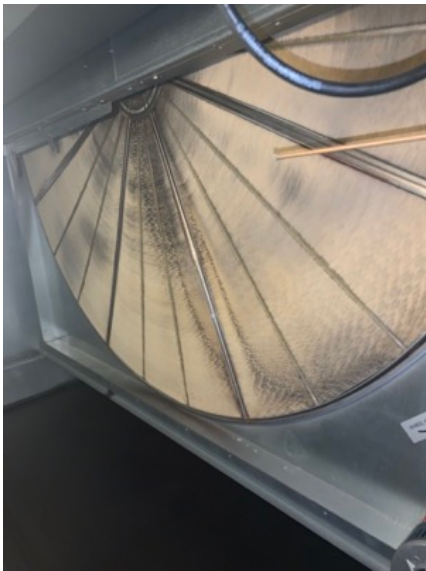
HEATING WHEEL  
There is a little bit of damage

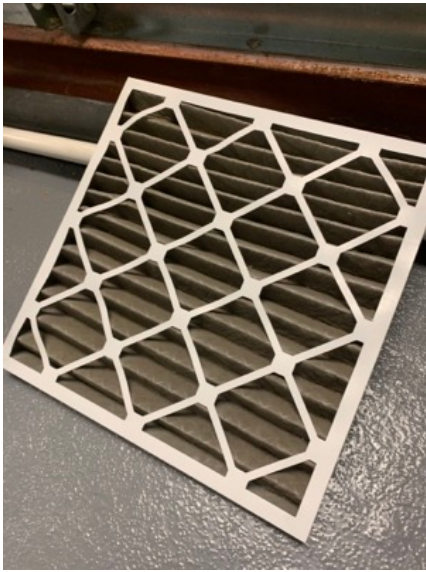
PREFILTER  
Has some dirt buildup

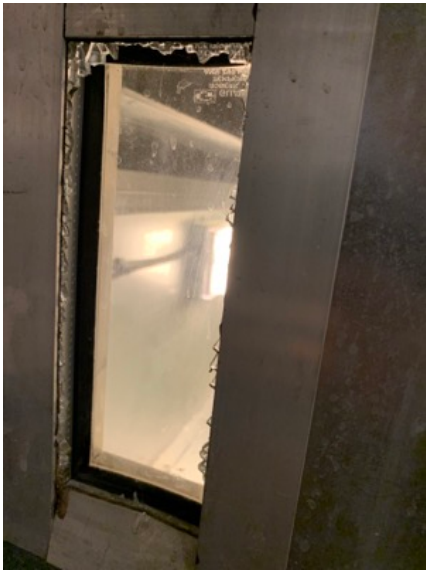
THE WINDOW IN THE RETURN PLENUM DOOR HAS A BROKEN/MISSING PANE OF GLASS. THE REMAINING PANE DOES NOT HAVE ANY LEAKAGE. WHEN THE UNIT IS IN UNOCCUPIED MODE THE RETURN FAN THAT FEEDS ATE-1/2 OVERPOWERS BOTH SUPPLY FANS. SUPPLY DUCT COULD NOT BE TRAVERSED DO TO SOUND ATTENUATION NOR COULD THE RETURNS BE READ OUT, HAD TO USE THE FLOW STATION TO USE AS THE SUPPLY TOTAL

BROKEN WINDOW ON RETURN PLENUM DOOR

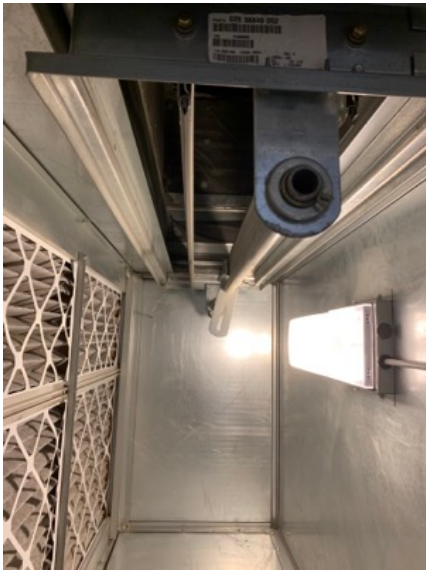
THERE IS A DAMPER IN THE RETURN OF THE UNIT THAT DOES NOT HAVE A MOTOR CONNECTED TO IT. DAMPER IS LOCKED OPEN. NO DAMPER IN SUPPLY THAT PREVENTS SHORT CYCLING WHEN UNIT IS IN NIGHT MODE.

RETURN DAMPER- NO ACTUATOR

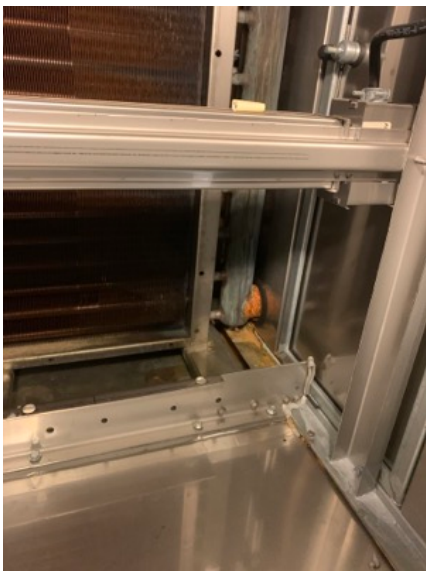
Cooling Coil(s) - Visual assessment and photo documentation.	COOLING COIL IS IN GOOD CONDITION. THERE IS SOME OXIDATION ON THE INLET PIPE OF THE COIL
Condensate Pan(s) - Visual assessment and photo documentation.	CONDENSATE PAN IS FREE OF DEBRIS. THERE ARE SOME SIGNS OF OXIDATION COMING FROM THE COIL INLET
Any unusual operation observed? (including vibration, over-pressure, etc.)	THERE IS A SMALL PUNCTURE IN THE CANVAS CONNECTOR OF THE SUPPLY DUCT THAT IS CAUSING MINOR LEAKAGE
Exhaust System Status (on/off). If this does not apply for this AHU, "N/A"	N/A UNIT DOES NOT HAVE EXHAUST

CORROSION ON COIL INLET

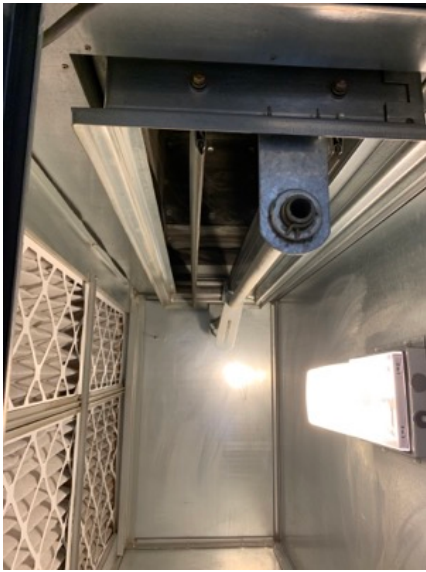
RETURN SIDE AIR DAMPER  
DOES NOT HAVE A MOTOR ATTACHED. DAMPER  
IS LOCKED INTO PLACE

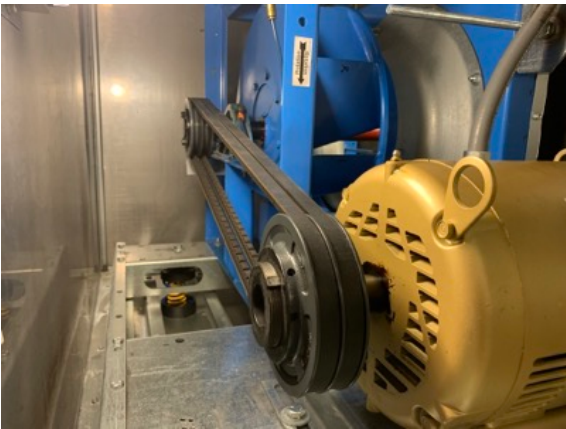
BELTS ARE IN GOOD CONDITION

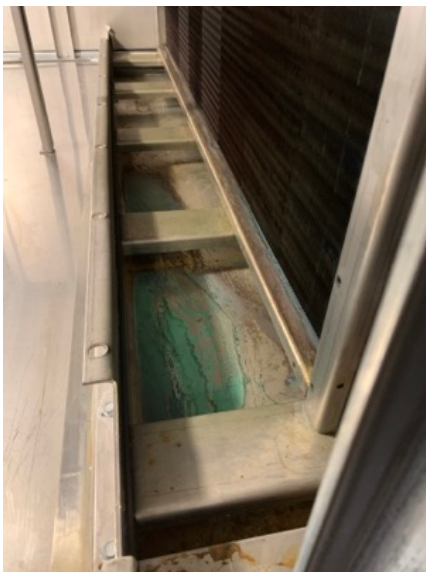
OXIDATION IN THE CONDENSATE PAN

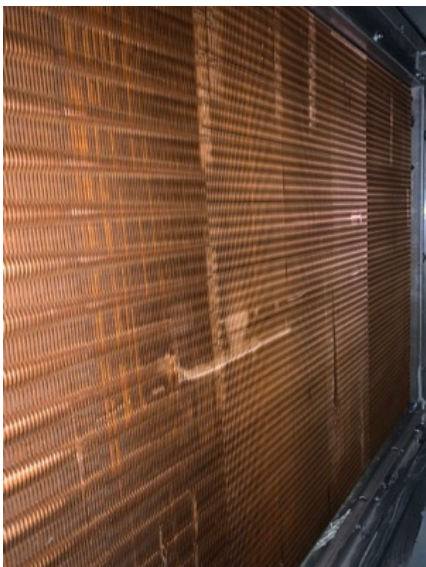
SLIGHT DAMAGE TO COOLING COIL.  
NO MORE THAN 5% OF COIL IS DAMAGED

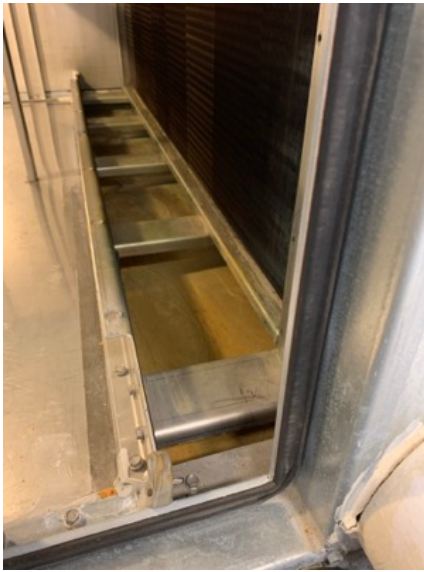
CONDENSATE PAN IS FREE OF DEBRIS

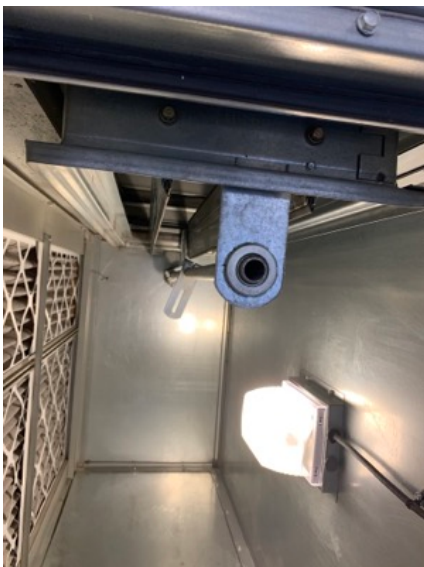
RETURN SIDE DAMPER DOES NOT HAVE MOTOR.  
DAMPER IS LOCKED INTO PLACE

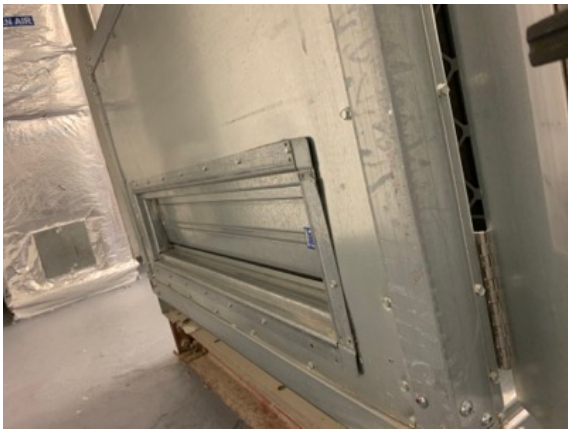
ZONE DAMPERS HAD TO BE MANUALLY OPENED SO UNIT WOULD REACH FULL SPEED. THE SPRING RETURN DOES NOT WORK ON ZONE DAMPERS THERE IS A DAMPER ON THE SIDE OF THE UNIT THAT IS FIXED CLOSED BUT COULD POTENTIALLY BE A FUTURE SOURCE OF RETURN LEAKAGE THERE IS A DAMPER INTERNAL TO THE RETURN IF THE UNIT THAT IS NOT MOTORIZED AND COULD BE A SOURCE OF LEAKAGE BACK SIDE OF COOLING COIL HAS A LOT OF OXIDATION FILTERS ARE DUE FOR A CHANGE. ONE OF THE BELTS IS STRETCHED AND SHOULD BE REPLACED.

DAMPER ON SIDE OF THE UNIT
