OAHU-SE2 GSA HQ

Monday, December 13, 2021

10 Remarks Identified

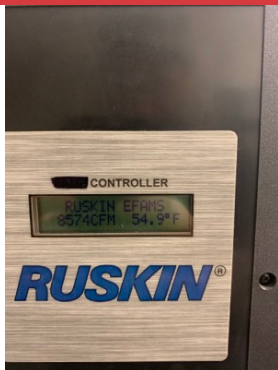
FLOW MONITOR

Measured flow via traverse: 10,388 CFM

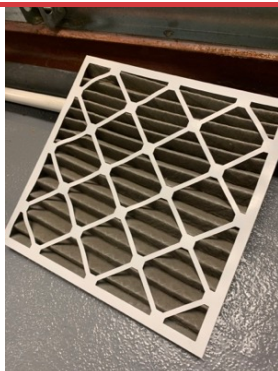
PREFILTER

Has some dirt buildup
