Report: TAB Report
Function: Test, Adjust, & Balance
Date: 06/11/2024

PROJECT
06-03-24 CULVERS JACKSONVILLE, FL

Project: 06-03-24 CULVERS JACKSONVILLE, FL

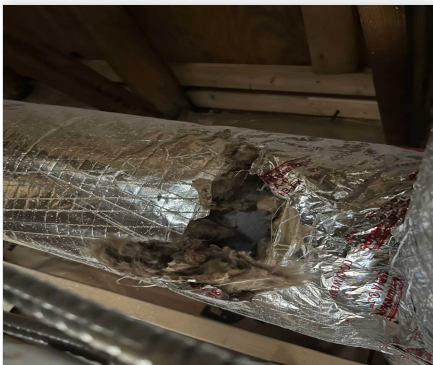
Broken_Damper_Handle...
06/11/2024

Issue Name : Diffuser 1-12 Broken Damper
Description : RTU 1 Diffuser 12 damper handle failed and the damper is stuck in the fully open position. Airflow is 216CFM out of 150CFM design as a result (137%). If comfort issues arise, recommend replacing damper and rebalancing.
Created By : National TAB **Assigned To :** National TAB - Will Turnbough
Status : Open
Priority : High **Asset Tag :**
Originated Date : 06/06/2024 - Stephen Tassinaro - National TAB

Asset	Notes	Date	Written By
RTU1-SGRD7	NO DAMPER LOCATED	06/05/2024	Stephen Tassinaro
RTU1-SGRD8	NO DAMPER LOCATED	06/05/2024	Stephen Tassinaro
RTU1-SGRD12	DAMPER BROKEN	06/05/2024	Stephen Tassinaro
RTU1-SGRD15	NO DAMPER LOCATED	06/05/2024	Stephen Tassinaro
RTU1-SGRD19	NO DAMPER LOCATED	06/05/2024	Stephen Tassinaro

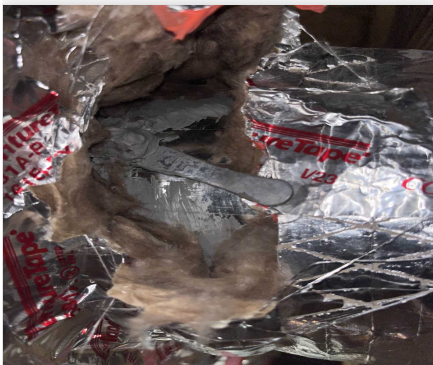
Diffuser_Mastic
06/03/2024

Issue Name : Diffuser 2-9 Damper Handle Jammed
Description : Damper 2-9 damper handle is jammed with mastic and locked in the fully open position. This diffuser was not balanced as a result. Recommend freeing damper from mastic and ensuring it has full range of motion.
Created By : National TAB **Assigned To :** National TAB - Will Turnbough
Status : Open
Priority : Urgent **Asset Tag :**
Originated Date : 06/03/2024 - Stephen Tassinaro - National TAB

Asset	Notes	Date	Written By
RTU2-SGRD9	DAMPER STUCK FULL OPEN - MASTIC ON HANDLE	06/11/2024	Stephen Tassinaro

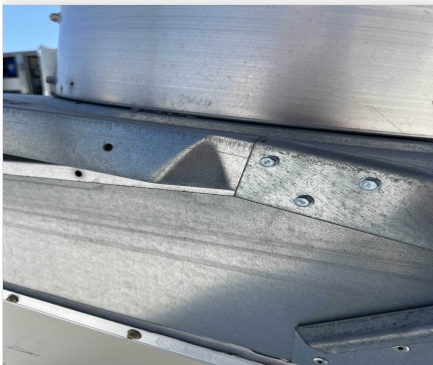
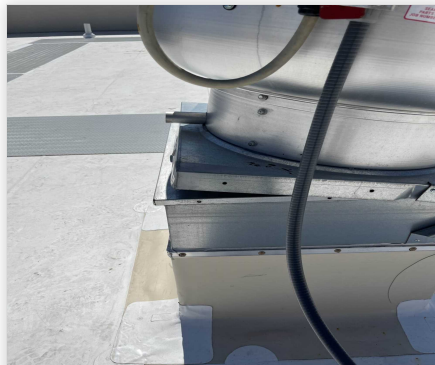
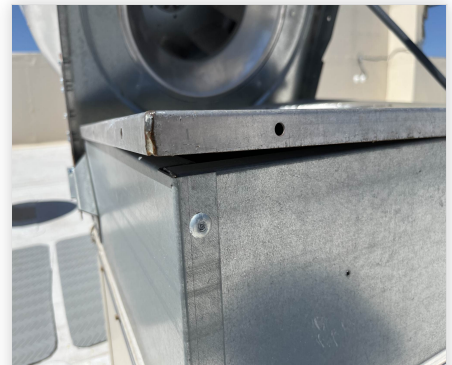
Issue Name : PRV 2 & 3 Curb / Hinge Assemblies
Description : PRV 2 nor PRV 3 curb caps fully secured to the curbs. The hinges and fan bases are interfering with the loose caps. Unable to measure static pressures in current conditions.
Created By : National TAB **Assigned To :** National TAB - Will Turnbough
Status : Open
Priority : Urgent **Asset Tag :**
Originated Date : 06/06/2024 - Stephen Tassinaro - National TAB

HINGE KITS INSTALLED, BUT DO NOT HINGE BACK SMOOTHLY. DIFFICULT TO RE-ALIGN FANS WHEN SETTING BACK DOWN ON CURB.

GREASE DUCT CURB CAPS NOT SECURED TO CURBS.

[1] CURB ASSEMBLY LOOSE. INTERFERING WITH HINGE ASSEMBLY. SEE ISSUE PICTURES.

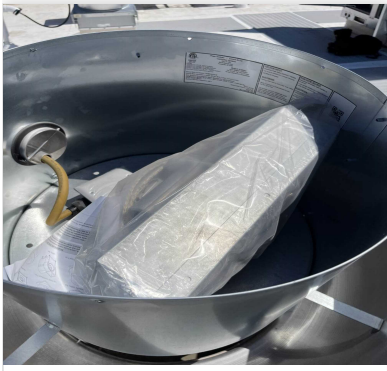
Grease_Cups_Not_Installed
06/11/2024

- **06/11/2024 National TAB - Stephen Tassinaro**
 - Grease cups found in motor compartments, both PRV 2 & PRV 3.

GREASE CUPS NOT INSTALLED. NTi LOCATED GREASE CUPS IN ORIGINAL PACKAGING INSIDE MOTOR COMPARTMENTS.

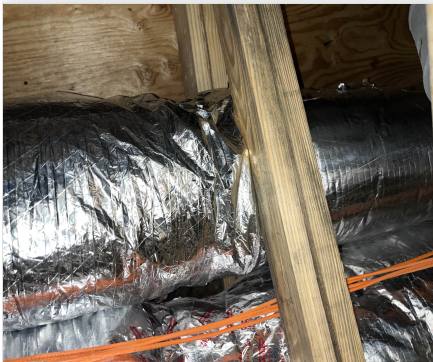
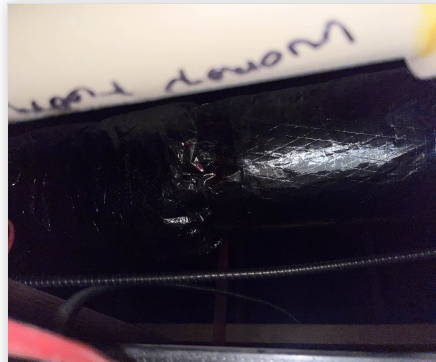
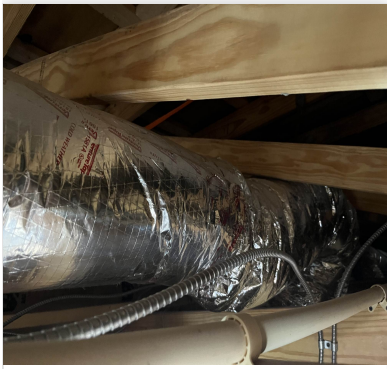
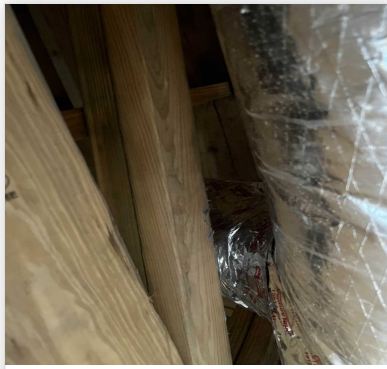
Issue Name : RTU 1 Missing Volume Dampers
Description : RTU 1 (Dining) there are 4 dampers that could not be located by NTi. Diffusers 2-7, 2-8, 2-15, and 2-19. There were no flags or handles protruding through the insulation to make any adjustments. The respective diffusers are above design airflow as a result. If comfort issues arise, recommend installing dampers and rebalancing.
