**Report: Test Report
Function: Test, Adjust, & Balance
Date: 11/19/2025
Completed By: National TAB**

09-01-25 BOJANGLES #791 MARIETTA, GA

Budderfly

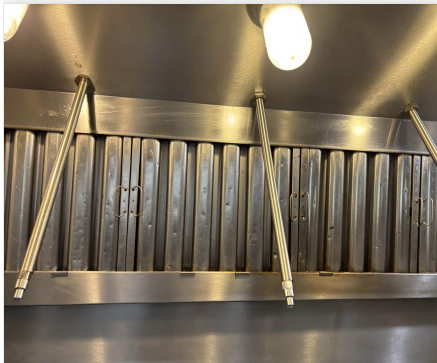
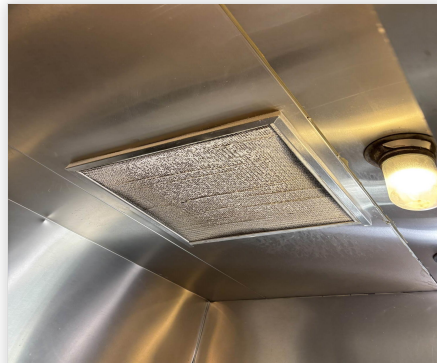
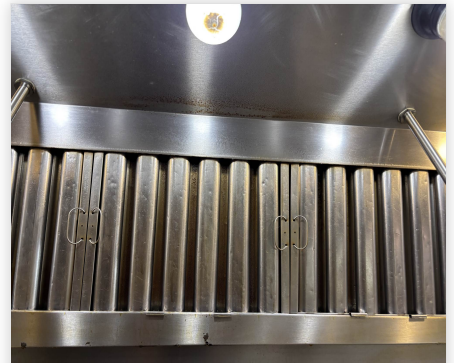
Issue Name : All Hoods: Damaged and Dirty Filters
Description : All hoods have dirty and damaged filters.
Created By : National TAB **Assigned To :** National TAB - Dan Hertenstein
Status : Open
Priority : High **Asset Tag :**
Originated Date : 11/17/2025 - Sagar Patel - National TAB

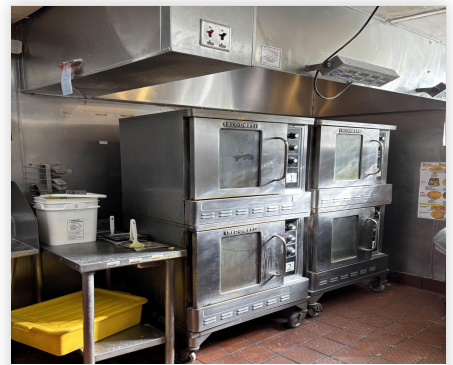
Issue Name : All Hoods: No End Panels
Description : Hood 1 is missing the right end panel. Hood 2 is missing both end panels. Hood 3 is missing the left end panel.
Created By : National TAB **Assigned To :** National TAB - Dan Hertenstein
Status : Open
Priority : Medium **Asset Tag :**
Originated Date : 11/17/2025 - Sagar Patel - National TAB

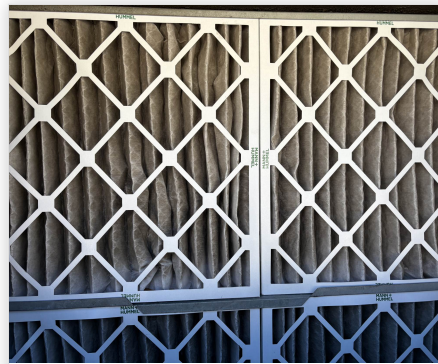
Issue Name : All RTU: Dirty Filter
Description : All RTUs have dirty filters.
Created By : National TAB **Assigned To :** National TAB - Dan Hertenstein
Status : Open
Priority : High **Asset Tag :**
Originated Date : 11/17/2025 - Sagar Patel - National TAB

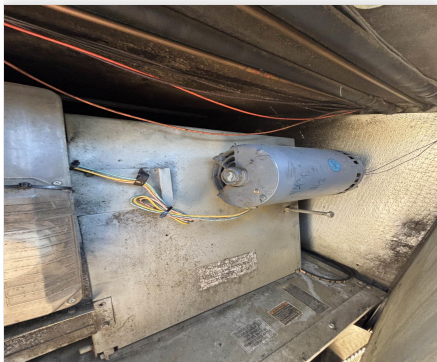
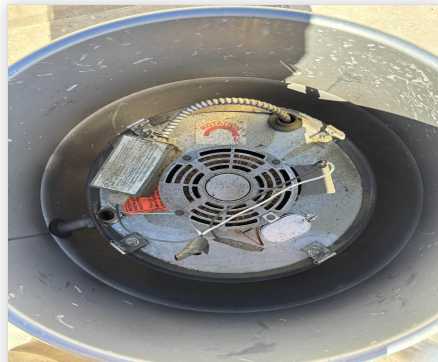
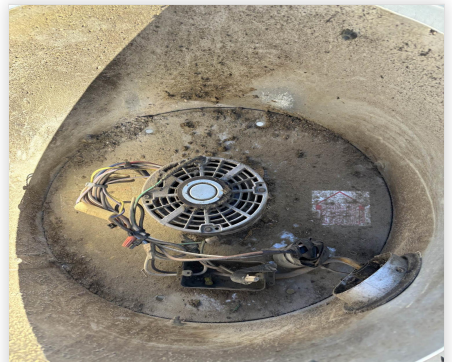
Issue Name : All Units: Dirty Motor Compartment
Description : All units have a dirty motor compartment
Created By : National TAB **Assigned To :** National TAB - Dan Hertenstein
Status : Open
Priority : **Medium** **Asset Tag :**
Originated Date : 11/17/2025 - Sagar Patel - National TAB

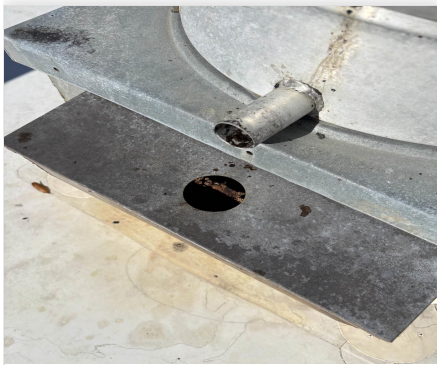
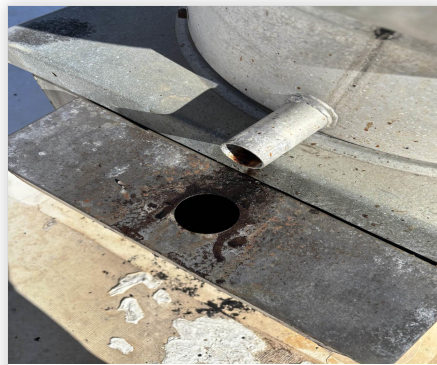
Issue Name : EF 1 and 2: Connector to Grease Catch
Description : A tube should be attached to the EF going into the grease catch to ensure no leakage onto the roof.
Created By : National TAB **Assigned To :** National TAB - Dan Hertenstein
Status : Open
Priority : High **Asset Tag :**
Originated Date : 11/17/2025 - Sagar Patel - National TAB

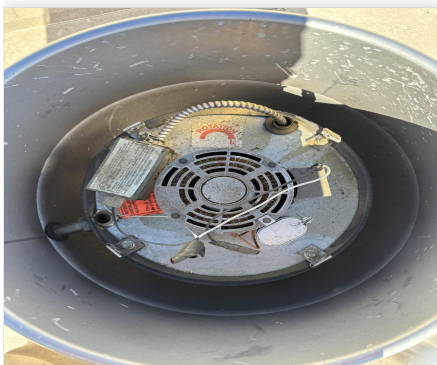
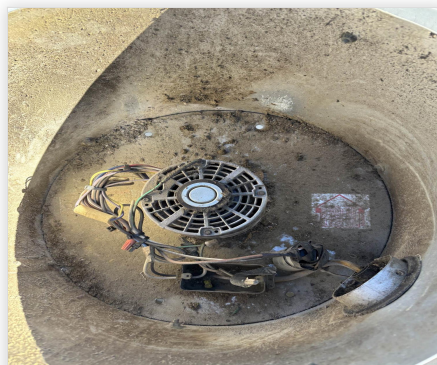
Issue Name : EF 3 and 4: No Speed Control
Description : There is no speed control on EF 3 and 4.
Created By : National TAB **Assigned To :** National TAB - Dan Hertenstein
Status : Open
Priority : High **Asset Tag :**
Originated Date : 11/17/2025 - Sagar Patel - National TAB

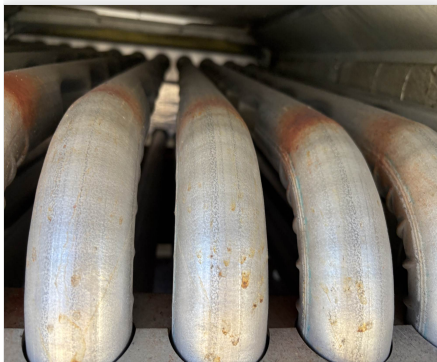
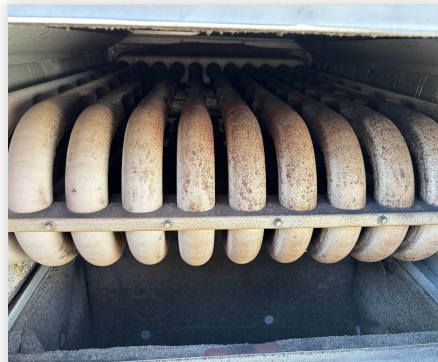
Issue Name : RTU 2 and 3: Dirty Heat Exchanger
Description : The heat exchanger in RTU 2 and 3 are dirty.
Created By : National TAB **Assigned To :** National TAB - Dan Hertenstein
Status : Open
Priority : Medium **Asset Tag :**
Originated Date : 11/17/2025 - Sagar Patel - National TAB

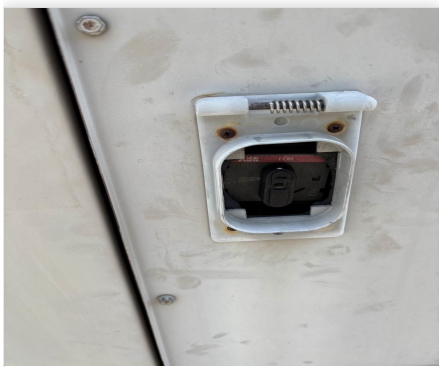
Issue Name : RTU 3: Power Switch Cover
Description : RTU 3 does not have a cover for the power switch
Created By : National TAB **Assigned To :** National TAB - Dan Hertenstein
Status : Open
Priority : Medium **Asset Tag :**
Originated Date : 09/04/2025 - Sagar Patel - National TAB

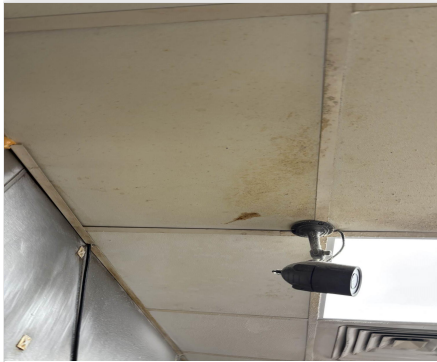
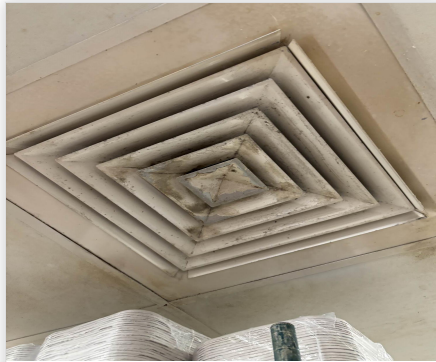
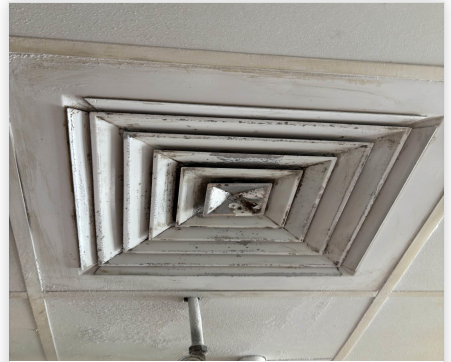
Issue Name : Stained Ceiling Tiles and Diffuser
Description : Ceiling tiles around the kitchen are stained. Diffuser in the kitchen are stained and showing signs of rust.
Created By : National TAB **Assigned To :** National TAB - Dan Hertenstein
Status : Open
Priority : High **Asset Tag :**
Originated Date : 11/17/2025 - Sagar Patel - National TAB
