Report: TAB REPORT
Function: Test, Adjust, & Balance
Date: 09/28/2023

PROJECT
09-25-23 ARBY'S 1600 - ATOKA, OK

Project: 09-25-23 ARBY'S 1600 - ATOKA, OK

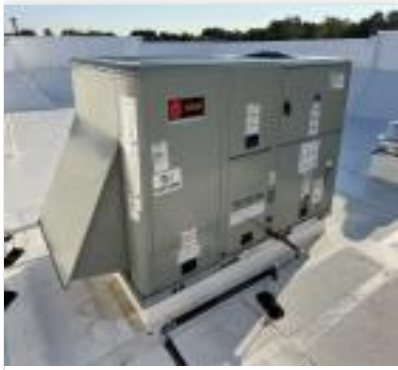
RTU-2

UNIT APPEARS TO NOT BE COOLING PROPERLY. AIR TEMPS THAT FOLLOW WERE RECORDED WHILE SPACE TEMPERATURE WAS 74. SUPPLY 68DB 64WB. RETURN 76DB 71WB.

UNIT HAS AN ECONIMIZER MODULATION ALARM, UNIT ECONIMIZER IS NOT OPERATIONAL.
