**Report: TAB REPORT**  
**Function: Test, Adjust, & Balance**  
**Date: 09/28/2023**

**PROJECT**  
**09-25-23 ARBY'S 1600 - ATOKA, OK**

Flynn Restaurant Group  
6200 Oak Tree Boulevard  
Suite 250  
Independence, OH 44131

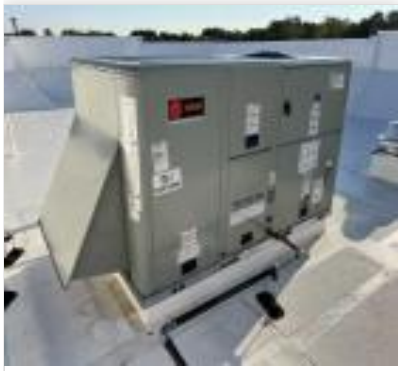
**ARBYS\_RTU\_1**  
**10/05/2023**

UNIT HAS AN ECONIMIZER MODULATION ALARM, UNIT ECONIMIZER IS NOT OPERATIONAL.

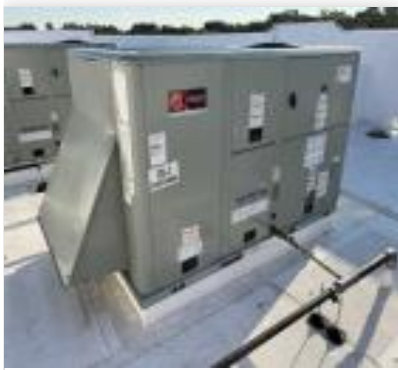
**ARBYS\_RTU\_2**  
**10/05/2023**

UNIT APPEARS TO NOT BE COOLING PROPERLY. AIR TEMPS THAT FOLLOW WERE RECORDED WHILE SPACE TEMPERATURE WAS 74. SUPPLY 68DB 64WB. RETURN 76DB 71WB.

UNIT HAS AN ECONIMIZER MODULATION ALARM, UNIT ECONIMIZER IS NOT OPERATIONAL.

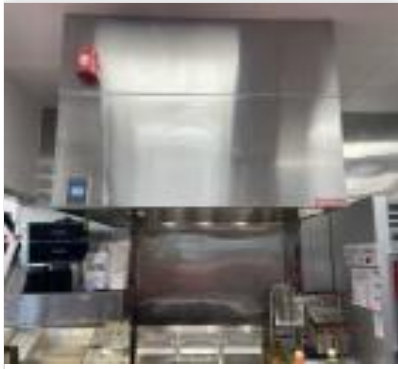
**ARBYS\_HD\_1**  
**10/05/2023**

**Issue Name :** HOOD-1 CAPTURE ISSUE  
**Description :** HOOD ONLY CAPTURES 75% AT TOP EDGES DUE TO TWO DIFFUSERS IN FRONT OF HOOD BEING 4-WAY DIRECTIONAL. PLANS SPECIFY 3-WAY DIRECTIONAL DIFFUSERS WERE TO BE INSTALLED.  
**Created By :** National TAB                      **Assigned To :** National TAB - Will Turnbough  
**Status :** Open  
**Originated Date :** 10/05/2023 - Bayley Morvant - National TAB

CAPTURED, 75% DUE TO DIFFUSERS IN FRON OF HOOD NOT BEING 3-WAY DIRECTIONAL. DIFFUSERS INSTALLED ARE 4-WAY DIRECTIONAL.
