Report: TAB REPORT
Function: Test, Adjust, & Balance
Date: 09/28/2023

PROJECT
09-25-23 ARBY'S 1600 - ATOKA, OK

Project: 09-25-23 ARBY'S 1600 - ATOKA, OK

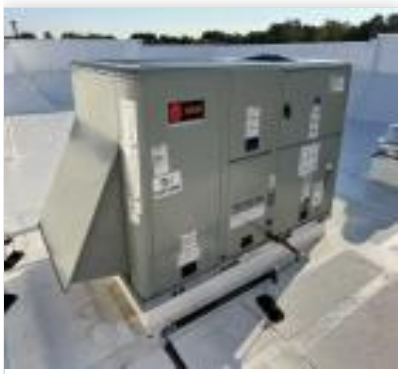
Issue Name : RTU-1 AND RTU-2 ECONOMIZERS NOT FUNCTIONAL
Description : THE ECONOMIZERS FOR RTU-1 AND RTU-2 ARE NOT FUNCTIONAL. ALARMS PRESENT ON EACH RTU FOR ECONOMIZER MODULATION. OUTSIDE AIR NOT SET ON EITHER RTU AS RESULT.
Created By : National TAB **Assigned To :** National TAB - Will Turnbough
Status : Open
Originated Date : 09/28/2023 - Bayley Morvant - National TAB

UNIT HAS AN ECONIMIZER MODULATION ALARM, UNIT ECONIMIZER IS NOT OPERATIONAL.

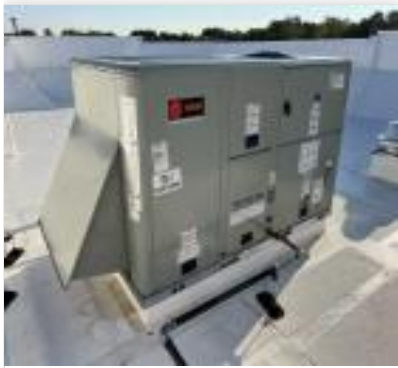
Issue Name : RTU-2 NOT COOLING COMPLETELY
Description : RTU-2 APPEARS TO BE HAVING TROUBLE KEEPING UP WITH THERMOSTAT SETPOINT. THERMOSTAT IS SET TO 68 DEGREES, HOWEVER SPACE TEMP GETS HOTTER AS THE DAYS PROGRESS. BY 2:00 PM IT IS 77 IN THE KITCHEN AND 73 IN FRONT OF HOUSE. KITCHEN IS SET TO 68 AND THE FRONT OF HOUSE IS SET TO 70.
Created By : National TAB **Assigned To :** National TAB - Will Turnbough
Status : Open
Originated Date : 09/28/2023 - Bayley Morvant - National TAB

UNIT APPEARS TO NOT BE COOLING PROPERLY. AIR TEMPS THAT FOLLOW WERE RECORDED WHILE SPACE TEMPERATURE WAS 74. SUPPLY 68DB 64WB. RETURN 76DB 71WB.

UNIT HAS AN ECONIMIZER MODULATION ALARM, UNIT ECONIMIZER IS NOT OPERATIONAL.
