Project Issue Report

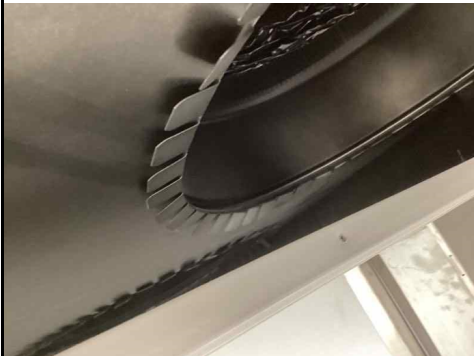
Name:	Return inlets R-06 and R-07 were combined in a sin.jpg				
Captured:	1/24/2023 7:11 PM

Issue ID:	0019	Status:	Open	Issue Priority:	
Equipment:	RTU-02/R-08	Created Date: 24-Jan-23			
Issue Description:					
Return inlets R-06 and R-07 were combined in a single 2x4' inlet and provided with one damper. (INFORMATION ONLY)					
Issue Type:	Installation				
Role Assignment:	Mechanical Contractor				
Comments / Signature:					
Issue Photos:
