Report: ISSUE REPORT
Function: Test, Adjust, & Balance
Date: 02/08/2024

PROJECT
02-05-24 PERRY'S - VERNON HILLS, IL

122 HAWTHORN CENTER

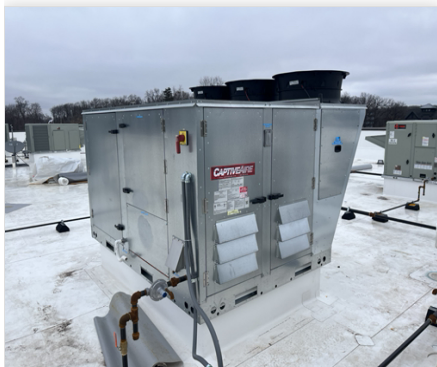
Doas
02/08/2024

Issue Name : DOAS not interlocked with Hood Operation
Description : DOAS does not appear to be interlocked with hood operation. DOAS is also scheduled to modulate with Hood operation, and does not appear setup to do so. CAS is scheduled for 2/12.
Created By : National TAB **Assigned To :** National TAB - Michael McDonnell
Status : Open
Priority : High **Asset Tag :**
Originated Date : 02/08/2024 - Michael McDonnell - National TAB

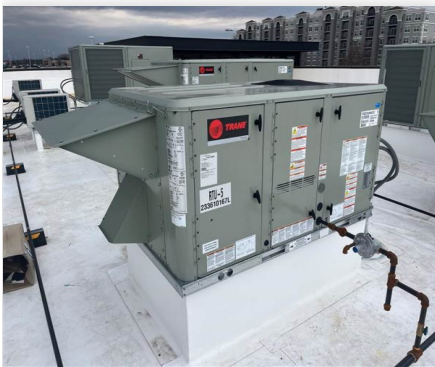
RTU_5
02/08/2024

Issue Name : RTU-5: Not Operational
Description : RTU-5 is not operational as the control board is fried. Waiting on replacement board. Unit not yet balanced as result.
Created By : National TAB **Assigned To :** National TAB - Michael McDonnell
Status : Open
Priority : High **Asset Tag :**
Originated Date : 02/08/2024 - Michael McDonnell - National TAB

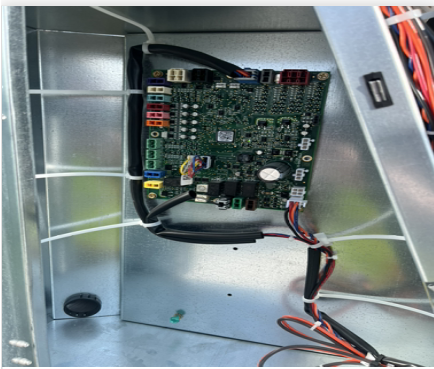
RTU-6
02/08/2024

Issue Name : RTU-6: Outside Air Damper not Functional
Description : OA damper / Econ not functional on RTU-6. Unit is giving fresh air options module Communication error. Needs service.
Created By : National TAB **Assigned To :** National TAB - Michael McDonnell
Status : Open
Priority : High **Asset Tag :**
Originated Date : 02/08/2024 - Michael McDonnell - National TAB

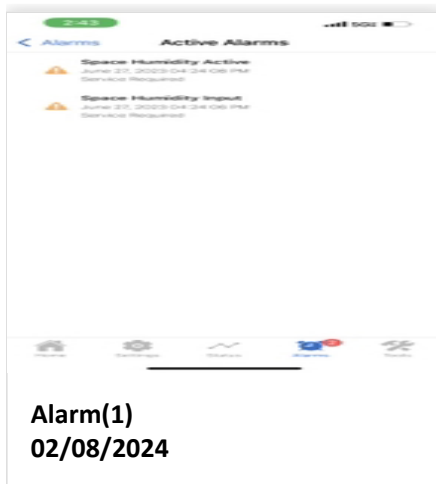
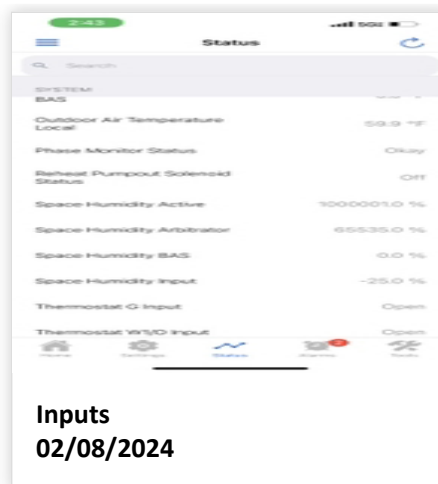
Issue Name : Symbio RTUs: Humidity Alarm
Description : All Symbio RTUs have an alarm regarding space humidity. Space humidity is being displayed as 1000001.0% at the RTUs. Space humidity arbitrator displays 65535.0%. Space humidity input displays -25.0%. Thermostats display space humidity reading. Recommend wiring is reviewed, space humidity readings configured.
Created By : National TAB **Assigned To :** National TAB - Michael McDonnell
Status : Open
Priority : **Asset Tag :**
Originated Date : 02/08/2024 - Michael McDonnell - National TAB
