**Report: ISSUE REPORT**  
**Function: Test, Adjust, & Balance**  
**Date: 02/08/2024**

**PROJECT**  
**02-05-24 PERRY'S - VERNON HILLS, IL**

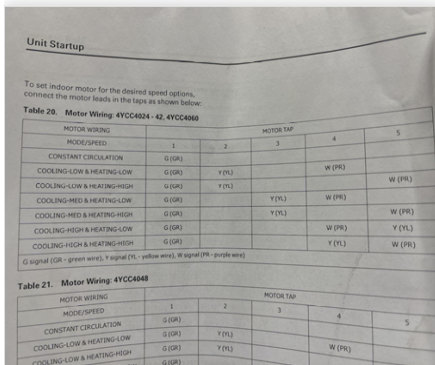
**Speedtaps**  
**02/08/2024**

**Issue Name :** RTU-4: High on airflow  
**Description :** RTU-4 is multispeed unit scheduled for 600cfm with speed taps. Plans call for constant volume. Unit is within design at Speed tap 1, where G is landed. Manual indicates placing W(heat) at 4 and Y (cool) at tap 2, puts heating and cooling to low speed, this is 940cfm. Not possible to wire all stages to same speed. No indication if jumpers are allowed.
