**National TAB
1329 E. KEMPER ROAD
SUITE 4210
CINCINNATI, OH 45246**

**Report: ISSUE REPORT
Function: Test, Adjust, & Balance
Date: 02/08/2024**

**PROJECT
02-05-24 PERRY'S - VERNON HILLS, IL**

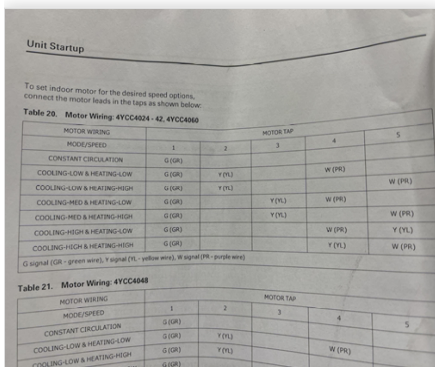
Speedtaps
02/08/2024

Issue Name : RTU-4: High on airflow
Description : RTU-4 is multispeed unit scheduled for 600cfm with speed taps. Plans call for constant volume. Unit is within design at Speed tap 1, where G is landed. Manual indicates placing W(heat) at 4 and Y (cool) at tap 2, puts heating and cooling to low speed, this is 940cfm. Not possible to wire all stages to same speed. No indication if jumpers are allowed.

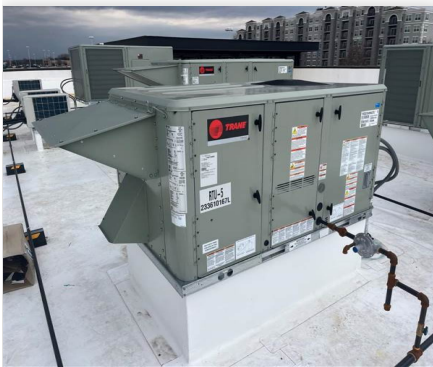
RTU_5
02/08/2024

Issue Name : RTU-5: Not Operational
Description : RTU-5 is not operational as the control board is fried. Waiting on replacement board. Unit not yet balanced as result.
Created By : National TAB **Assigned To :** National TAB - Michael McDonnell
Status : Open
Priority : Urgent **Asset Tag :**
Originated Date : 02/08/2024 - Michael McDonnell - National TAB
