Report: ISSUE REPORT
Function: Test, Adjust, & Balance
Date: 02/08/2024

PROJECT
02-05-24 PERRY'S - VERNON HILLS, IL

122 HAWTHORN CENTER

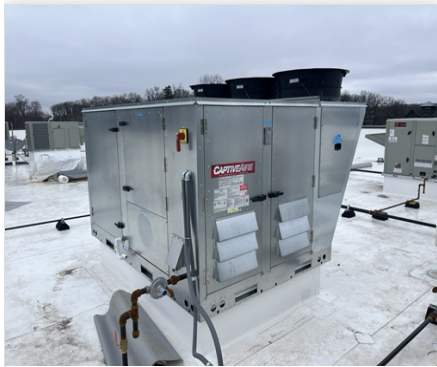
Doas
02/08/2024

Issue Name : DOAS not interlocked with Hood Operation
Description : DOAS does not appear to be interlocked with hood operation. DOAS is also scheduled to modulate with Hood operation, and does not appear setup to do so. CAS is scheduled for 2/12.
Created By : National TAB **Assigned To :** National TAB - Michael McDonnell
Status : Open
Priority : High **Asset Tag :**
Originated Date : 02/08/2024 - Michael McDonnell - National TAB

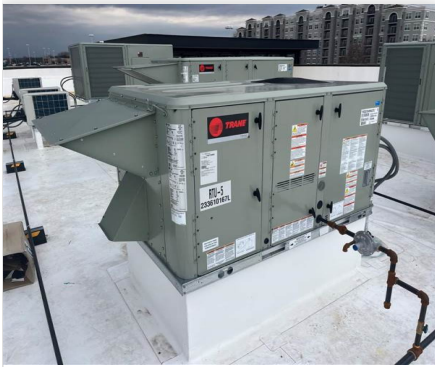
RTU_5
02/08/2024

Issue Name : RTU-5: Not Operational
Description : RTU-5 is not operational as the control board is fried. Waiting on replacement board. Unit not yet balanced as result.
Created By : National TAB **Assigned To :** National TAB - Michael McDonnell
Status : Open
Priority : High **Asset Tag :**
Originated Date : 02/08/2024 - Michael McDonnell - National TAB
