Report: ISSUE REPORT
Function: Test, Adjust, & Balance
Date: 02/08/2024

PROJECT
02-05-24 PERRY'S - VERNON HILLS, IL

Issue List

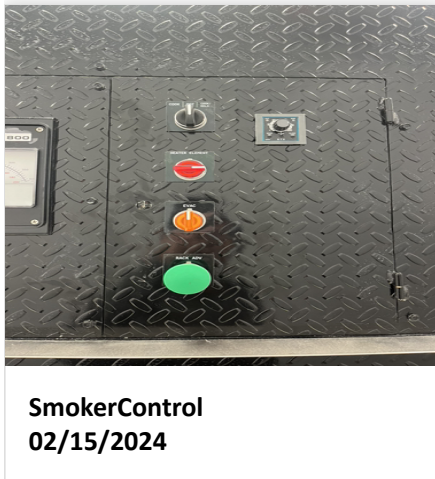
Issue Name : EF-5 (Smoker): High on Airflow
Description : EF-5 measured at 1343/1000 cfm. Fan does not have a speed controller installed and no speed control is listed in exhaust fan schedule. EF-5 is to be controlled through smoker operation, but control is not fully functional. Control bypassed and fan measured at max single speed.
Created By : National TAB **Assigned To :** National TAB - Michael McDonnell
Status : Open
Priority : Low **Asset Tag :**
Originated Date : 02/15/2024 - Michael McDonnell - National TAB

- **02/15/2024 National TAB - Michael McDonnell**
 - A speed control will need to be installed and functional to bring EF-5 into design. Not anticipated to cause any issues as EF-5 only operates when smoker is fully evacuated of smoke.

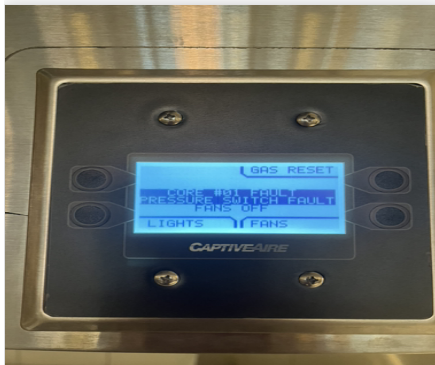
Faults
02/15/2024

Issue Name : Exhaust Hood Alarms
Description : Exhaust hood HMI is displaying two faults: 1. Core #1 Fault and 2. Pressure Switch Fault. Core fault is due to fire suppression system not yet set up. Recommend faults are addressed and cleared. Hoods functional.

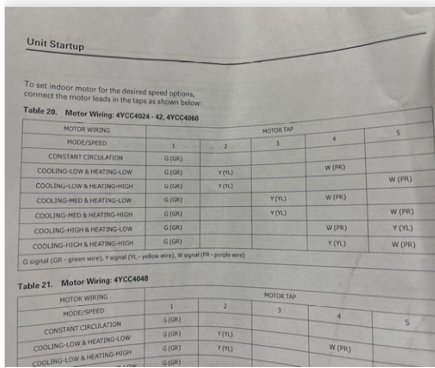
Speedtaps
02/08/2024

Issue Name : RTU-4: High on airflow
Description : RTU-4 is multispeed unit scheduled for 600cfm with speed taps. Plans call for constant volume. Unit is within design at Speed tap 1, where G is landed. Manual indicates placing W(heat) at 4 and Y (cool) at tap 2, puts heating and cooling to low speed, this is 940cfm. Not possible to wire all stages to same speed. No indication if jumpers are allowed.

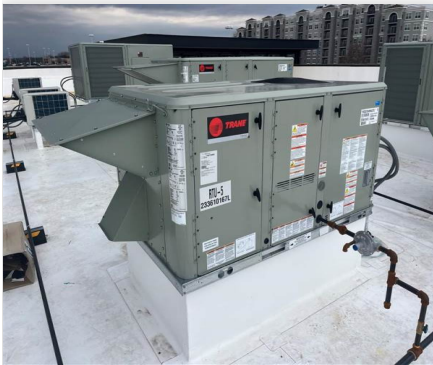
RTU_5
02/08/2024

Issue Name : RTU-5: Not Operational
Description : RTU-5 is not operational as the control board is fried. Waiting on replacement board. Unit not yet balanced as result.
Created By : National TAB **Assigned To :** National TAB - Michael McDonnell
Status : Open
Priority : **Urgent** **Asset Tag :**
Originated Date : 02/08/2024 - Michael McDonnell - National TAB

- **02/15/2024 National TAB - Michael McDonnell**
 - Trane Service was on site 2/14/24 to replace the board. They were unable to get the unit running.

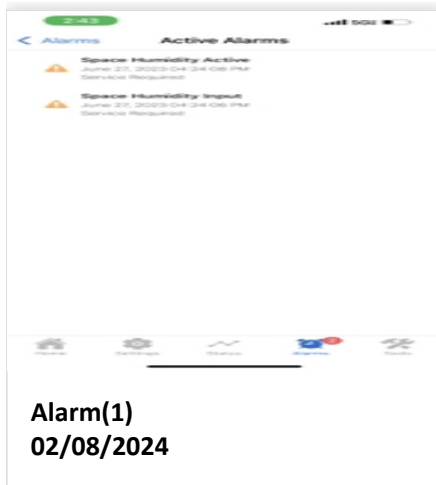
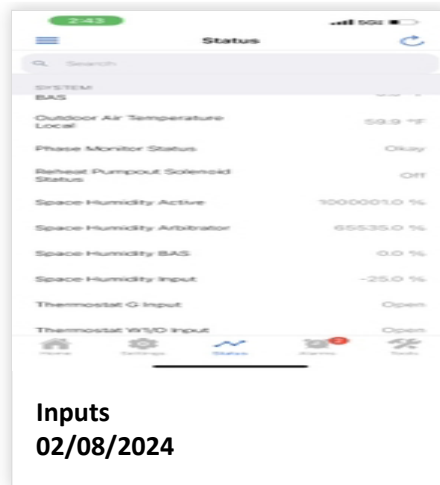
Issue Name : Symbio RTUs: Humidity Alarm
Description : All Symbio RTUs have an alarm regarding space humidity. Space humidity is being displayed as 1000001.0% at the RTUs. Space humidity arbitrator displays 65535.0%. Space humidity input displays -25.0%. Thermostats display space humidity reading. Recommend wiring is reviewed, space humidity readings configured.
Created By : National TAB **Assigned To :** National TAB - Michael McDonnell
Status : Open
Priority : Urgent **Asset Tag :**
Originated Date : 02/08/2024 - Michael McDonnell - National TAB
