Report: TAB REPORT
Function: Test, Adjust, & Balance
Date: 05/22/2025
Completed By: National TAB

PROJECT
05-19-25 CAVA CHARLOTTE, NC
(NORTHLAKE)

Project: 05-19-25 CAVA CHARLOTTE, NC (NORTHLAKE)

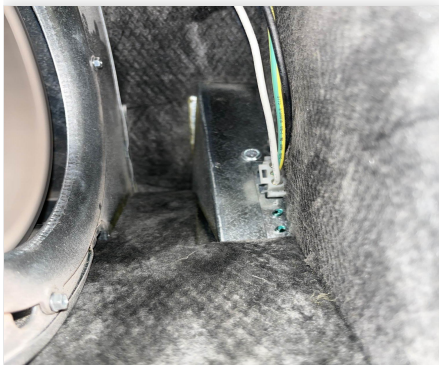
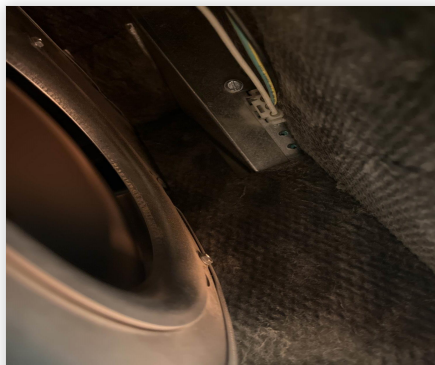
Issue Name : CEF1 & CEF2 / Speed Controllers
Description : CEF1 & CEF2 speed controllers are not installed. Unable to balance fans to design CFM.
Created By : National TAB **Assigned To :** National TAB - Dale Wheeler
Status : Open
Priority : High **Asset Tag :**
Originated Date : 05/20/2025 - Dale Wheeler - National TAB

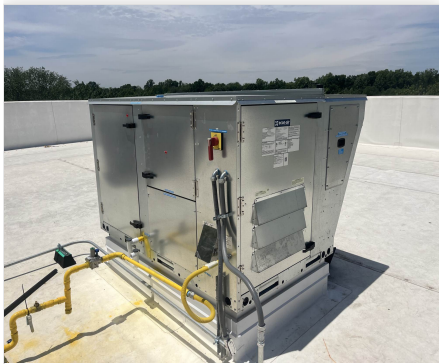
Issue Name : DOS/MAU - No Label
Description : No I.D. Tag is installed on the MAU/DOS unit.
Created By : National TAB **Assigned To :** National TAB - Dale Wheeler
Status : Open
Priority : Low **Asset Tag :**
Originated Date : 05/19/2025 - Dale Wheeler - National TAB

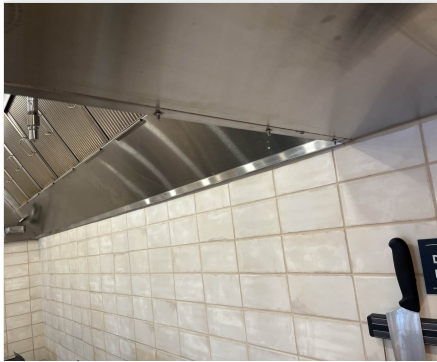
Issue Name : Hood / End Panel
Description : Hood end panel is not installed.
Created By : National TAB **Assigned To :** National TAB - Dale Wheeler
Status : Open
Priority : Medium **Asset Tag :**
Originated Date : 05/20/2025 - Dale Wheeler - National TAB

HOOD END PANEL IS NOT INSTALLED

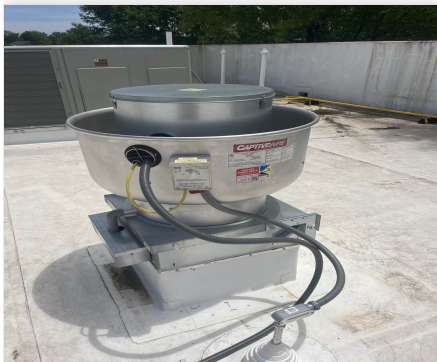
Issue Name : KEF1 / Label
Description : KEF1 is not labeled on rooftop.
Created By : National TAB **Assigned To :** National TAB - Dale Wheeler
Status : Open
Priority : Low **Asset Tag :**
Originated Date : 05/19/2025 - Dale Wheeler - National TAB

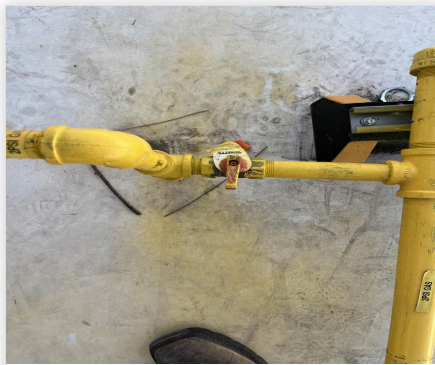
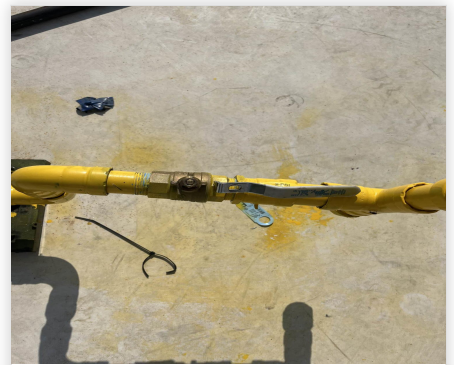
Issue Name : MAU / Gas Pipe Connection Leak
Description : MAU gas pipe connection is leaking gas. Heater is unable to be tested. Gas valve's for MAU, RTU1, RTU2 were in the off position upon arrival.
Created By : National TAB **Assigned To :** National TAB - Dale Wheeler
Status : Open
Priority : Medium **Asset Tag :**
Originated Date : 05/20/2025 - Dale Wheeler - National TAB

UNABLE TO TEST HEATER DUE TO GAS LEAK AT PIPE AND UNIT.

[1] HEATER CANNOT BE TESTED DUE TO GAS LINE LEAKING GAS AT PIPE CONNECTION TO THE UNIT. GAS VAVLE WAS IN THE OFF POSITION UPON ARRIVAL.

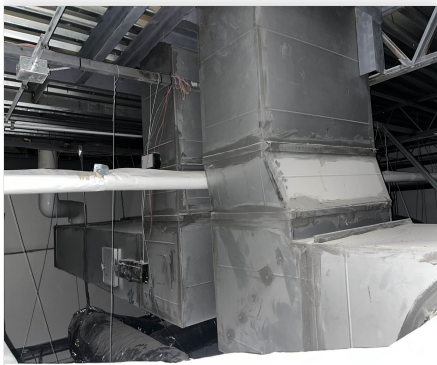
Issue Name : RTU1 / Ductwork & insulation
Description : RTU1 ductwork is not installed per plans due unit location on rooftop. Also ductwork is not externally insulated
Created By : National TAB **Assigned To :** National TAB - Dale Wheeler
Status : Open
Priority : High **Asset Tag :**
Originated Date : 05/20/2025 - Dale Wheeler - National TAB

NO / RTU1 DUCTWORK IS NOT ROUTED PER PLANS DUE TO UNIT NOT BEING LOCATED IN THE CORRECT LOCATION ON THE ROOFTOP. YES / RTU2

RTU1 DUCT IS NOT EXTERNALLY INSULATED

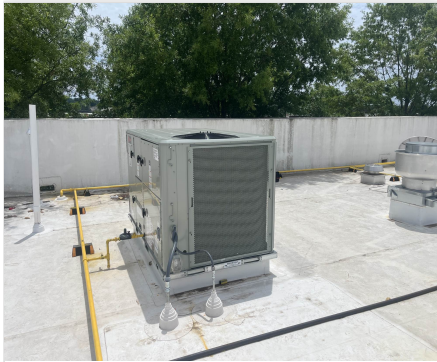
Issue Name : RTU1 / Location & Orientation
Description : RTU1 rooftop location and orientation is different then shown on prints.
Created By : National TAB **Assigned To :** National TAB - Dale Wheeler
Status : Open
Priority : Low **Asset Tag :**
Originated Date : 05/19/2025 - Dale Wheeler - National TAB

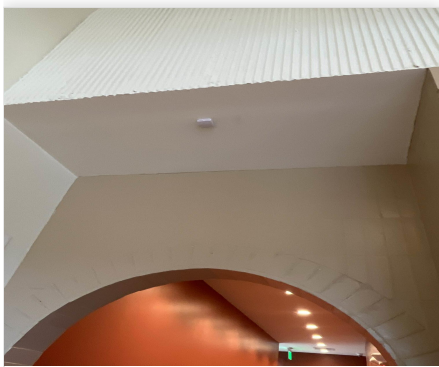
Issue Name : RTU2 / Humidity Sensor
Description : RTU2 humidity sensor is not installed.
Created By : National TAB **Assigned To :** National TAB - Dale Wheeler
Status : Open
Priority : **Medium** **Asset Tag :**
Originated Date : 05/20/2025 - Dale Wheeler - National TAB

YES / RTU1 HAS A WIRESLESS TEMP & HUMIDITY SENSOR INSTALLED. NO / RTU2 ONLY HAS A TEMP. SENSOR INSTALLED. HUMIDITY SENSORS NEEDS TO BE INSTALLED.
