Report: TAB REPORT
Function: Test, Adjust, & Balance
Date: 05/22/2025
Completed By: National TAB

PROJECT
05-19-25 CAVA CHARLOTTE, NC
(NORTHLAKE)

9815 NORTHLAKE CENTRE PARKWAY, SUITE 6

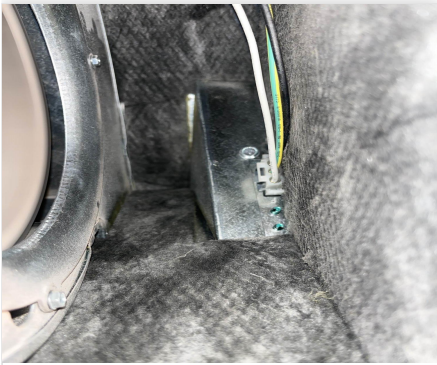
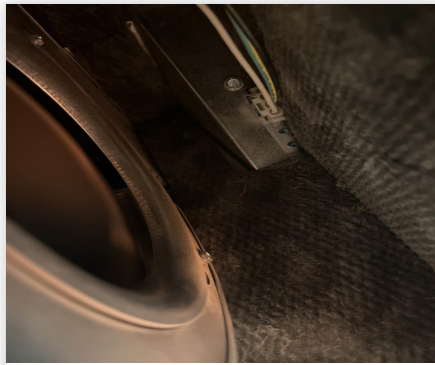
Issue Name : CEF1 & CEF2 / Speed Controllers
Description : CEF1 & CEF2 speed controllers are not installed. Unable to balance fans to design CFM.
Created By : National TAB **Assigned To :** National TAB - Dale Wheeler
Status : Open
Priority : High **Asset Tag :**
Originated Date : 05/20/2025 - Dale Wheeler - National TAB

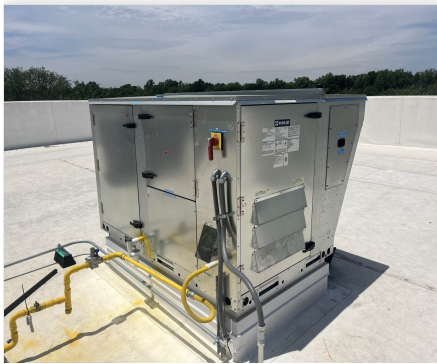
Issue Name : DOS/MAU - No Label
Description : No I.D. Tag is installed on the MAU/DOS unit.
Created By : National TAB **Assigned To :** National TAB - Dale Wheeler
Status : Open
Priority : Low **Asset Tag :**
Originated Date : 05/19/2025 - Dale Wheeler - National TAB

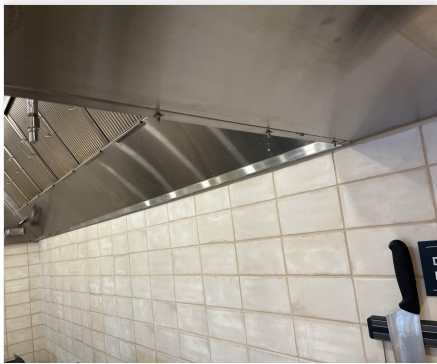
Issue Name : Hood / End Panel
Description : Hood end panel is not installed.
Created By : National TAB **Assigned To :** National TAB - Dale Wheeler
Status : Open
Priority : Medium **Asset Tag :**
Originated Date : 05/20/2025 - Dale Wheeler - National TAB

HOOD END PANEL IS NOT INSTALLED

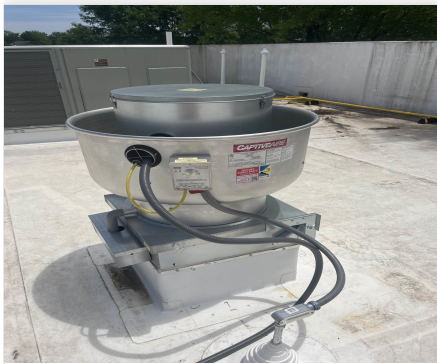
Issue Name : KEF1 / Label
Description : KEF1 is not labeled on rooftop.
Created By : National TAB **Assigned To :** National TAB - Dale Wheeler
Status : Open
Priority : Low **Asset Tag :**
Originated Date : 05/19/2025 - Dale Wheeler - National TAB

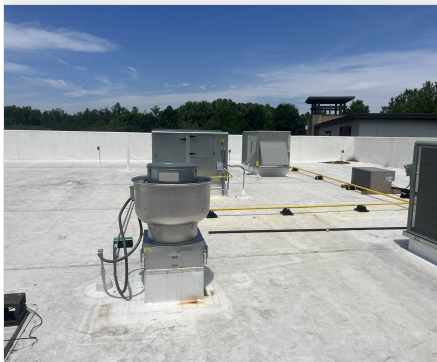
Issue Name : KEF1 / Rooftop Location
Description : KEF1 is located on rooftop in a different location then shown on prints
Created By : National TAB **Assigned To :** National TAB - Dale Wheeler
Status : Open
Priority : Low **Asset Tag :**
Originated Date : 05/19/2025 - Dale Wheeler - National TAB

KEF1 IS LOCATED IN A DIFFERENT LOCATION THEN SHOWN ON PLANS

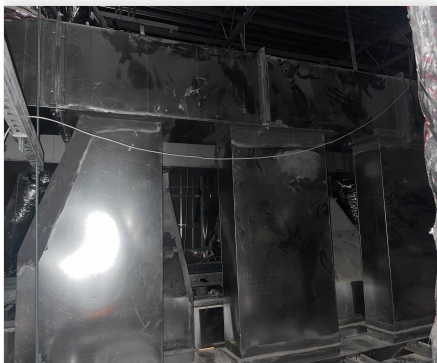
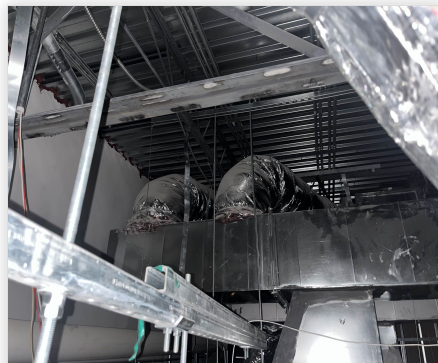
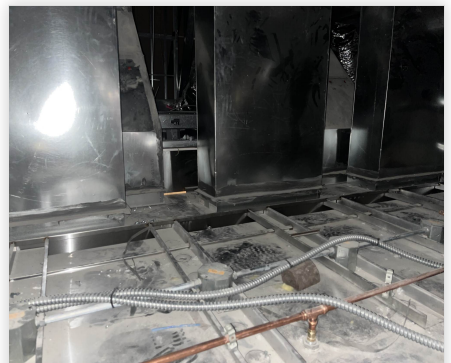
Issue Name : MAU / Ductwork
Description : MAU ductwork is not externally insulated & ductwork drop is installed different then called for on prints. Connection to the hood MUA plenum is not secured with foil taped to prevent air leakage
Created By : National TAB **Assigned To :** National TAB - Dale Wheeler
Status : Open
Priority : Medium **Asset Tag :**
Originated Date : 05/20/2025 - Dale Wheeler - National TAB

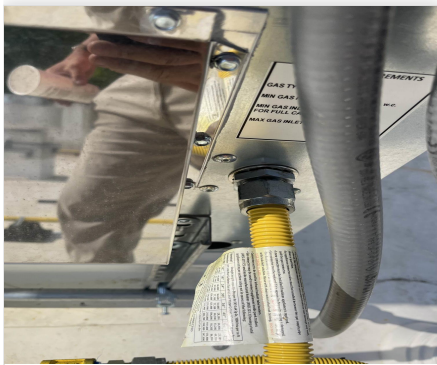
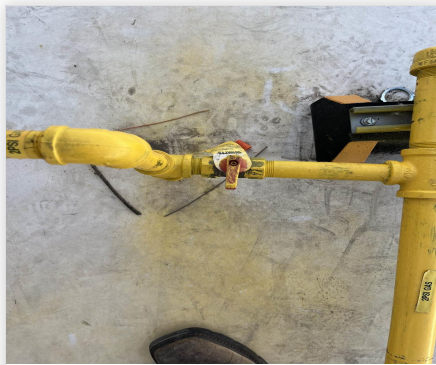
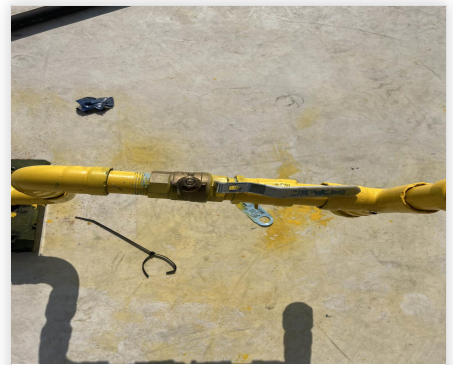
Issue Name : MAU / Gas Pipe Connection Leak
Description : MAU gas pipe connection is leaking gas. Heater is unable to be tested. Gas valve's for MAU, RTU1, RTU2 were in the off position upon arrival.
Created By : National TAB **Assigned To :** National TAB - Dale Wheeler
Status : Open
Priority : Medium **Asset Tag :**
Originated Date : 05/20/2025 - Dale Wheeler - National TAB

UNABLE TO TEST HEATER DUE TO GAS LEAK AT PIPE AND UNIT.

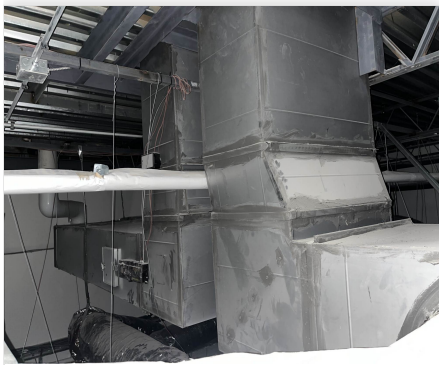
Issue Name : RTU1 / Ductwork & insulation
Description : RTU1 ductwork is not installed per plans due unit location on rooftop. Also ductwork is not externally insulated
Created By : National TAB **Assigned To :** National TAB - Dale Wheeler
Status : Open
Priority : High **Asset Tag :**
Originated Date : 05/20/2025 - Dale Wheeler - National TAB

NO / RTU1 DUCTWORK IS NOT ROUTED PER PLANS DUE TO UNIT NOT BEING LOCATED IN THE CORRECT LOCATION ON THE ROOFTOP. YES / RTU2

RTU1 DUCT IS NOT EXTERNALLY INSULATED

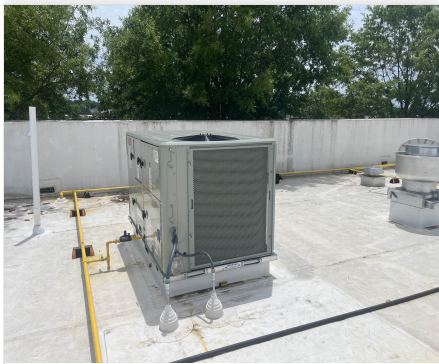
Issue Name : RTU1 / Location & Orientation
Description : RTU1 rooftop location and orientation is different then shown on prints.
Created By : National TAB **Assigned To :** National TAB - Dale Wheeler
Status : Open
Priority : Low **Asset Tag :**
Originated Date : 05/19/2025 - Dale Wheeler - National TAB

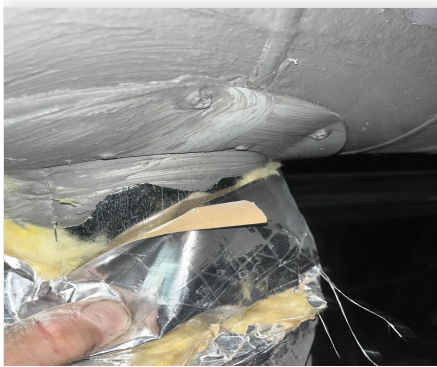
Issue Name : RTU1 / SGRD14 Damper
Description : RTU1 SGRD14 damper is broke and supply grill is unable to be balanced to design CFM.
Created By : National TAB **Assigned To :** National TAB - Dale Wheeler
Status : Open
Priority : High **Asset Tag :**
Originated Date : 05/20/2025 - Dale Wheeler - National TAB

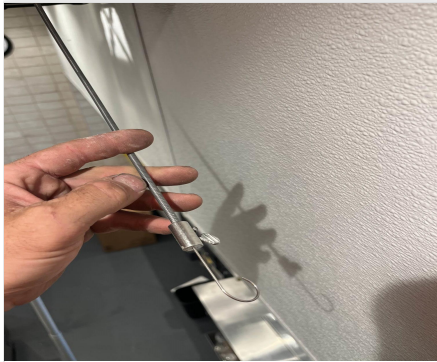
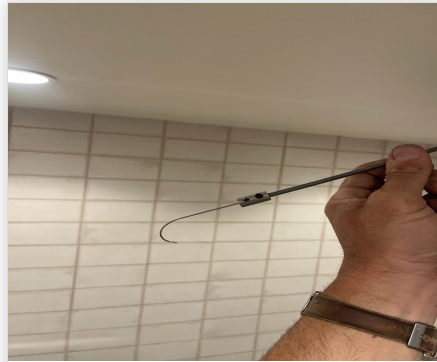
Issue Name : RTU1 / SGRD3 & SGRD7
Description : Dampers for sgrd3 & sgrd7 are not operational and are unable to close down to allow supply grills to be within design CFM.
Created By : National TAB **Assigned To :** National TAB - Dale Wheeler
Status : Open
Priority : Medium **Asset Tag :**
Originated Date : 05/21/2025 - Dale Wheeler - National TAB

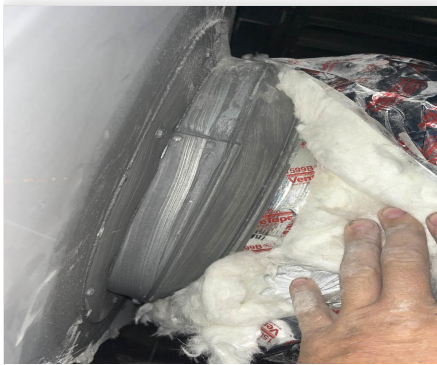
Issue Name : RTU1 / SGRD8 No Damper
Description : RTU1 sgrd8 damper is not installed causing supply grill to be high of design cfm & causing sgrd11 to be low of design cfm.
Created By : National TAB **Assigned To :** National TAB - Dale Wheeler
Status : Open
Priority : Medium **Asset Tag :**
Originated Date : 05/21/2025 - Dale Wheeler - National TAB

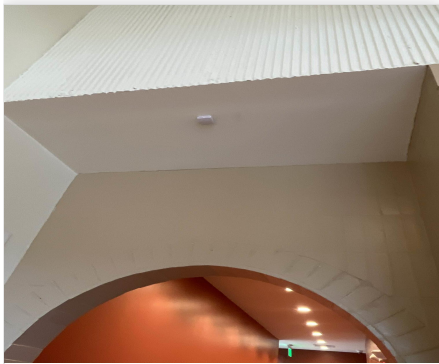
Issue Name : RTU2 / Humidity Sensor
Description : RTU2 humidity sensor is not installed.
Created By : National TAB **Assigned To :** National TAB - Dale Wheeler
Status : Open
Priority : **Medium** **Asset Tag :**
Originated Date : 05/20/2025 - Dale Wheeler - National TAB

YES / RTU1 HAS A WIRESLESS TEMP & HUMIDITY SENSOR INSTALLED. NO / RTU2 ONLY HAS A TEMP. SENSOR INSTALLED. HUMIDITY SENSORS NEEDS TO BE INSTALLED.
