**Report: TAB REPORT**  
**Function: Test, Adjust, & Balance**  
**Date: 05/22/2025**  
**Completed By: National TAB**

**PROJECT**  
**05-19-25 CAVA CHARLOTTE, NC**  
**(NORTHLAKE)**

9815 NORTHLAKE CENTRE PARKWAY, SUITE 6

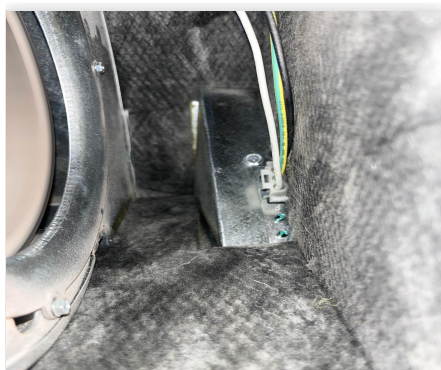
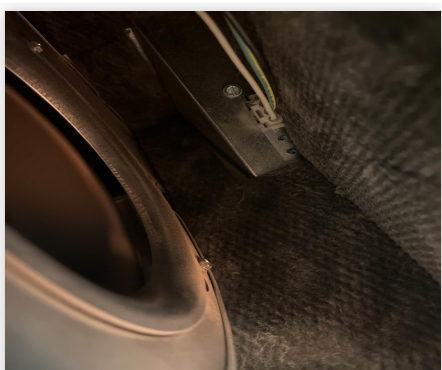
**Issue Name :** CEF1 & CEF2 / Speed Controllers  
**Description :** CEF1 & CEF2 speed controllers are not installed. Unable to balance fans to design CFM.  
**Created By :** National TAB                      **Assigned To :** National TAB - Dale Wheeler  
**Status :** Open  
**Priority :** High                                      **Asset Tag :**  
**Originated Date :** 05/20/2025 - Dale Wheeler - National TAB

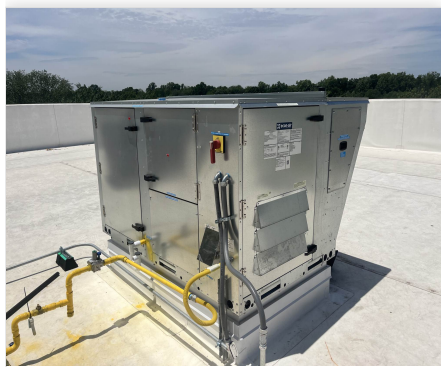
**Issue Name :** DOS/MAU - No Label  
**Description :** No I.D. Tag is installed on the MAU/DOS unit.  
**Created By :** National TAB                      **Assigned To :** National TAB - Dale Wheeler  
**Status :** Open  
**Priority :** Low                                      **Asset Tag :**  
**Originated Date :** 05/19/2025 - Dale Wheeler - National TAB

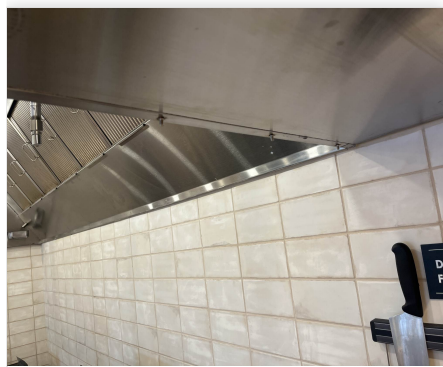
**Issue Name :** Hood / End Panel  
**Description :** Hood end panel is not installed.  
**Created By :** National TAB      **Assigned To :** National TAB - Dale Wheeler  
**Status :** Open  
**Priority :** Medium      **Asset Tag :**  
**Originated Date :** 05/20/2025 - Dale Wheeler - National TAB

HOOD END PANEL IS NOT INSTALLED

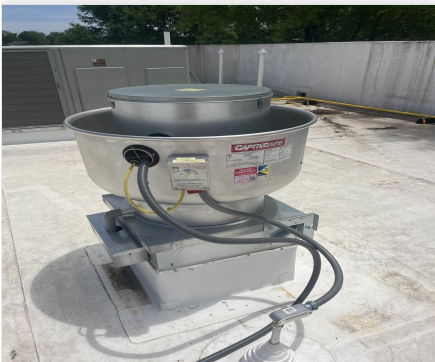
**Issue Name :** KEF1 / Label

**Description :** KEF1 is not labeled on rooftop.

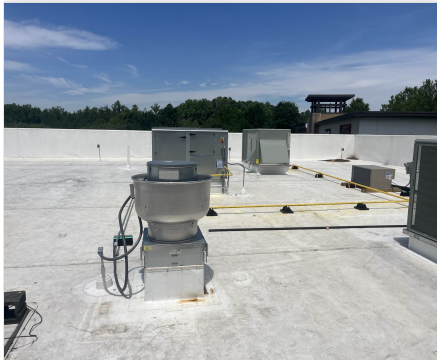
**Issue Name :** KEF1 / Rooftop Location  
**Description :** KEF1 is located on rooftop in a different location then shown on prints  
**Created By :** National TAB **Assigned To :** National TAB - Dale Wheeler  
**Status :** Open  
**Priority :** Low **Asset Tag :**  
**Originated Date :** 05/19/2025 - Dale Wheeler - National TAB

KEF1 IS LOCATED IN A DIFFERENT LOCATION THEN SHOWN ON PLANS

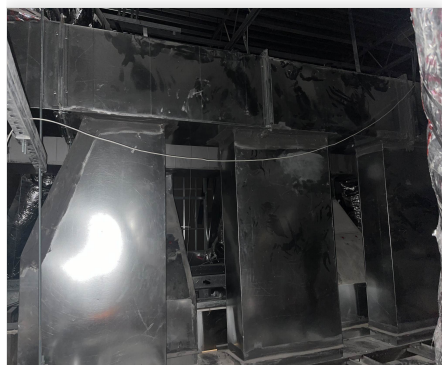
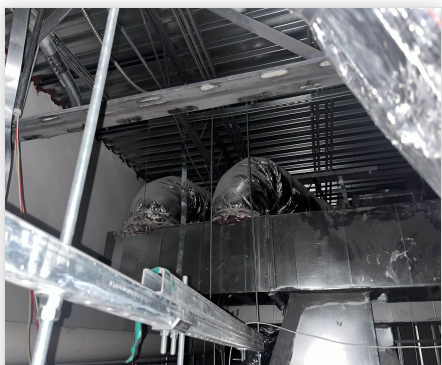
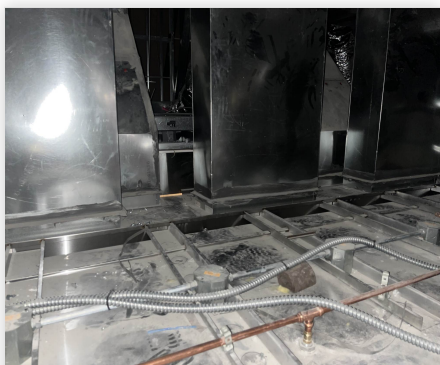
**Issue Name :** MAU / Ductwork  
**Description :** MAU ductwork is not externally insulated & ductwork drop is installed different then called for on prints. Connection to the hood MUA plenum is not secured with foil taped to prevent air leakage  
**Created By :** National TAB                      **Assigned To :** National TAB - Dale Wheeler  
**Status :** Open  
**Priority :** Medium                      **Asset Tag :**  
**Originated Date :** 05/20/2025 - Dale Wheeler - National TAB

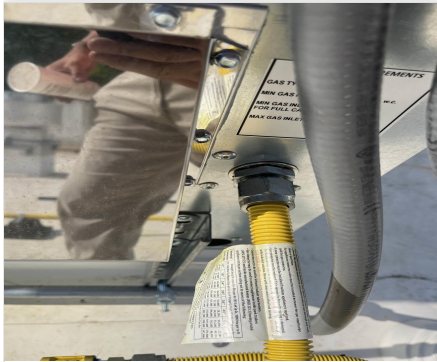
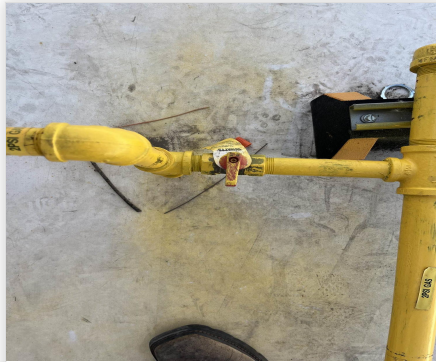
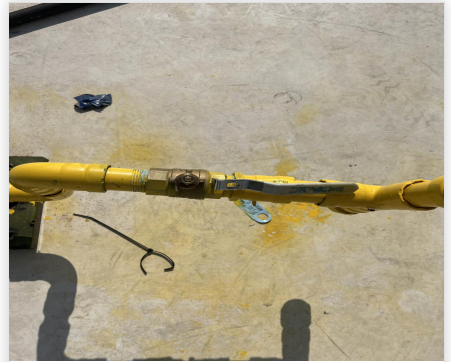
**Issue Name :** MAU / Gas Pipe Connection Leak  
**Description :** MAU gas pipe connection is leaking gas. Heater is unable to be tested. Gas valve's for MAU, RTU1, RTU2 were in the off position upon arrival.  
**Created By :** National TAB **Assigned To :** National TAB - Dale Wheeler  
**Status :** Open  
**Priority :** Medium **Asset Tag :**  
**Originated Date :** 05/20/2025 - Dale Wheeler - National TAB

UNABLE TO TEST HEATER DUE TO GAS LEAK AT PIPE AND UNIT.

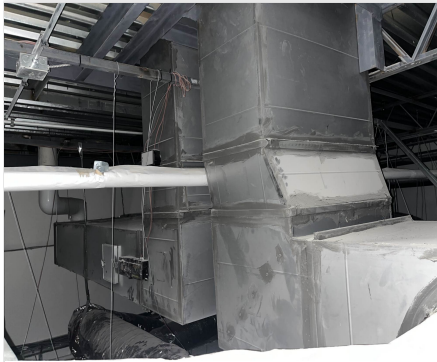
**Issue Name :** RTU1 / Ductwork & insulation  
**Description :** RTU1 ductwork is not installed per plans due unit location on rooftop. Also ductwork is not externally insulated  
**Created By :** National TAB **Assigned To :** National TAB - Dale Wheeler  
**Status :** Open  
**Priority :** High **Asset Tag :**  
**Originated Date :** 05/20/2025 - Dale Wheeler - National TAB

NO / RTU1 DUCTWORK IS NOT ROUTED PER PLANS DUE TO UNIT NOT BEING LOCATED IN THE CORRECT LOCATION ON THE ROOFTOP. YES / RTU2

RTU1 DUCT IS NOT EXTERNALLY INSULATED

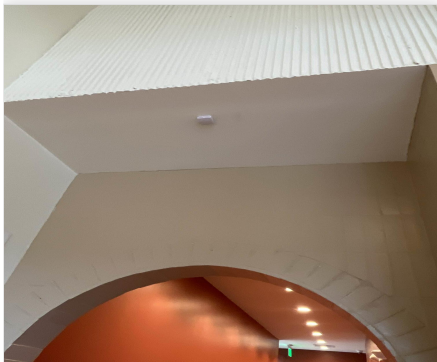
**Issue Name :** RTU2 / Humidity Sensor  
**Description :** RTU2 humidity sensor is not installed.  
**Created By :** National TAB **Assigned To :** National TAB - Dale Wheeler  
**Status :** Open  
**Priority :** Medium **Asset Tag :**  
**Originated Date :** 05/20/2025 - Dale Wheeler - National TAB

YES / RTU1 HAS A WIRESLESS TEMP & HUMIDITY SENSOR INSTALLED. NO / RTU2 ONLY HAS A TEMP. SENSOR INSTALLED. HUMIDITY SENSORS NEEDS TO BE INSTALLED.
