Report: TAB Report
Function: Test, Adjust, & Balance
Date: 03/11/2026
Completed By: National TAB

PROJECT
03-09-26 QT #0484 PEORIA, AZ

Project: 03-09-26 QT #0484 PEORIA, AZ

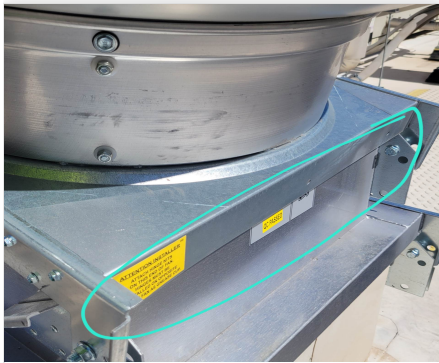
Issue Name : CAN'T TILT EF3 FAN BACK
Description : EF3 was installed incorrectly. Not sure why 2 hinges were installed... but neither of them work. The top, the only one necessary, won't open due to back edge of base hitting the hinges and curb top as shown below. Recommend checking equipment function after installation.
Created By : National TAB **Assigned To :** National TAB - Dan Hertenstein
Status : Open
Priority : Low **Asset Tag :** EF3
Originated Date : 03/11/2026 - Christine Weale - National TAB

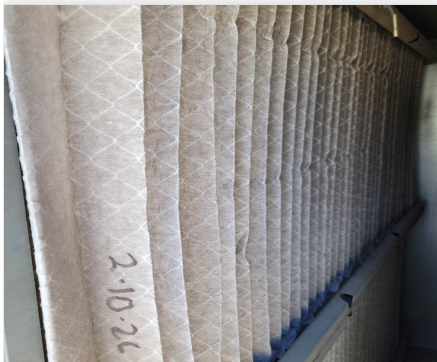
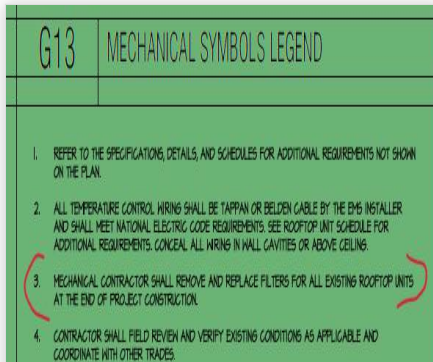
Issue Name : DIRTY FINAL FILTERS
Description : See pics. All Units.
Created By : National TAB **Assigned To :** National TAB - Dan Hertenstein
Status : Open
Priority : Low **Asset Tag :**
Originated Date : 03/11/2026 - Christine Weale - National TAB

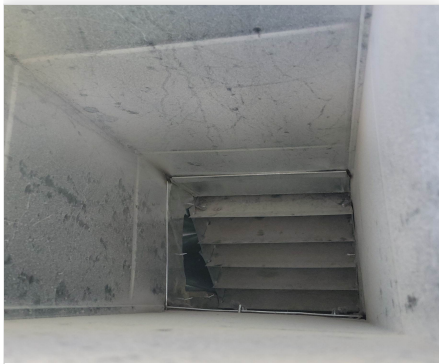
Issue Name : EF1 DAMPER
Description : Damper has fallen into the duct.
Created By : National TAB **Assigned To :** National TAB - Dan Hertenstein
Status : Open
Priority : Medium **Asset Tag :** EF1
Originated Date : 03/11/2026 - Christine Weale - National TAB

LOW SP DUE TO BROKEN BACKDRAFT DAMPER, SEE 'REMARKS'.

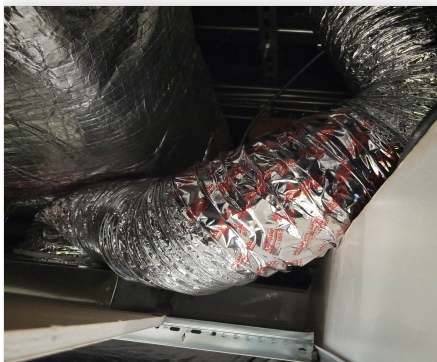
Issue Name : INCORRECT DUCT INSTALLATION
Description : Flex is way too long, bent over, and restricting air flow. Flow reading ranges from -40 to 65 which means more air is probably flowing from it, but is too turbulent to function as an exhaust or get a proper measurement of. EF2 is probably balanced (impossible to be sure), once duct is installed correctly no problems anticipated.
Created By : National TAB **Assigned To :** National TAB - Dan Hertenstein
Status : Open
Priority : High **Asset Tag :** EGRD1
Originated Date : 03/10/2026 - Christine Weale - National TAB

Asset	Notes	Date	Written By
EGRD1	INCORRECT DUCT INSTALLATION, SEE 'REMARKS'.	03/10/2026	Christine Weale

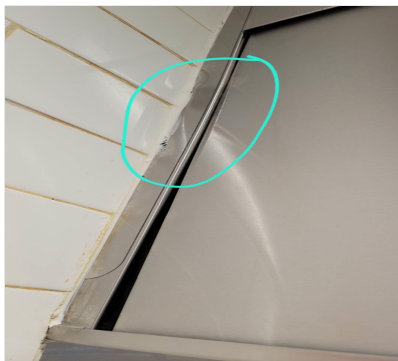
Hood is free of damage? Fail

One small dent makes the panel door hard to put in place.

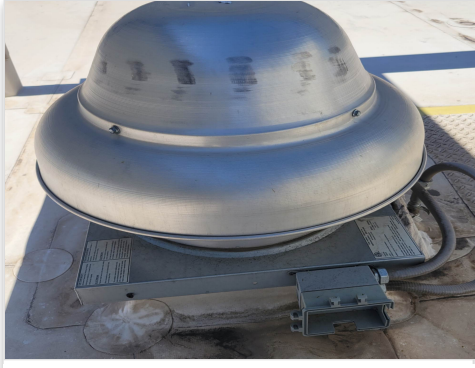
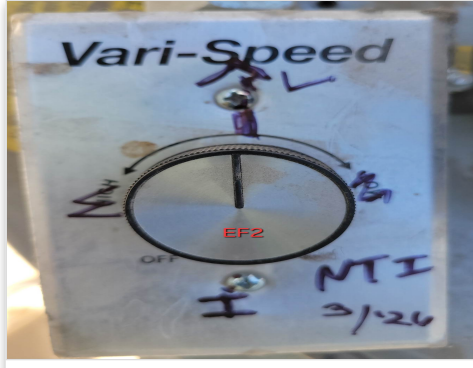
FAN IS BALANCED, FLOW BEFORE AIR DIVERTED FROM MEN'S RR DUCT WAS ~500-545CFM. DUCT ISSUE - SEE 'REMARKS'.
