Report: TAB Report
Function: Test, Adjust, & Balance
Date: 08/27/2025
Completed By: National TAB

PROJECT
08-25-25 CAVA DANBURY, CT

44 BACKUS AVENUE

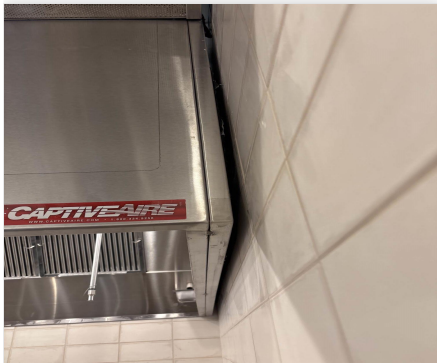
Small gap between right side of hood and wall.

Issue Name : HD1: Gap Next to Wall
Description : Small gap between hood and well. Recommend filling.
Created By : National TAB **Assigned To :** National TAB - Dan Hertenstein
Status : Open
Priority : Low **Asset Tag :**
Originated Date : 08/25/2025 - Ryan Smith - National TAB

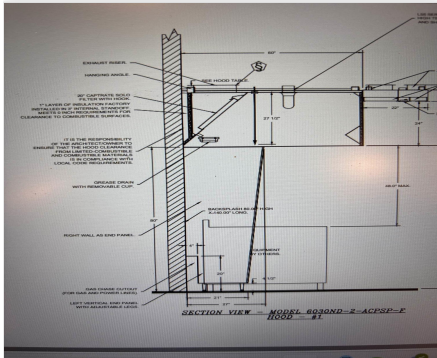
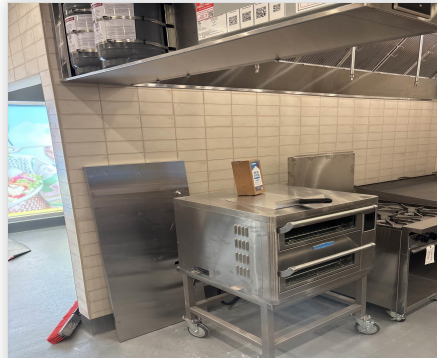
Left end panel not installed.

Issue Name : HD1: Left End Panel Not Installed
Description : Hood is designed to have left end panel. Recommend installing according to drawings.
Created By : National TAB **Assigned To :** National TAB - Dan Hertenstein
Status : Open
Priority : Medium **Asset Tag :**
Originated Date : 08/25/2025 - Ryan Smith - National TAB

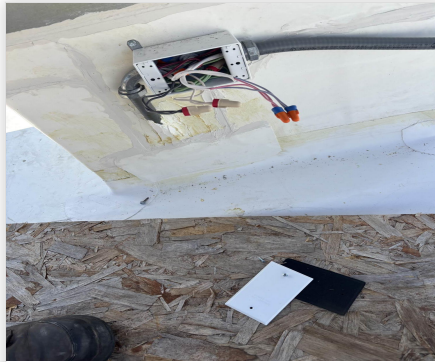
Issue Name : KEF1: Electrical Boxes Left Open
Description : Electrical boxes are open, potentially exposing wiring to elements. Recommend closing.
Created By : National TAB **Assigned To :** National TAB - Dan Hertenstein
Status : Open
Priority : Low **Asset Tag :**
Originated Date : 08/25/2025 - Ryan Smith - National TAB

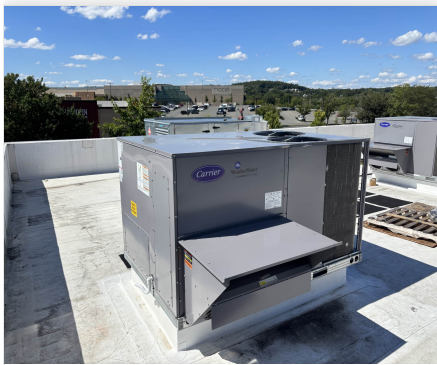
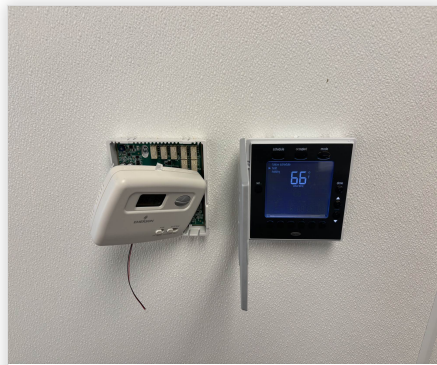
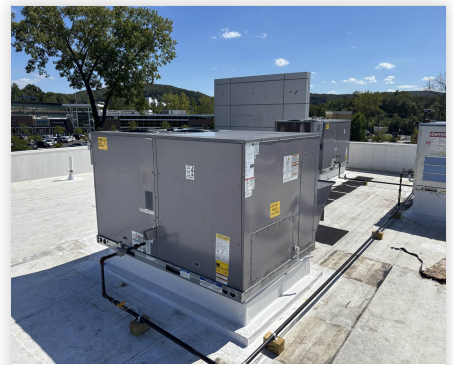
No identification tag

No identification tags.

Issue Name : Rooftop Assets & Thermostats: No Identification Tags
Description : No permanent tags or labels to identify rooftop units as RTU1, RTU2, MAU, KEF1. Also no permanent tags or labels to identify which thermostat serves which area.
Created By : National TAB **Assigned To :** National TAB - Dan Hertenstein
Status : Open
Priority : Low **Asset Tag :**
Originated Date : 08/25/2025 - Ryan Smith - National TAB

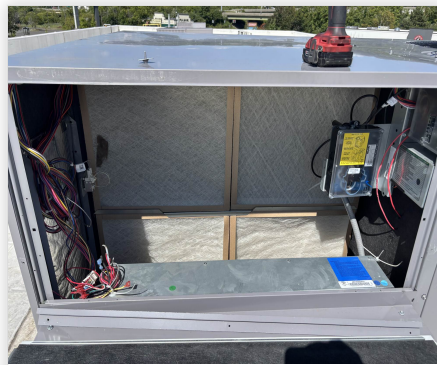
Issue Name : RTU1, RTU2: Construction Filters Still Installed
Description : Construction filters still installed in both RTUs. Recommend replacing with MERV8 filters.
Created By : National TAB **Assigned To :** National TAB - Dan Hertenstein
Status : Open
Priority : Medium **Asset Tag :**
Originated Date : 08/25/2025 - Ryan Smith - National TAB

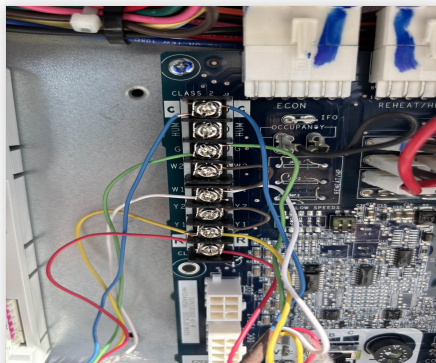
Issue Name : RTU1, RTU2: Controller Wiring Incorrect
Description : Controllers in RTUs are wired incorrectly. Y1 is jumped to Y2 and W1 is jumped to W2. Also, thermostats do not send occupancy signal to correct terminal on board, only toggling fan mode instead.
Created By : National TAB **Assigned To :** National TAB - Dan Hertenstein
Status : Open
Priority : Low **Asset Tag :**
Originated Date : 08/27/2025 - Ryan Smith - National TAB

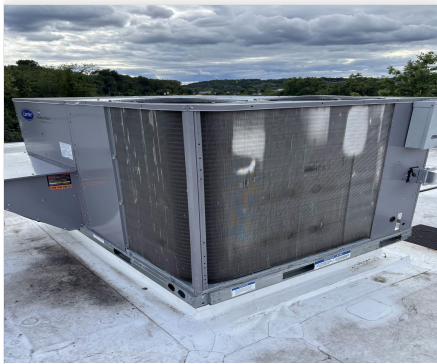
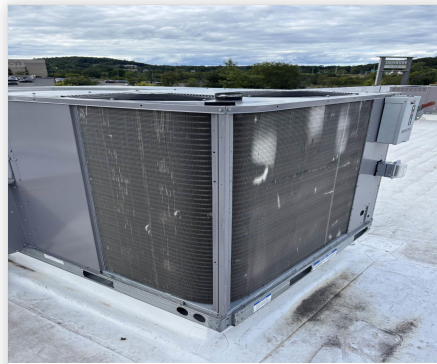
Issue Name : RTU1, RTU2: No Hailguards on Condenser Fins
Description : No hailguards installed on condenser fins. Recommend installing.
Created By : National TAB **Assigned To :** National TAB - Dan Hertenstein
Status : Open
Priority : Low **Asset Tag :**
Originated Date : 08/27/2025 - Ryan Smith - National TAB

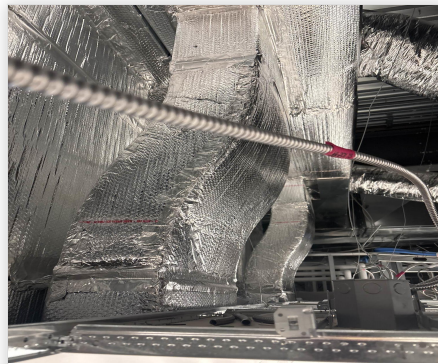
Issue Name : RTU1-1: No Dampers in ACPSP
Description : No dampers in ACPSP. Unable to adjust kitchen diffusers.
Created By : National TAB **Assigned To :** National TAB - Dan Hertenstein
Status : Open
Priority : High **Asset Tag :**
Originated Date : 08/27/2025 - Ryan Smith - National TAB

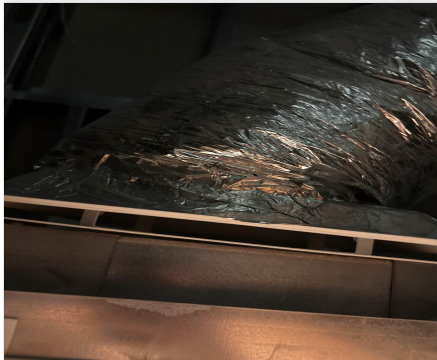
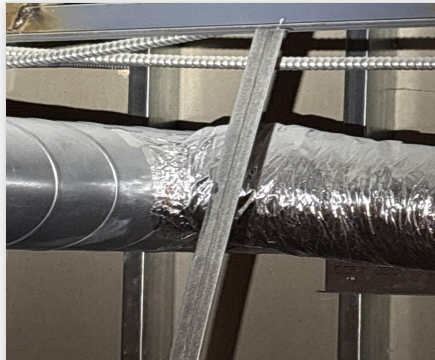
Issue Name : RTU2-10,12: No Dampers in Bathroom Supply Diffusers
Description : Bathroom supply diffusers do not have dampers. Unable to adjust.
Created By : National TAB **Assigned To :** National TAB - Dan Hertenstein
Status : Open
Priority : Low **Asset Tag :**
Originated Date : 08/27/2025 - Ryan Smith - National TAB
