Report: TAB Report
Function: Test, Adjust, & Balance
Date: 08/27/2025
Completed By: National TAB

PROJECT
08-25-25 CAVA DANBURY, CT

Project: 08-25-25 CAVA DANBURY, CT

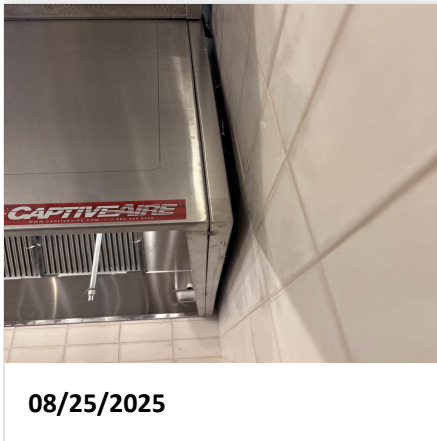
Small gap between right side of hood and wall.

Issue Name : HD1: Gap Next to Wall
Description : Small gap between hood and well. Recommend filling.
Created By : National TAB **Assigned To :** National TAB - Dan Hertenstein
Status : Open
Priority : Low **Asset Tag :**
Originated Date : 08/25/2025 - Ryan Smith - National TAB

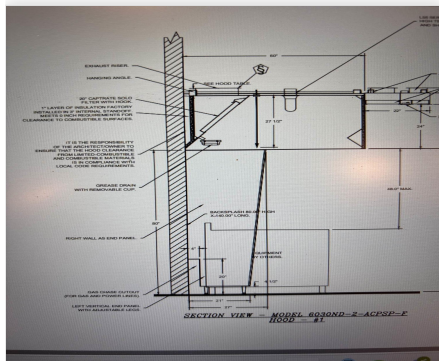
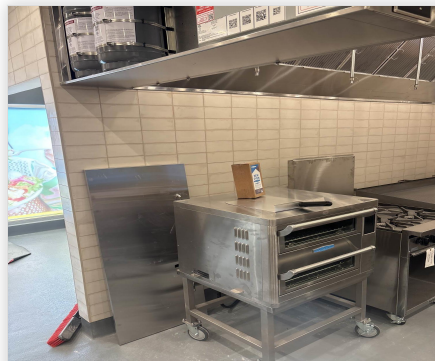
Left end panel not installed.

Issue Name : HD1: Left End Panel Not Installed
Description : Hood is designed to have left end panel. Recommend installing according to drawings.
Created By : National TAB **Assigned To :** National TAB - Dan Hertenstein
Status : Open
Priority : Medium **Asset Tag :**
Originated Date : 08/25/2025 - Ryan Smith - National TAB

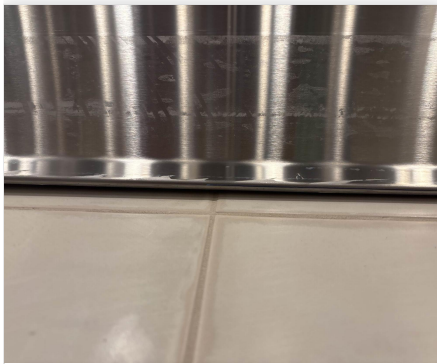
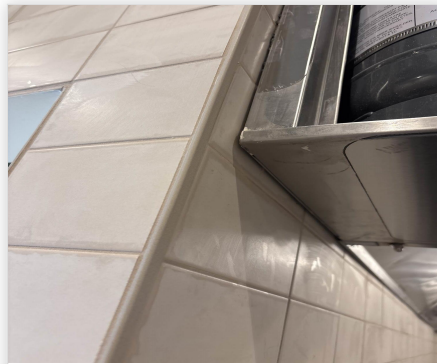
Caulk not applied

Issue Name : HD1: Not Caulked Along Wall
Description : Hood not caulked where it meets wall. Recommend caulking.
Created By : National TAB **Assigned To :** National TAB - Dan Hertenstein
Status : Open
Priority : Medium **Asset Tag :**
Originated Date : 08/25/2025 - Ryan Smith - National TAB

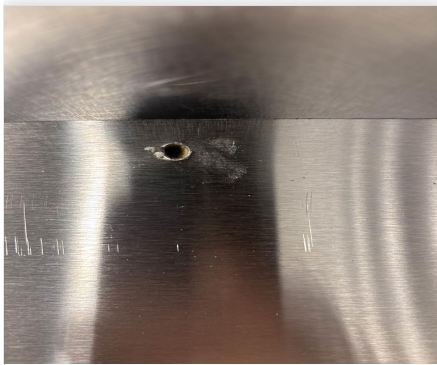
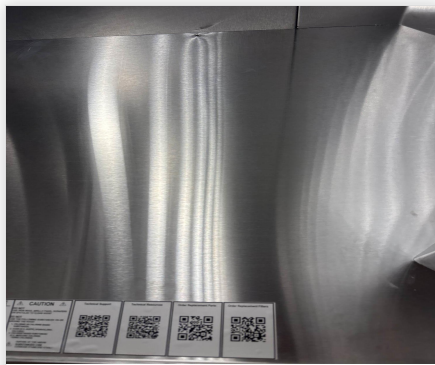
Small hole drilled high up onn the right side.

Issue Name : HD1: Small Penetration in Canopy
Description : Small penetration in hood canopy high up on right side. Recommend repairing according to manufacture directions.
Created By : National TAB **Assigned To :** National TAB - Dan Hertenstein
Status : Open
Priority : Low **Asset Tag :**
Originated Date : 08/25/2025 - Ryan Smith - National TAB

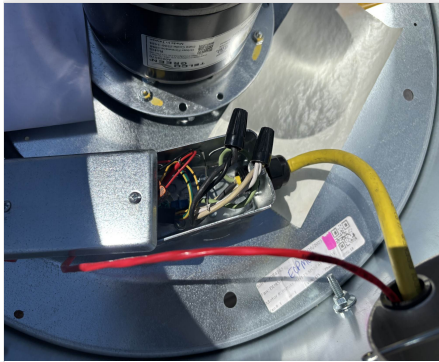
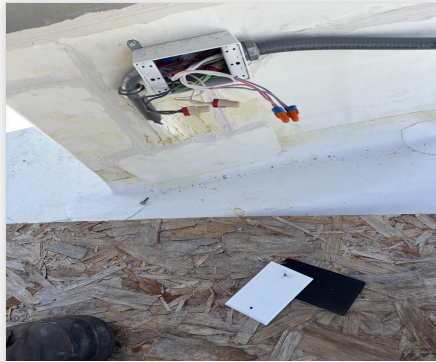
Issue Name : KEF1: Electrical Boxes Left Open
Description : Electrical boxes are open, potentially exposing wiring to elements. Recommend closing.
Created By : National TAB **Assigned To :** National TAB - Dan Hertenstein
Status : Open
Priority : Low **Asset Tag :**
Originated Date : 08/25/2025 - Ryan Smith - National TAB

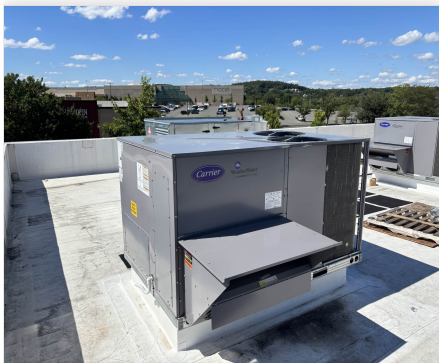
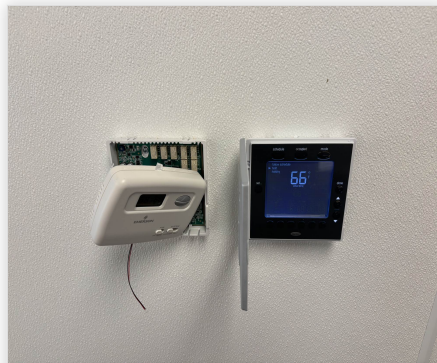
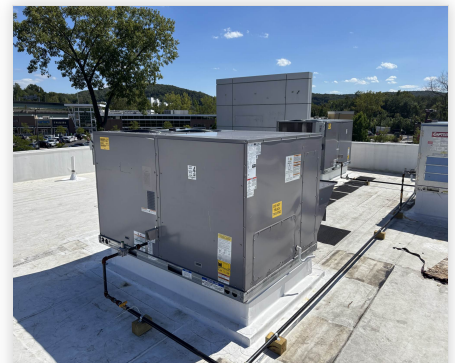
No identification tag

No identification tags.

Issue Name : Rooftop Assets & Thermostats: No Identification Tags
Description : No permanent tags or labels to identify rooftop units as RTU1, RTU2, MAU, KEF1. Also no permanent tags or labels to identify which thermostat serves which area.
Created By : National TAB **Assigned To :** National TAB - Dan Hertenstein
Status : Open
Priority : Low **Asset Tag :**
Originated Date : 08/25/2025 - Ryan Smith - National TAB

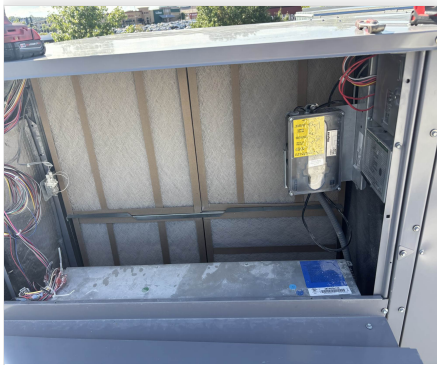
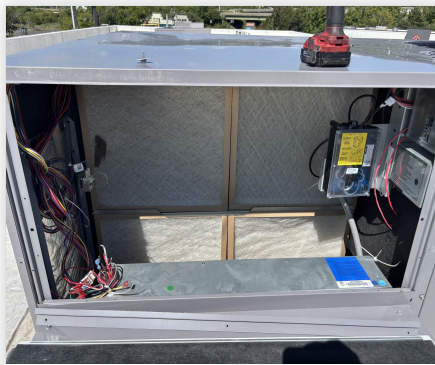
Issue Name : RTU1, RTU2: Construction Filters Still Installed
Description : Construction filters still installed in both RTUs. Recommend replacing with MERV8 filters.
Created By : National TAB **Assigned To :** National TAB - Dan Hertenstein
Status : Open
Priority : Medium **Asset Tag :**
Originated Date : 08/25/2025 - Ryan Smith - National TAB

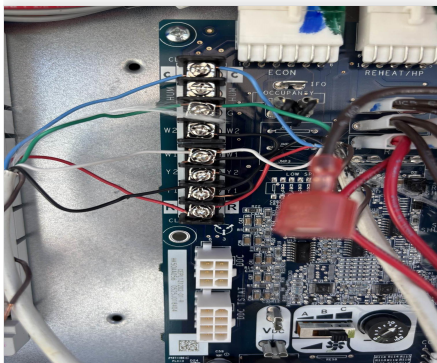
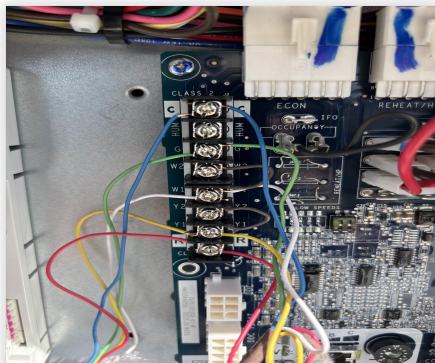
Issue Name : RTU1, RTU2: Controller Wiring Incorrect
Description : Controllers in RTUs are wired incorrectly. Y1 is jumped to Y2 and W1 is jumped to W2. Also, thermostats do not send occupancy signal to correct terminal on board, only toggling fan mode instead.
Created By : National TAB **Assigned To :** National TAB - Dan Hertenstein
Status : Open
Priority : Low **Asset Tag :**
Originated Date : 08/27/2025 - Ryan Smith - National TAB

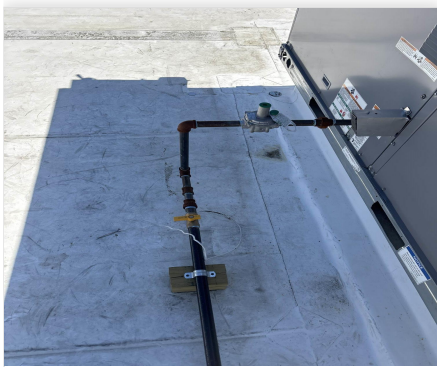
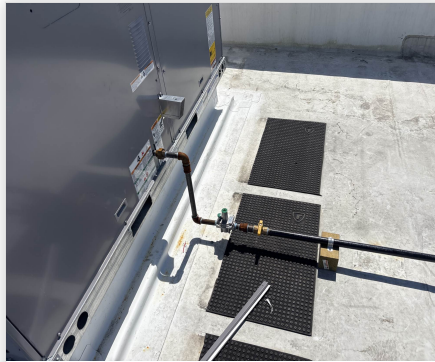
Gas valves closed and burners not started up. See OA temperature.

Issue Name : RTU1, RTU2: Gas Valves Closed
Description : Gas valves for both RTUs are closed. Open valves and perform burner startup.
Created By : National TAB **Assigned To :** National TAB - Dan Hertenstein
Status : Open
Priority : Low **Asset Tag :**
Originated Date : 08/25/2025 - Ryan Smith - National TAB

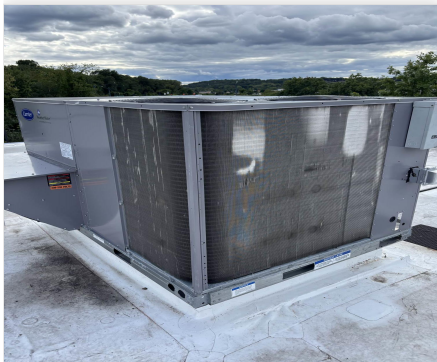
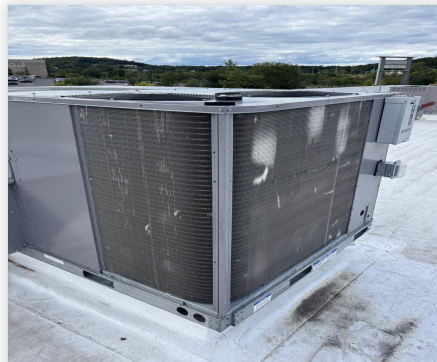
Issue Name : RTU1, RTU2: No Hailguards on Condenser Fins
Description : No hailguards installed on condenser fins. Recommend installing.
Created By : National TAB **Assigned To :** National TAB - Dan Hertenstein
Status : Open
Priority : Low **Asset Tag :**
Originated Date : 08/27/2025 - Ryan Smith - National TAB

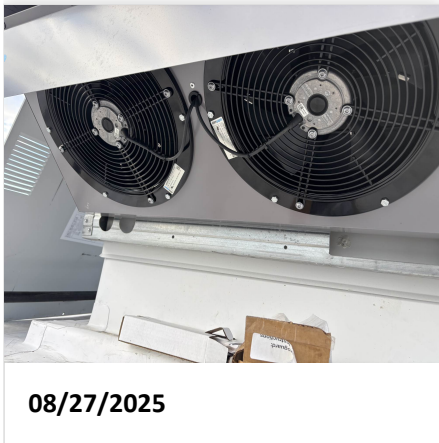
Issue Name : RTU1, RTU2: Power Exhaust Not Operational
Description : Power exhaust on both RTUs is not operational. Recommend servicing.
Created By : National TAB **Assigned To :** National TAB - Dan Hertenstein
Status : Open
Priority : Low **Asset Tag :**
Originated Date : 08/27/2025 - Ryan Smith - National TAB

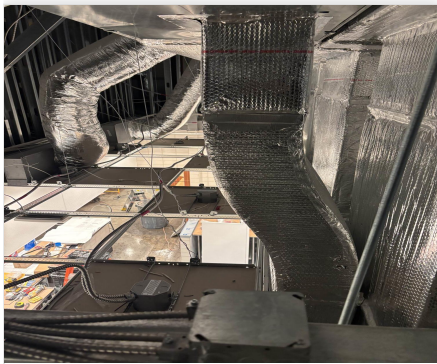
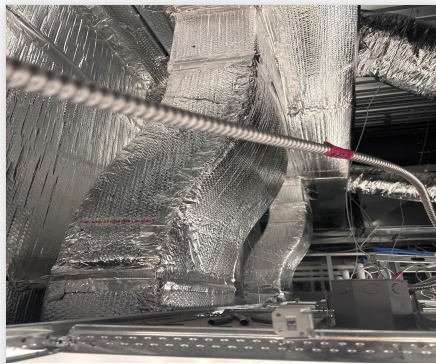
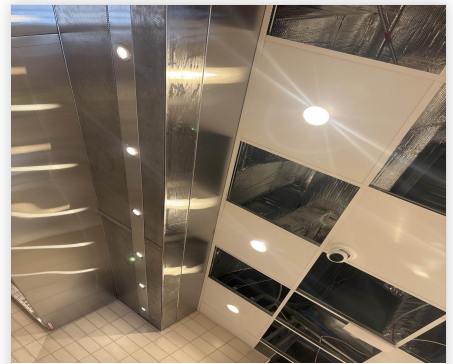
Issue Name : RTU1-1: No Dampers in ACPSP
Description : No dampers in ACPSP. Unable to adjust kitchen diffusers.
Created By : National TAB **Assigned To :** National TAB - Dan Hertenstein
Status : Open
Priority : High **Asset Tag :**
Originated Date : 08/27/2025 - Ryan Smith - National TAB

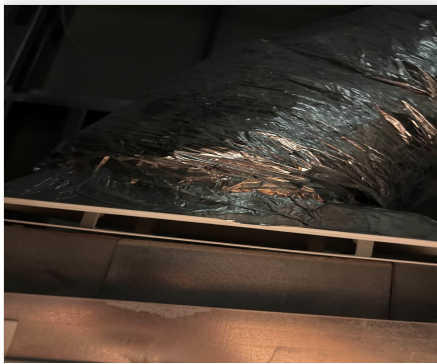
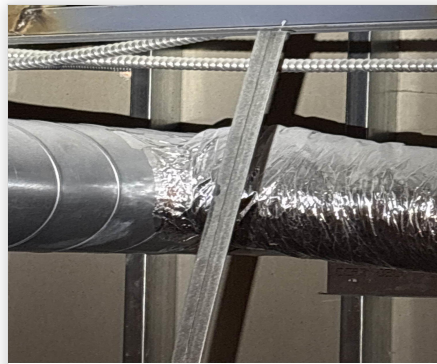
Issue Name : RTU2-10,12: No Dampers in Bathroom Supply Diffusers
Description : Bathroom supply diffusers do not have dampers. Unable to adjust.
Created By : National TAB **Assigned To :** National TAB - Dan Hertenstein
Status : Open
Priority : Low **Asset Tag :**
Originated Date : 08/27/2025 - Ryan Smith - National TAB
