**Report: Final Report  
Function: Test, Adjust, & Balance  
Date: 8/24/2022**

**PROJECT  
08-15 CULVERS - WHEATON, IL**

Project: 08-15 CULVERS - WHEATON, IL

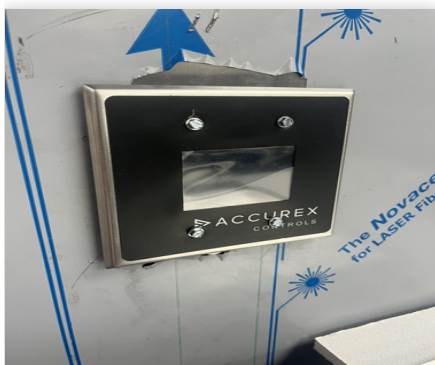
**Issue Name :** Accurex hood control screwed through.

**Description :** Typically the hood control screen clips into the wall box. In this instance the incorrect box was installed in the wall.

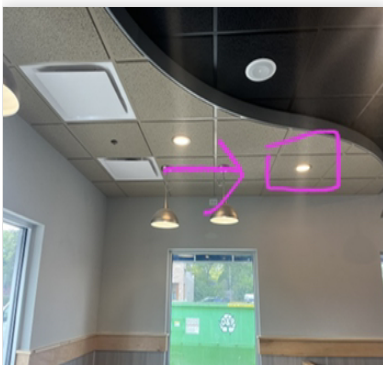
**Issue Name :** Diffuser 1-11 in wrong location.  
**Description :** Lighting installed in ceiling tile for diffuser. Not anticipated to cause any issues.  
**Created By :** National TAB **Assigned To :** National TAB - Will Turnbough  
**Status :** Open  
**Originated Date :** 08/18/2022 - Michael McDonnell - National TAB

- **08/19/2022** National TAB - Michael McDonnell
  - Correct location.

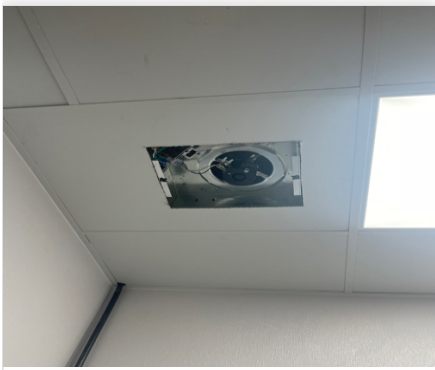
**Issue Name :** EF-1A (mop room) cover not yet installed.

**Description :** EF-1A fan cover not yet in place.

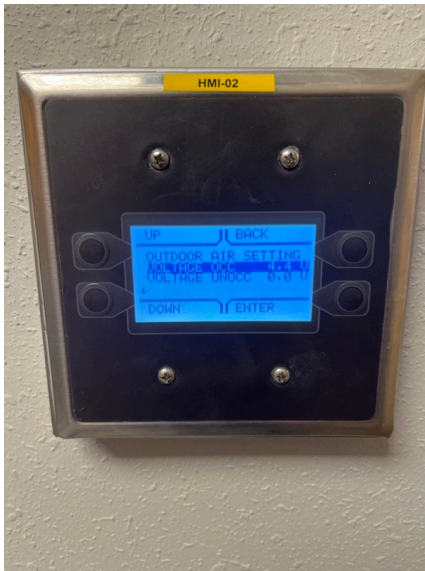
RTU-1  
OA Damper Position Marked

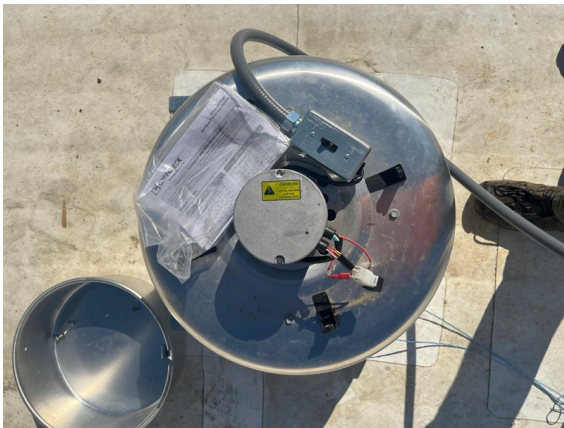
PRV-1  
Disconnect and speed controller installed.
