08-15 CULVERS - WHEATON, IL

Project Issue Information

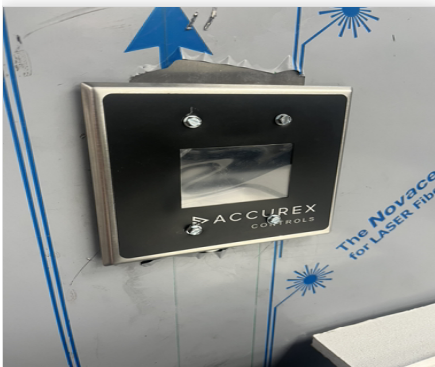
FuselT35e3fc49334d48458bc196
6f0106c729.jpeg

Issue Name : Accurex hood control screwed through.

Description : Typically the hood control screen clips into the wall box. In this instance the incorrect box was installed in the wall.
