**Report: FINAL TAB REPORT  
Function: Test, Adjust, & Balance  
Date: 8/24/2022**

**PROJECT  
08-15 CULVERS - WHEATON, IL**

Project: 08-15 CULVERS - WHEATON, IL

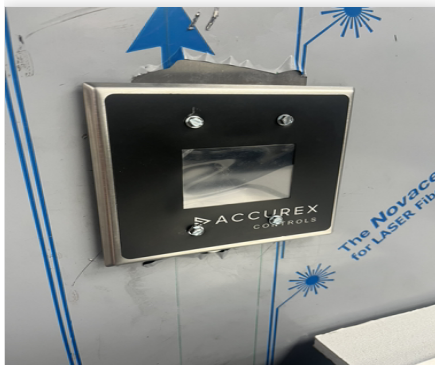
**Issue Name :** Accurex hood control screwed through.

**Description :** Typically the hood control screen clips into the wall box. In this instance the incorrect box was installed in the wall.

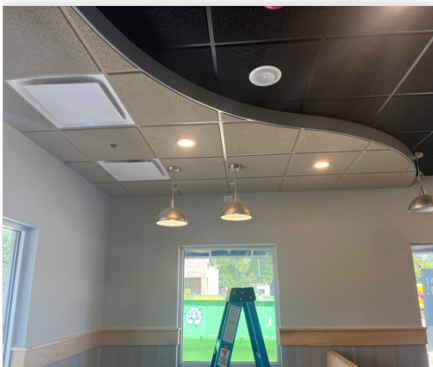
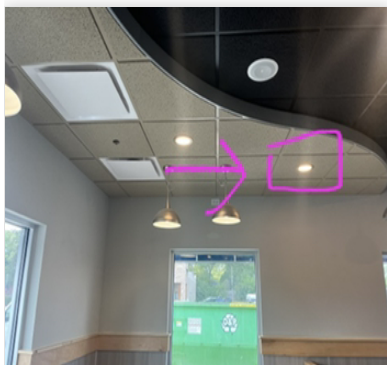
**Issue Name :** Diffuser 1-11 in wrong location.  
**Description :** Lighting installed in ceiling tile for diffuser. Not anticipated to cause any issues.  
**Created By :** National TAB **Assigned To :** National TAB - Will Turnbough  
**Status :** Open  
**Originated Date :** 08/18/2022 - Michael McDonnell - National TAB

- **08/19/2022** National TAB - Michael McDonnell
  - Correct location.

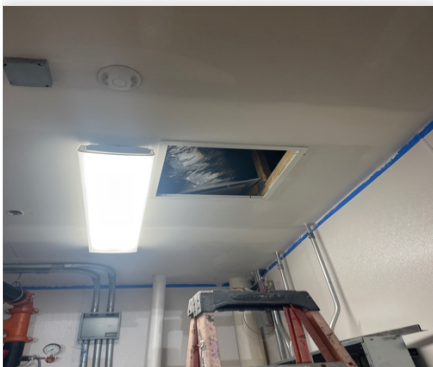
**Issue Name :** Diffuser 2-14 has 10" neck. Plans call for 12".

**Description :** 10"neck diffuser installed. Diffuser scheduled for 600cfm. MC installing 12-10" reducer.

- **08/19/2022 National TAB - Michael McDonnell**
  - Diffuser is low on airflow (480/600cfm-80%) with all other diffusers within design and unit at FLA. Cannot push more air to diffuser. In mechanical room. Not anticipated to cause any issue.

Notes: [1] DIFFUSER 2-14 LOW ON AIRFLOW (480/600CFM-80%) DUE TO INCORRECT NECK SIZE. 10" INSTALLED, PLANS CALL FOR 12". REDUCER INSTALLED BEFORE NECK, CANNOT PUSH ANY MORE AIR TO DIFFUSER WITH ALL OTHER DIFFUSERS ACHIEVING DESIGN. [2] INFORMATION TAKEN FROM VFD. RECIEVED PERMISSION FROM CAPTIVE AIRE TO PUSH UNIT TO UNIT STICKER FLA (27.0A) BASED ON UNIT VOLTAGE OF 204V. [3] SERVED BY RIGHT HMI (THERMOSTAT) IN OFFICE.

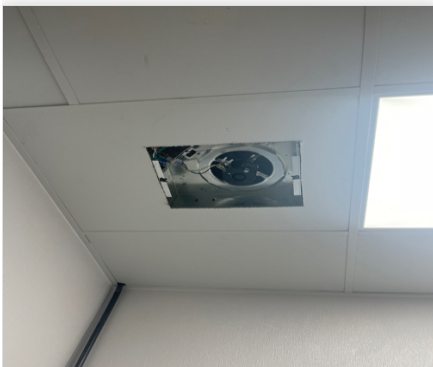
**Issue Name :** EF-1A (mop room) cover not yet installed.

**Description :** EF-1A fan cover not yet in place.

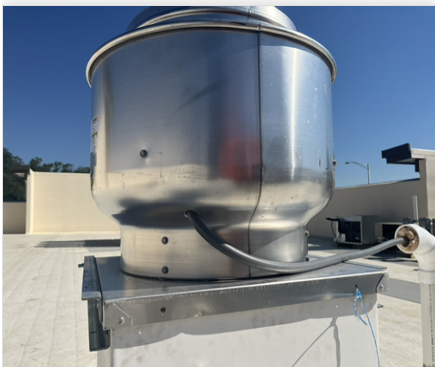
**Issue Name :** PRV-2 and PRV-3 conduit drilled through fan housing.  
**Description :** Conduit was routed/drilled through fan housing. Typically is routed through motor housing exhaust vent.  
**Created By :** National TAB **Assigned To :** National TAB - Will Turnbough  
**Status :** Open  
**Originated Date :** 08/18/2022 - Michael McDonnell - National TAB

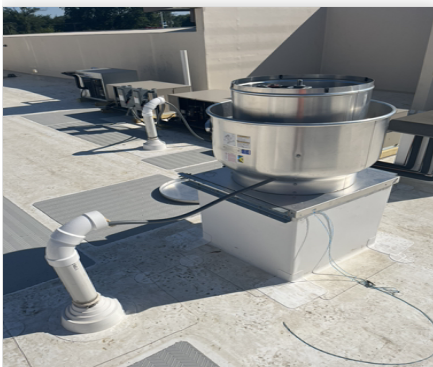
**Issue Name :** PRV-2 and PRV-3 conduit too short.

**Description :** Conduit to fans is too short. Need enough slack to be able to tilt fans completely back for maintenance/grease duct cleaning. EC notified and will rectify today.

- **08/19/2022**      **National TAB - Michael McDonnell**
  - EC was able to demonstrate fans can be completely tilted back.

- **08/18/2022**      **National TAB - Michael McDonnell**
  - EC was able to tilt fans completely back and says conduit is fine.

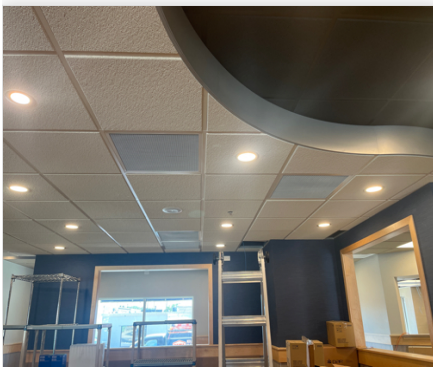
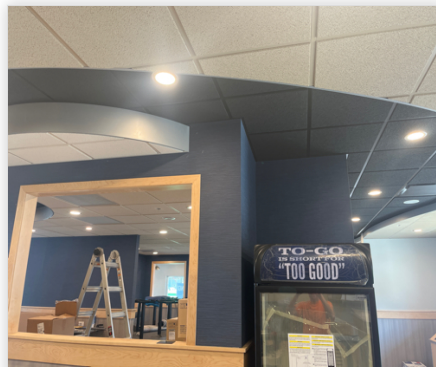
**Issue Name :** RTU-1 (dining) missing return.  
**Description :** Plans call for (5) 16" returns. (4) 18" returns are installed, and not in precise locations.  
**Created By :** National TAB **Assigned To :** National TAB - Will Turnbough  
**Status :** Open  
**Originated Date :** 08/18/2022 - Michael McDonnell - National TAB

- **08/19/2022 National TAB - Michael McDonnell**
  - Due to limited ceiling space MC increased size of returns from 16" to 18" and deleted one return grille. Unit is achieving design airflow and return not causing issues.

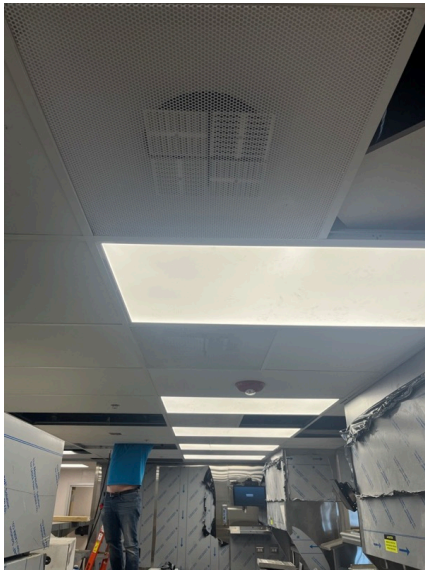
RTU-2  
Cookline diffusers perforated.

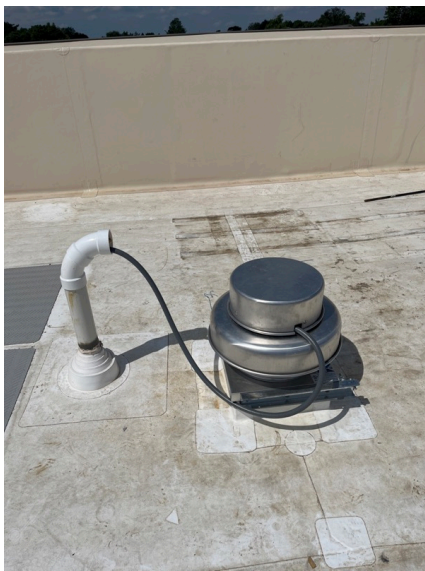
PRV-1  
Restrooms

Notes: [1] FAN NOT BALANCED DUE TO INCORRECT ROTATION. SINGLE PHASE MOTOR COMES FACTORY WIRED AND CANNOT BE CHANGED IN THE FIELD. ACCUREX IS SENDING REPLACEMENT.

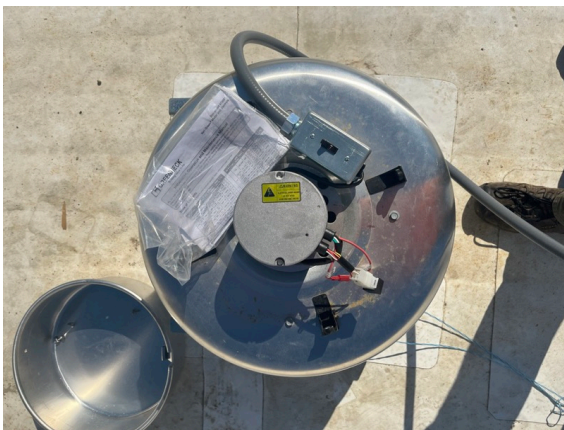
PRV-1  
Disconnect and speed controller installed.

PRV-1  
Speed controller

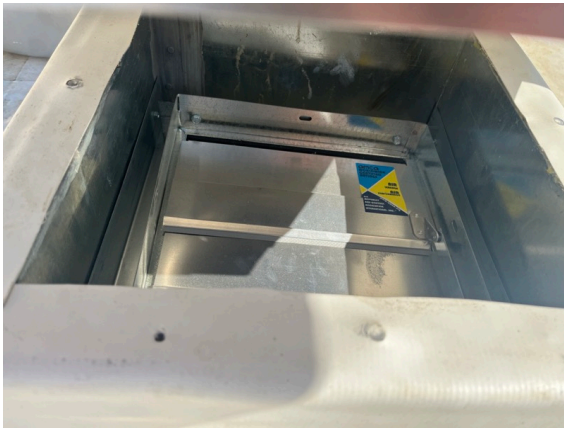
PRV-1  
Backdraft damper installed and functional

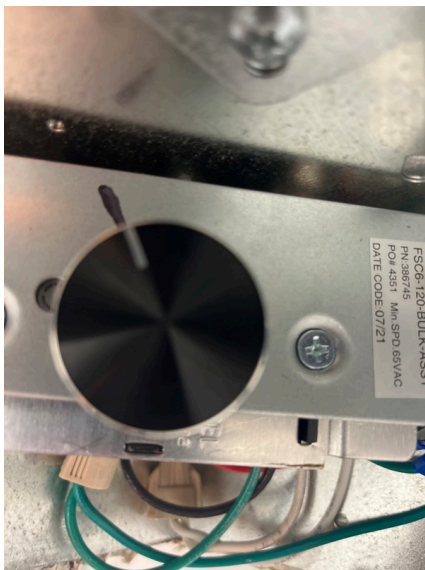
EF-1A  
Speed controller marked. Set to max.

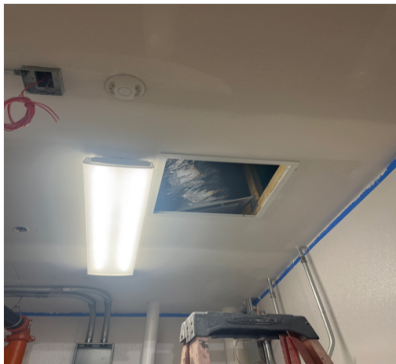
Diffuser 2-14 not yet installed. 10" neck diffuser shipped to site. MC is installing a 12-10" reducer on the diffuser. RTU-1 only has 4 returns installed. Plans call for 5.
