08-15 CULVERS - WHEATON, IL

Project Issue Information

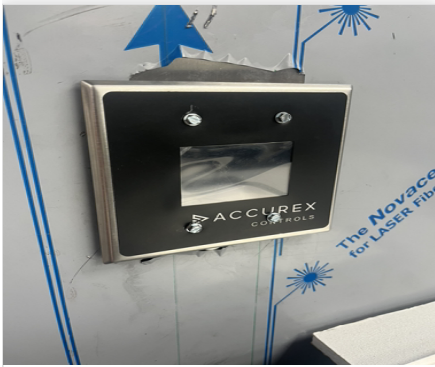
Issue Name : Accurex hood control screwed through.

Description : Typically the hood control screen clips into the wall box. In this instance the incorrect box was installed in the wall.

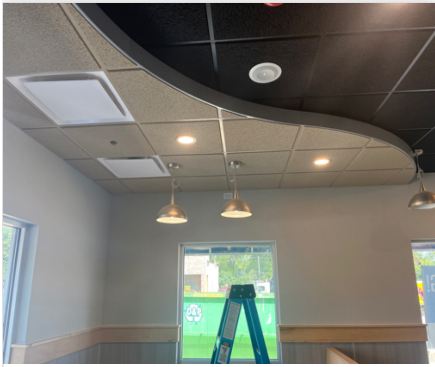
Issue Name : Diffuser 1-11 in wrong location.

Description : Lighting installed in ceiling tile for diffuser. Not anticipated to cause any issues.

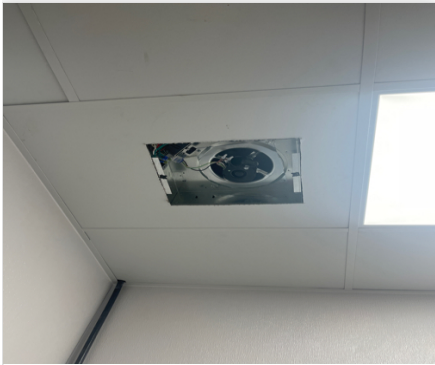
Issue Name : EF-1A (mop room) cover not yet installed.

Description : EF-1A fan cover not yet in place.

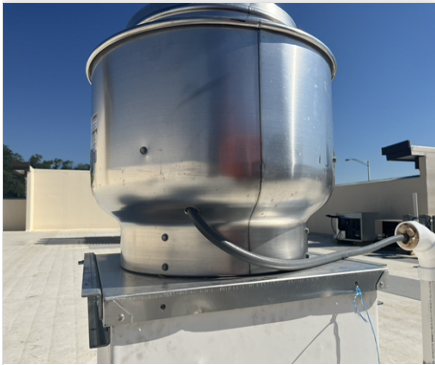
Issue Name : PRV-2 and PRV-3 conduit drilled through fan housing.
Description : Conduit was routed/drilled through fan housing. Typically is routed through motor housing exhaust vent.
Created By : National TAB **Assigned To :** National TAB - Will Turnbough
Status : Open
Originated Date : 08/18/2022 - Michael McDonnell - National TAB

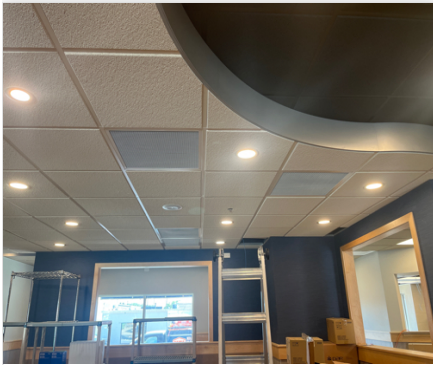
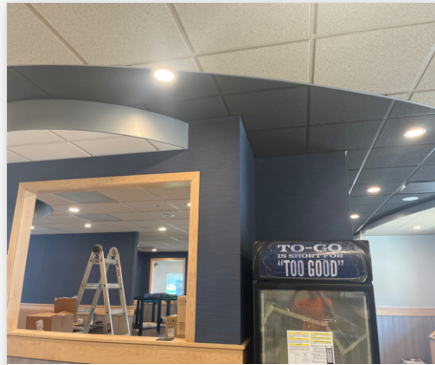
Issue Name : RTU-1 (dining) missing return.
Description : Plans call for (5) 16" returns. (4) 18" returns are installed, and not in precise locations.
Created By : National TAB **Assigned To :** National TAB - Will Turnbough
Status : Open
Originated Date : 08/18/2022 - Michael McDonnell - National TAB

- **08/19/2022 National TAB - Michael McDonnell**
 - Due to limited space MC increased size of returns from 16" to 18" and deleted one return grille. Unit is achieving design airflow and return does not seem to be causing any issues.
