Report: TAB REPORT
Function: Test, Adjust, & Balance
Date: 07/03/2024

07-01-24 Pet Supplies Plus, Marion OH

Project Summary

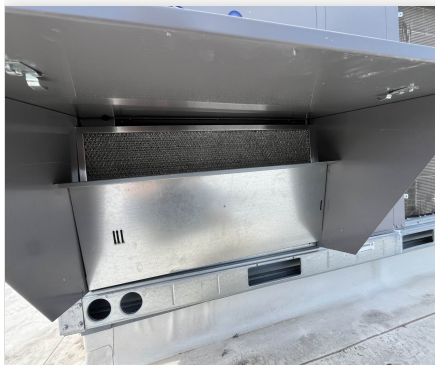
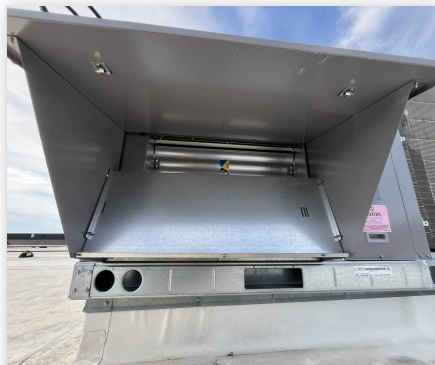
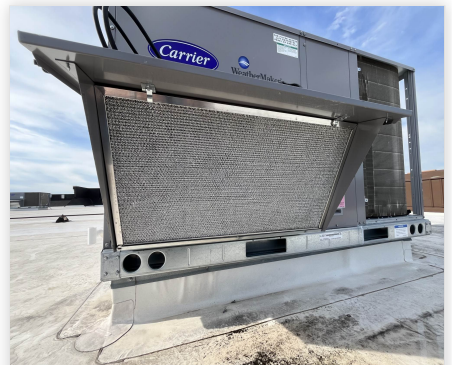
Issue Name : RTU 1 and RTU 3 OA intake hoods were installed incorrectly; reinstalled correctly by TAB technician.
Description : RTU 1 and RTU 3 OA intake were hoods installed incorrectly; reinstalled correctly by TAB technician.
Created By : National TAB **Assigned To :** National TAB - Will Turnbough
Status : Open
Priority : InfoOnly **Asset Tag :**
Originated Date : 07/04/2024 - Cody Collett - National TAB

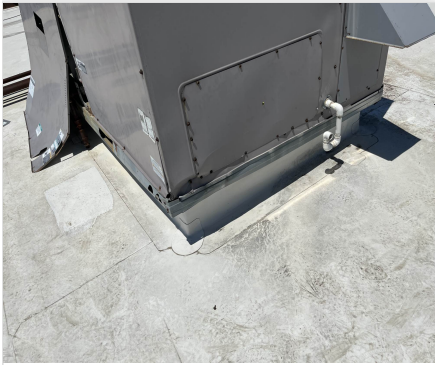
Issue Name : RTU 2 mangled/bent near unit discharge causing leakage.
Description : RTU 2 mangled/bent near unit discharge at the roof curb causing leakage.
Created By : National TAB **Assigned To :** National TAB - Will Turnbough
Status : Open
Priority : High **Asset Tag :** RTU2
Originated Date : 07/04/2024 - Cody Collett - National TAB
