Report: FINAL TAB REPORT
Function: Test, Adjust, & Balance
Date1: 09/22/2022

08-29 ARBY'S #5451 - OKMULGEE, OK

Project: 08-29 ARBY'S #5451 - OKMULGEE, OK

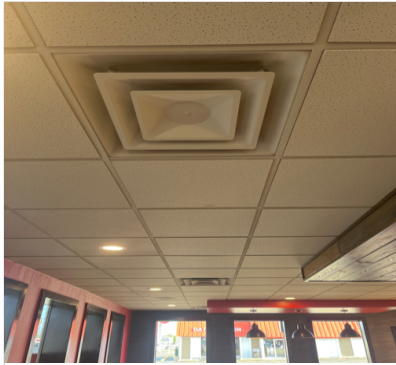
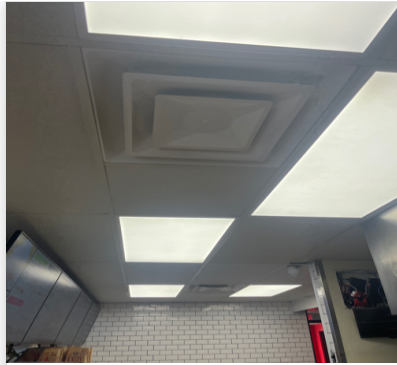
Take pictures of diffusers in the dining and kitchen. Are there "Plaque" style diffusers installed (ie., 4-way diffusers with the flat face). No

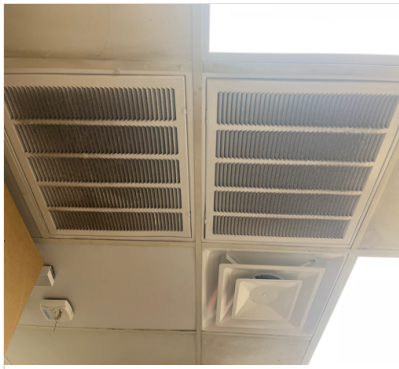
All hood filters installed and accounted for?	Yes
Any drafting occurring?	No
Any Comfort issues noticed or manager statements?	Yes
Any significant or abnormal ventilation noise in dining or kitchen?	No
Do return grilles in kitchen or dining have significant amount of dirt buildup that might impact airflow?	Yes

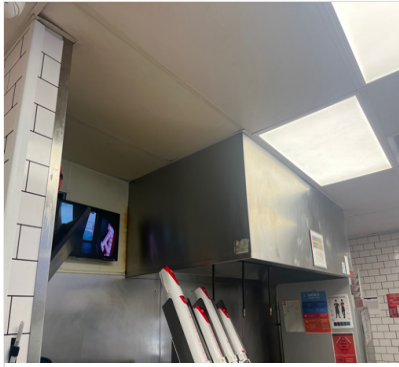
Do ceiling tiles near the hoods have any evidence of staining that might indicate an issue with hood performance?

Yes

[1] MANAGER STATED KITCHEN GETS HOT AND HUMID. FRYER HOOD DOES NOT CAPTURE WELL WHEN ALL FRYERS ARE DROPPED AT ONCE (LUNCH RUSH).

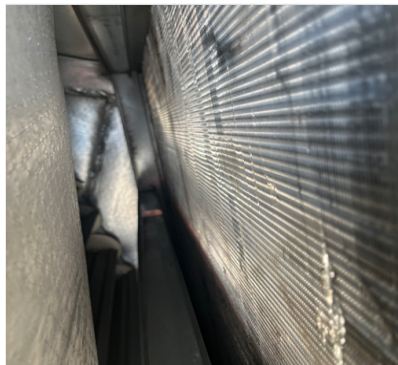
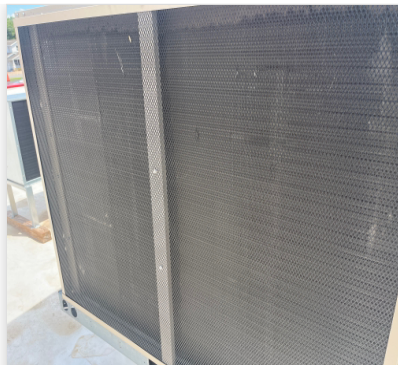
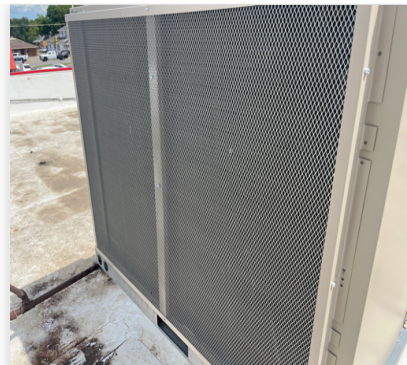
Economizers are assembled and functional?	Yes
Free cooling enthalpy set point set for lowest setting (Typically "D")	Yes
Are belts tight and in good condition?	Yes
If direct drive unit is the speed controller working?	No
Is gas piping installed and valves turned on?	Yes
Are the condenser coils free of damage and clean? (Take picture)	Yes

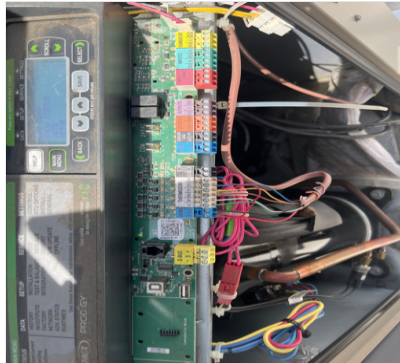
Take pictures of the electrical compartment including the low voltage wiring Yes

Are the humidity sensors wired properly? No

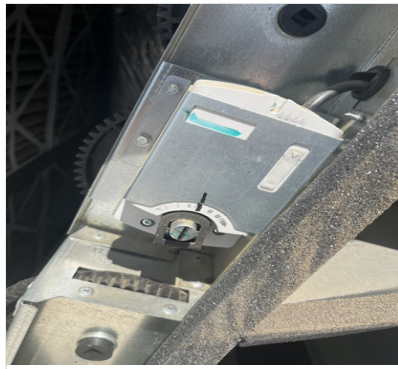
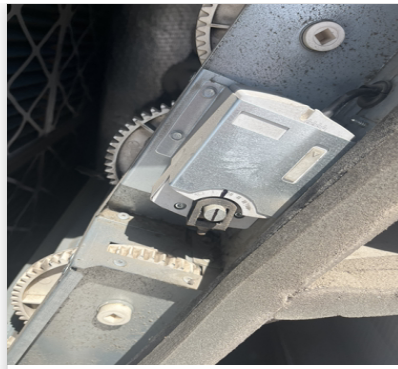
Final damper position is clearly marked with permanent marker or white out? Yes

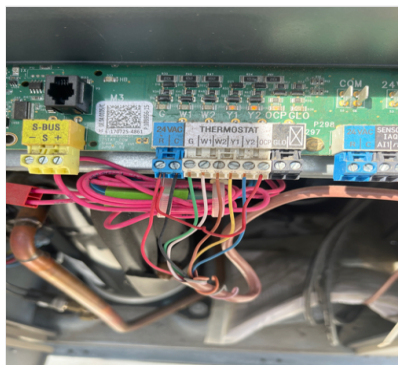
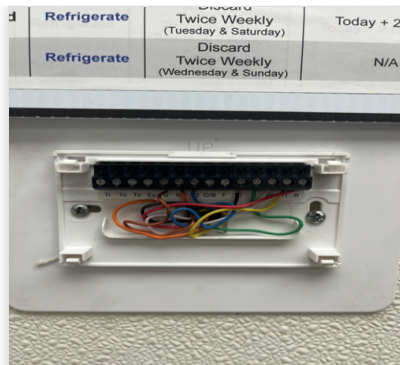
For Honeywell Pro 8000 (TH8321R) thermostats, make sure it is set up for "Commercial", "2 Stage", and "A" terminal is wired and assigned to "Economizer"	Yes
For Lennox Comfort Sense CS7500-CS8500 thermostats, make sure the "EC" terminal is wired, set up for 2 stage operation, stage delay timer is off, and stage 2 differential is 1.5F	EC terminal not wired on RTU-2 THERMOSTAT.

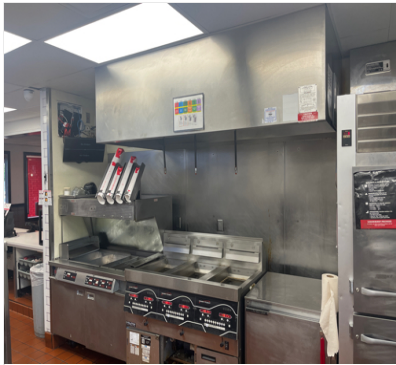
HOOD 1

Hood has self-compensating style supply which is causing turbulence inside the hood canopy no matter the MAU volume. Smoke wants to drift out left side of hood and far-left front of hood. Recommend left end panel is installed.

Notes: [1] HOOD CAPTURE IS 85-90%. SMOKE WANTS TO DRIFT OUT THE LEFT SIDE AND FAR-LEFT FRONT OF HOOD. SELF-COMPENSATING SUPPLY IS CUASING TURBULANT AIR WITHIN THE CANOPY NO MATTER AIR VOLUME. RECOMMEND END PANEL IS INSTALLED ON LEFT SIDE. ARE TO COVER IS 19" X 42"
